INSPECTION PROTOCOL

Chervonooskol hydropower plant
and the adjacent territory near the village of
Oskil
Izyum district
Kharkiv region

"18" May 2023

Continuation of the inspection report of the scene of the incident: Chervonooskil hydropower plant, located at
Kharkiv region, Izyum district near the village of Oskil

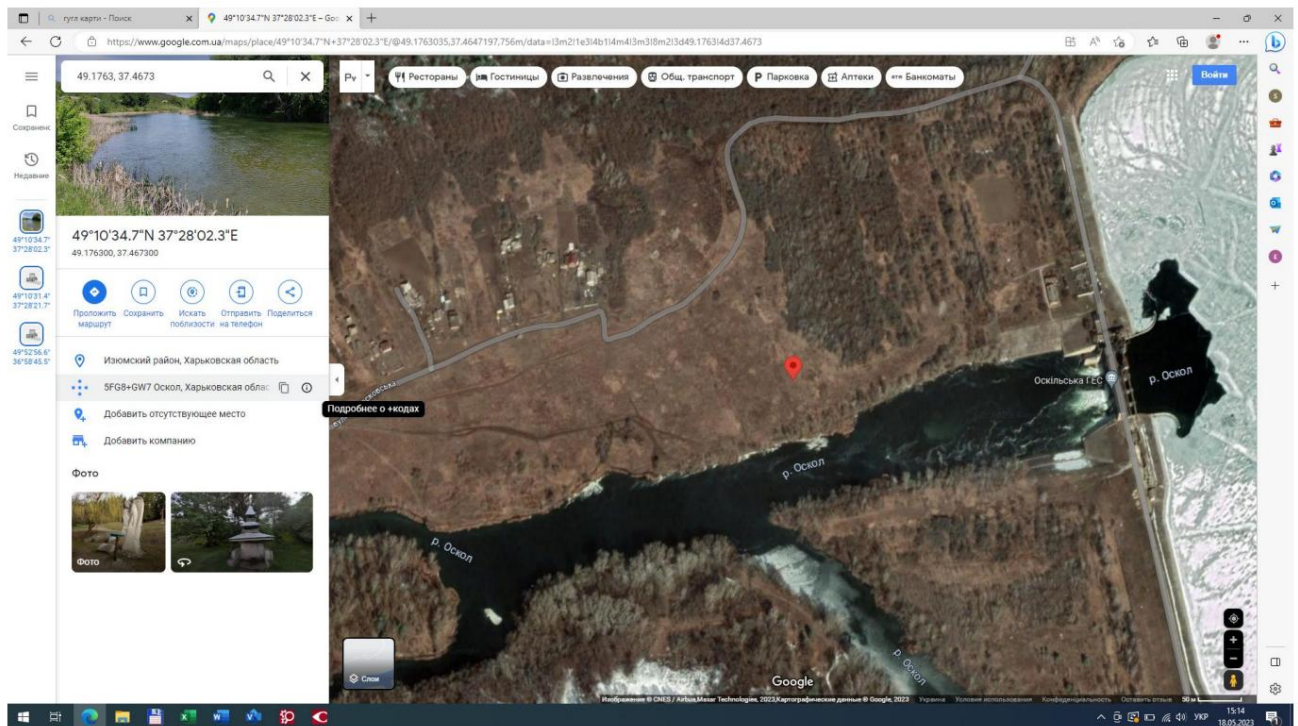
Image #2

Thus, during the inspection of this territory, a crater from an aircraft shell with a diameter of 14 m and a depth of 4 m was discovered, where a fragment was found near it, which, according to specialists, is a fragment from the tail part of an OSHAB 500 aircraft bomb with the marking "336-7" applied in black paint (in shape and size), which was removed from the inspection site. According to Legutskyi O.P., these aerial attacks took place on 09/17/2022.

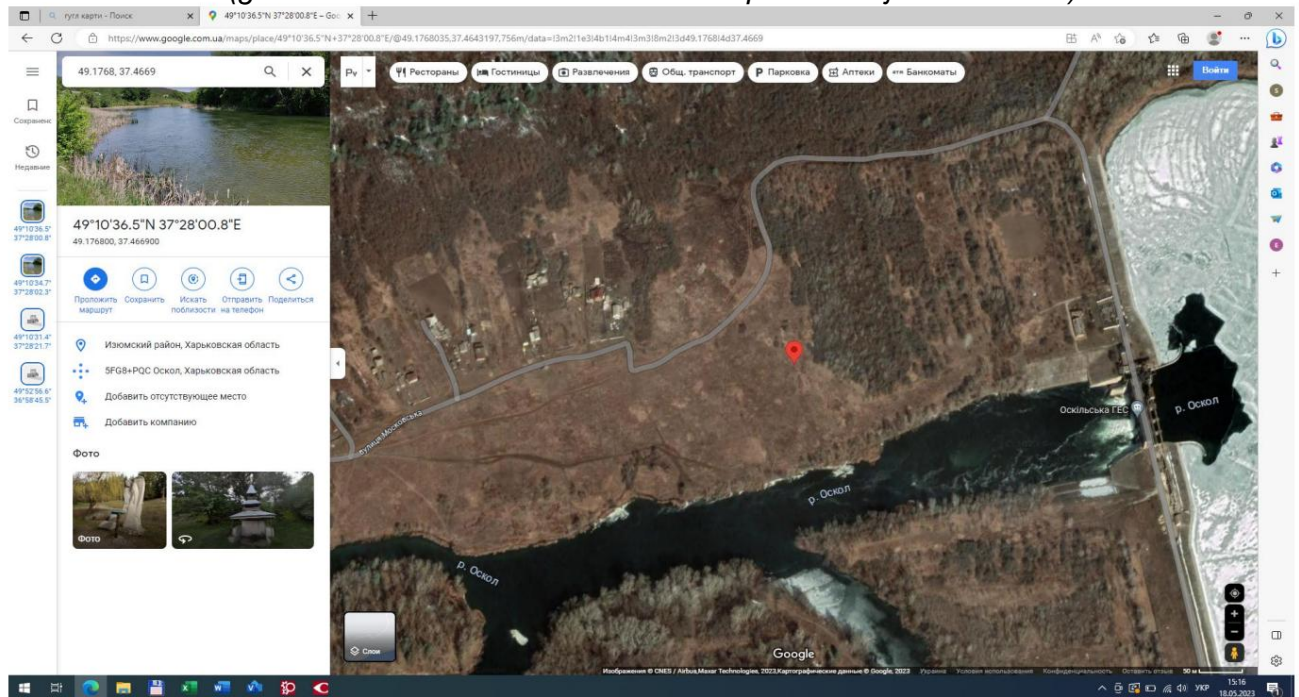
Image #3

Thus, during the inspection of this territory, a crater from an aircraft shell with a diameter of 6 m and a depth of 2.1 m was discovered, where 3 fragments were found near it, which, according to specialists, based on the characteristic dimensions of the crater, the shape and size of the fragments, are fragments of an FAB 250 aircraft bomb, which were removed from the inspection site. These aerial attacks, according to Legutskyi O.P., took place on 09/17/2022.

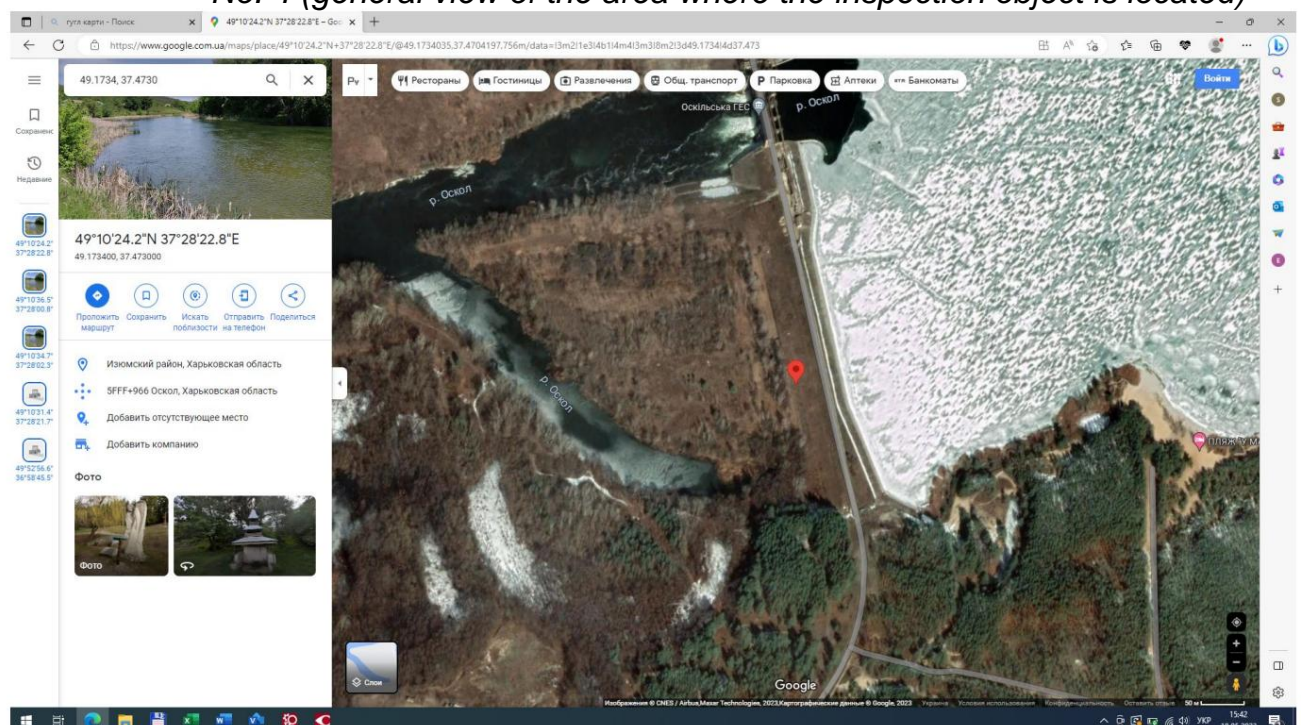
No. 4 (general view of the area where the inspection object is located)

Thus, during an inspection of this territory on the slope of the dam from the side of the Oskil River, closer to the exit from the territory of the Chervonooskilska HPP (hydroelectric power plant), **2 craters were discovered, each about 1.5 m in diameter and up to 30 cm deep.**

Further **down the dam, closer to the forest belt and bushes**, near one of them, a fragment of an air bomb with a **diameter of 55 cm, a length of 1.1 m, and a thickness of 10 cm was discovered**, which was marked "541.021 OTK 370 TA 77*73 No. 3908", which, according to the specialist, is a fragment of a likely concrete-piercing air bomb, the detonation of which did not occur during the fall, the explosive burned out, as evidenced by the corresponding traces of burning and soot. This fragment was not removed from the inspection site, given its size and weight.
