REPORT

Marcelo Tunnel Inspection - Lama

Barrick Exploraciones Argentinas S. A., Proyecto Pascua Lama

March 20, 2018

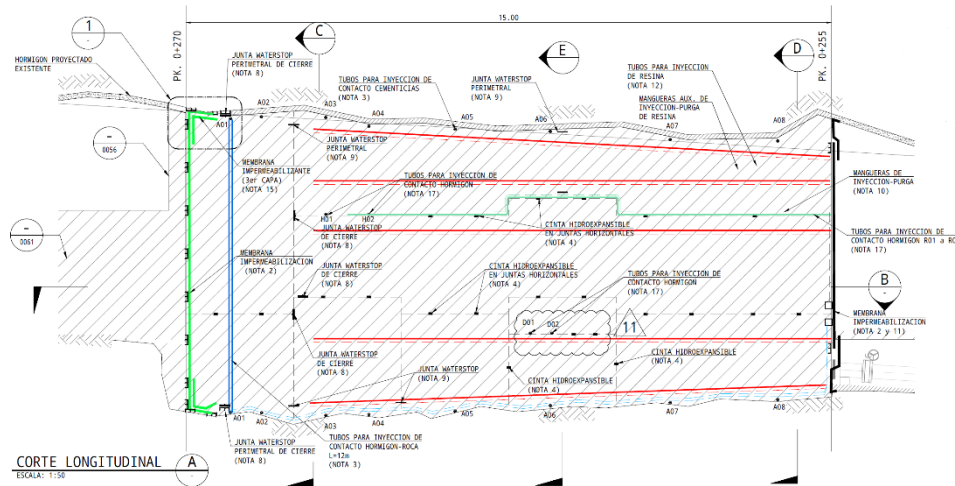
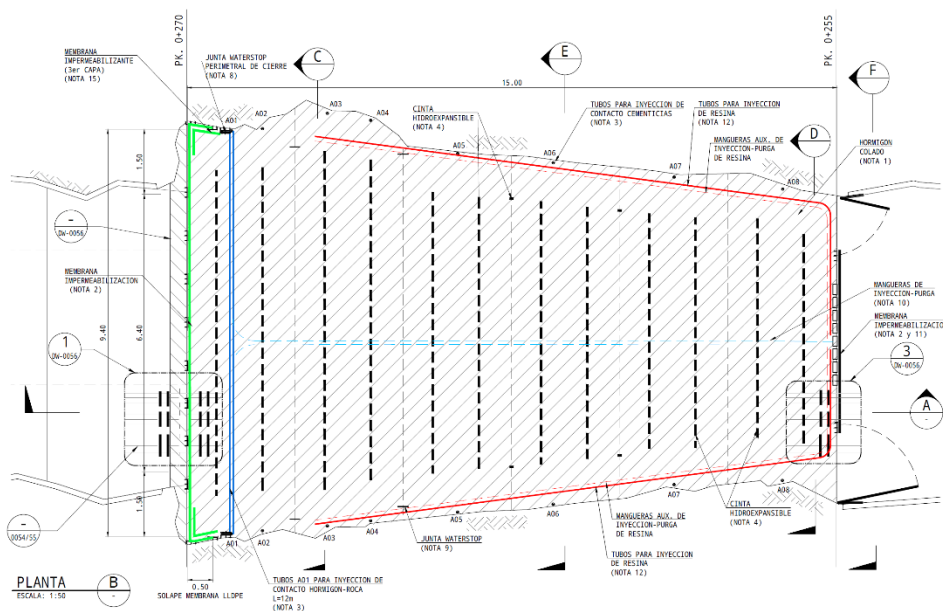
Figure 1: Plug design - shape and size (after BEASA12210-2211-C-DW-0013-11)

The tunnel was enlarged in the upstream side of the plug and tapered towards the downstream side. This wedge shape for the plug guarantees that there is a good mechanical contact between the concrete and the rock, without the need to rely solely on the frictional resistance of the interface (see Figure 1).

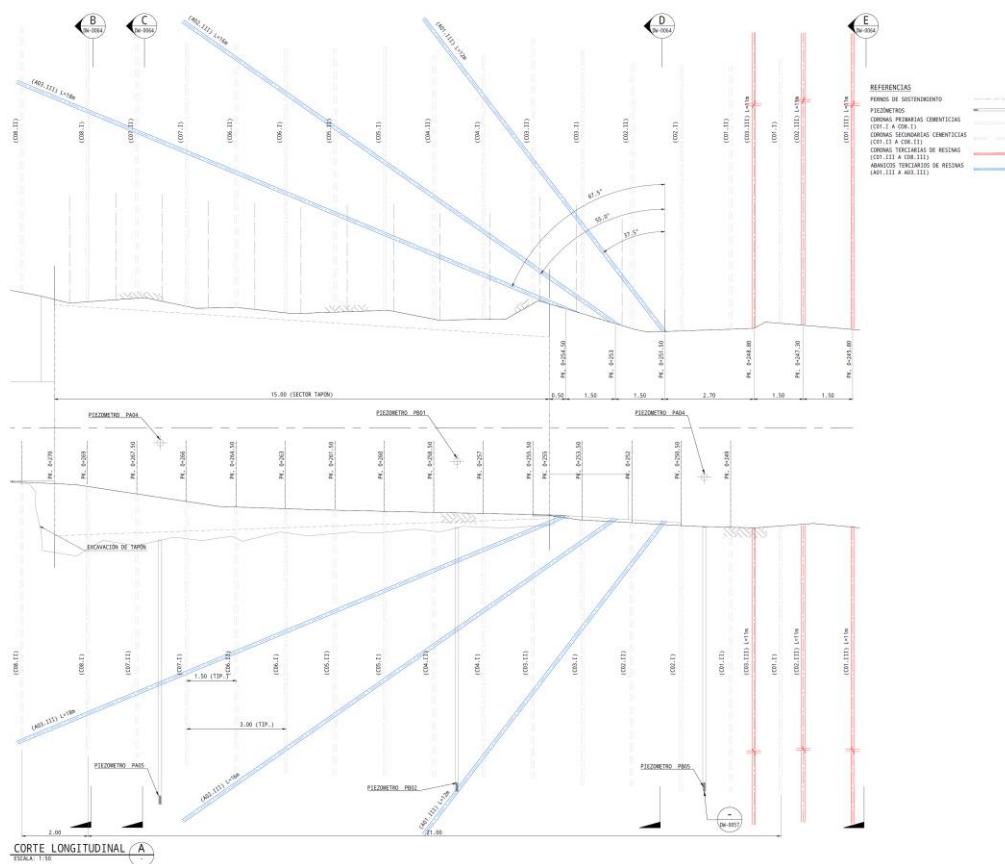
Figure 2: Layout of grouting holes (after BEASA12210-2211-C-DW-0059-6)

After the construction of the plug, a series of angled holes were drilled for the purpose of resin grouting the plug section, and an additional set of radial holes on the downstream side of the plug also for resin grouting (see Figure 2).

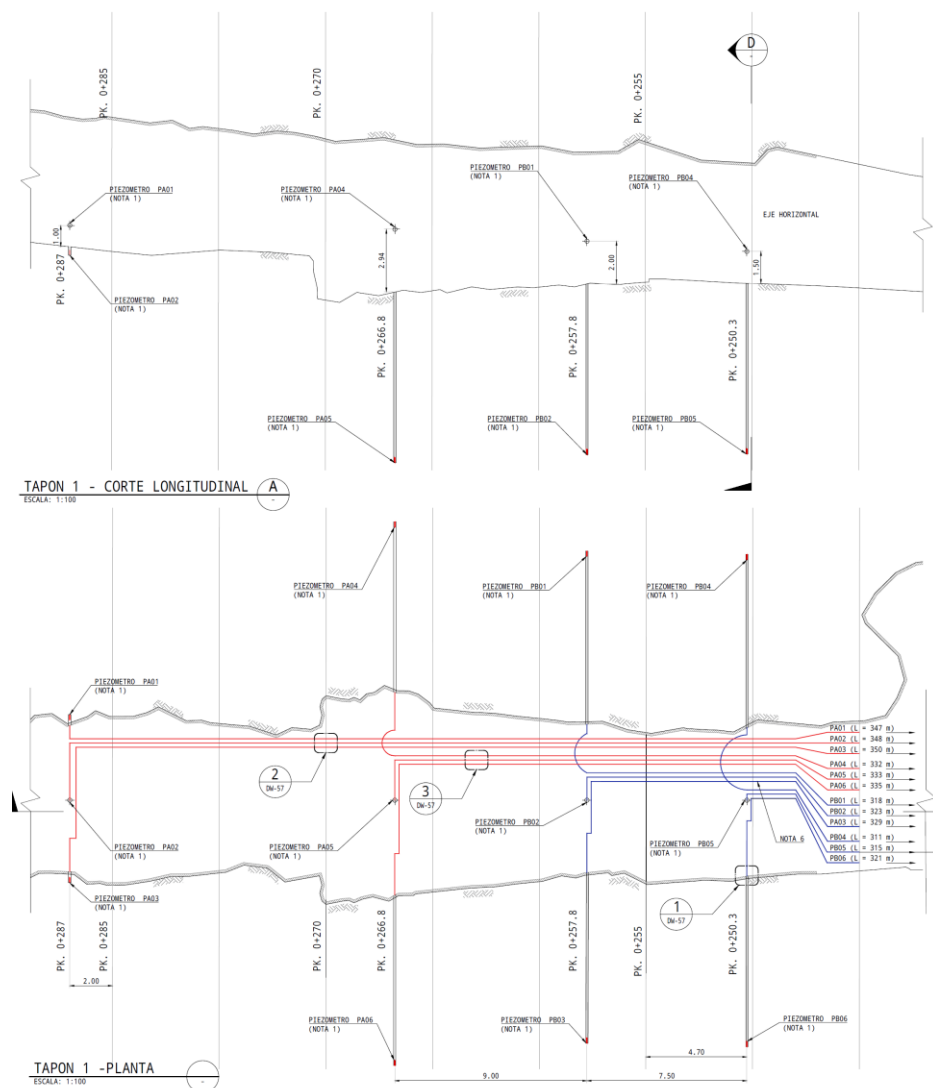
Figure 3: Location of piezometers (after BEASA12210-2211-J-DW-0057-3)

A series of piezometers were installed at 4 sections of the tunnel. Three piezometers were installed at each section (2 on the sidewalls, 1 in the floor). One section is upstream of the plug and the piezometers are installed close to the tunnel walls and floor. In the other 3 sections the piezometers were installed 8 m deep into the rock. Two of these sections are within the plug section and the other section is on the downstream side of the plug (see Figure 3).

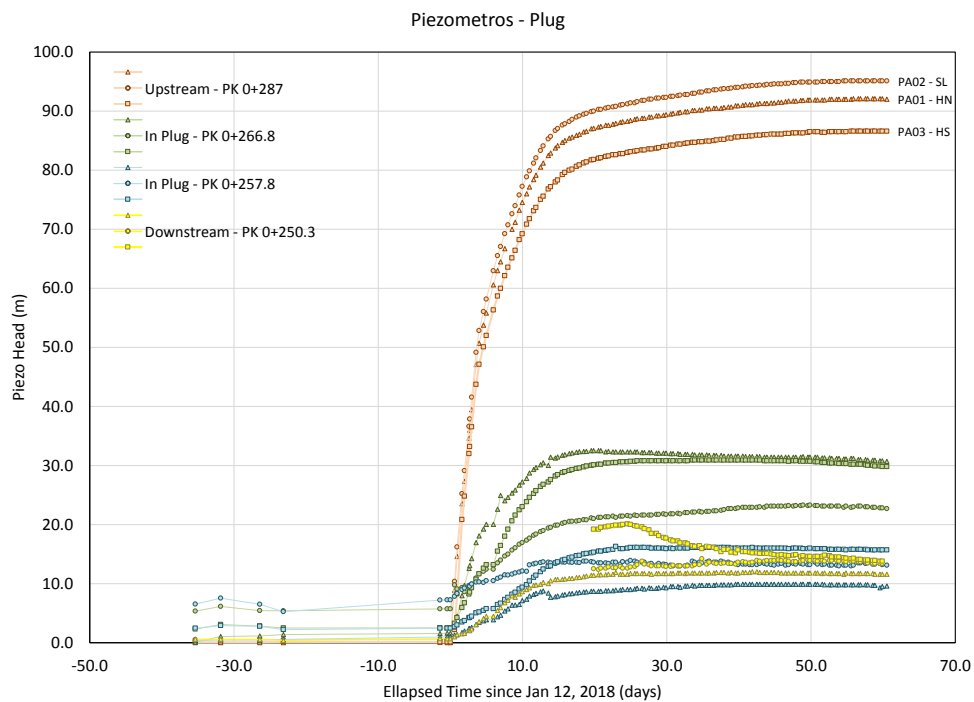
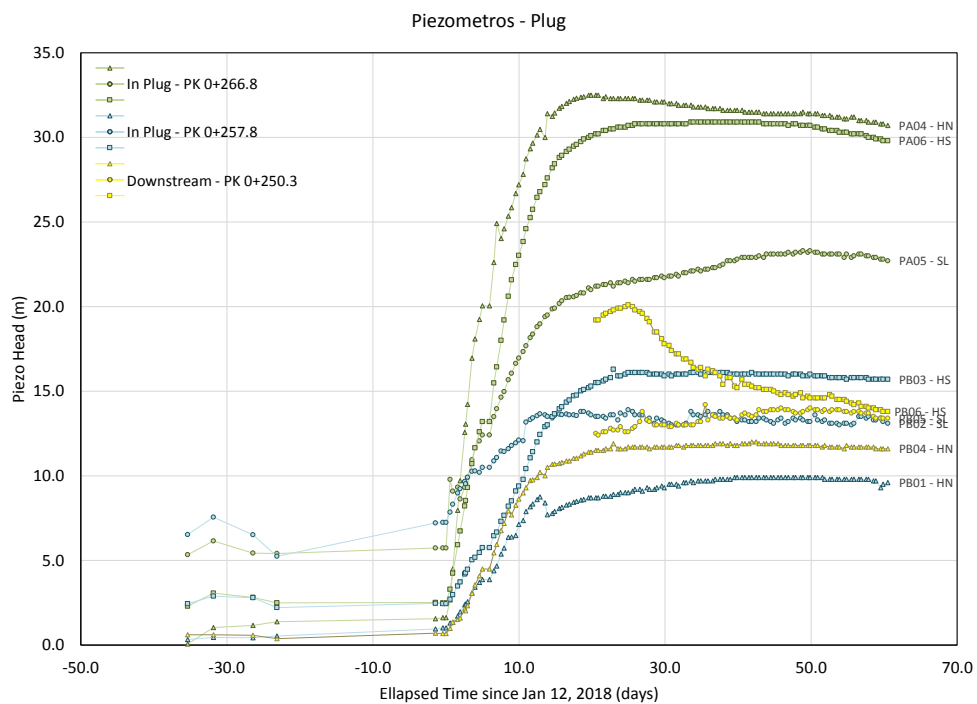
Figure 4 and Figure 5 show the time history of the pressure head in the piezometers. It took about 20 days to reach 95% of the full head, and 60 days after completion of the plug, the pressure head has stabilized on all piezometers. The pressure head on the downstream of the plug is between 10 and 15 m, with the higher head on the south sidewall. Figure 6 shows the flowrate history as a result of seepage through the rock around the plug. The flow rate reduced dramatically from 137 L/s to 2.5 L/s at the completion of the plug, and 60 days after completion it seems to be reaching a steady state flowrate of about 8 L/s. After the planned contact grouting is completed, it is expected that the flowrates will reduce further.

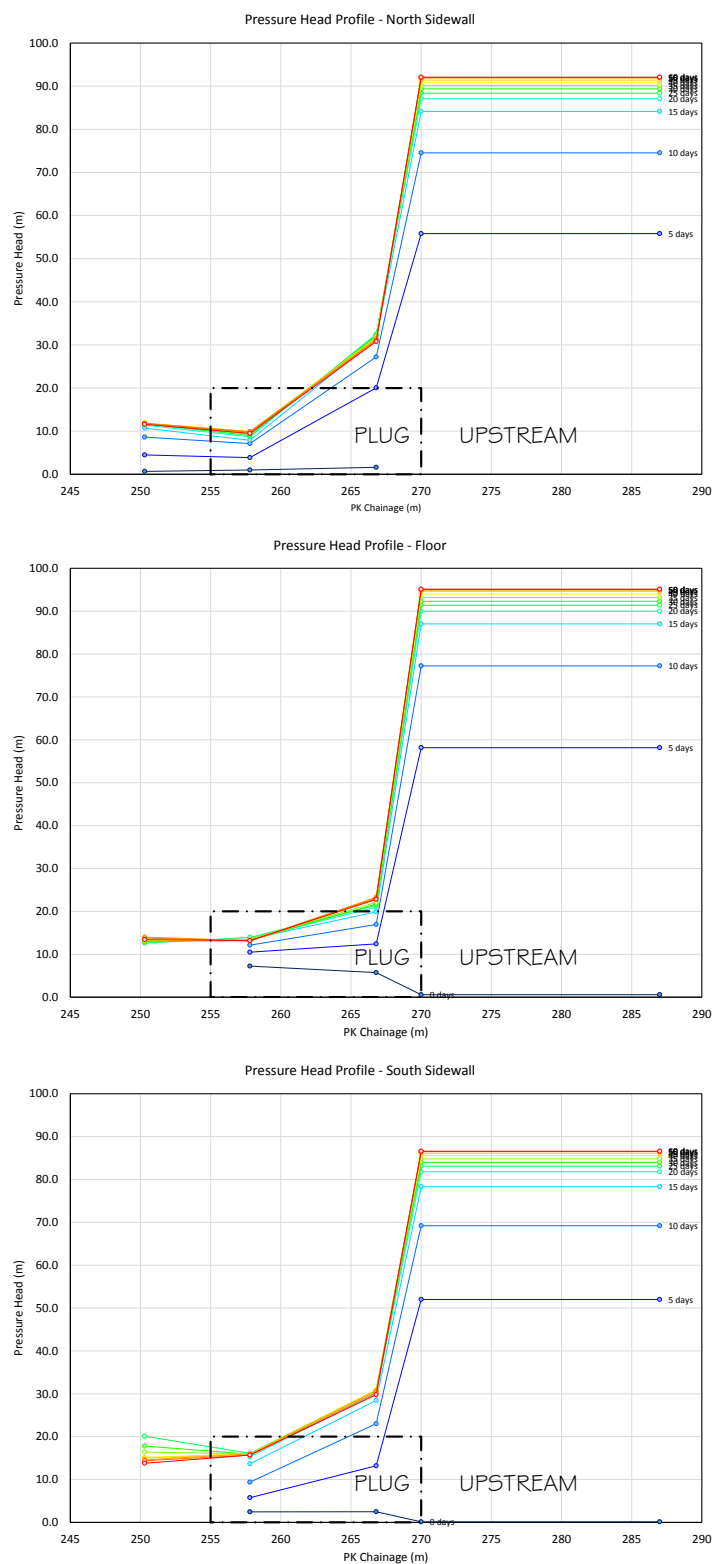
Figure 7: Pressure head profile in the rock around the plug

Figure 7 shows the pressure head profiles across the plug for the piezometers in the sidewalls and the floor. The average pressure head on the upstream side of the plug near the sidewalls and the floor is about 91 m. The pressure head drops across the plug to about 28 m at PK 0+266.8, and to about 13 m at PK 0+257.8. At the downstream array (PK 0+250.3) the average head is 13 m.
