**SP2 Report**

**Survey and Review of Current Rehabilitation and Coating Technologies for  
Many Entry Sewer Pipes and Manholes with Protective Coatings**

**Part 2: COATING PERFORMANCE**

**Date: 2nd December 2011**

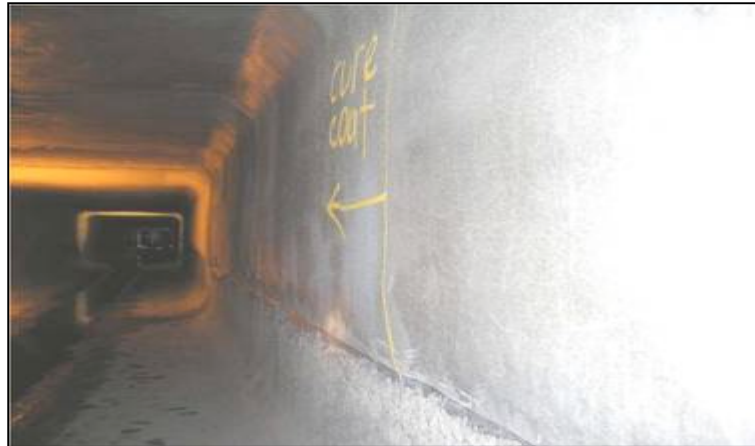
Figure 2. CAC Application Trial in SWSOOS 2007, SW showing minor crazing after 18-19 years of service, otherwise intact and in good conditions.

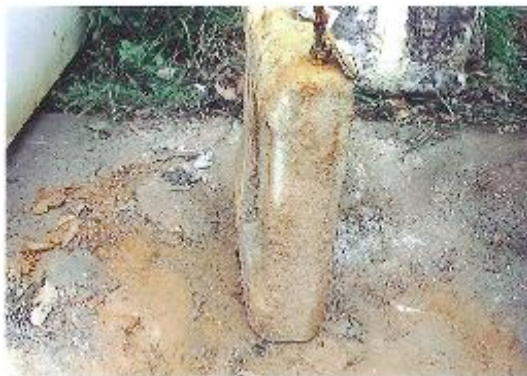
Sewpercoat, 3 years, 4 mm corrosion

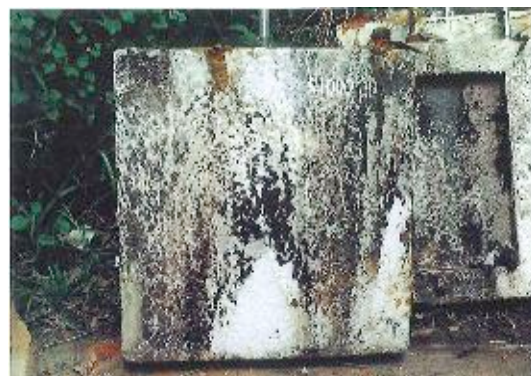
Polyester, 3 years, flaking and cracking

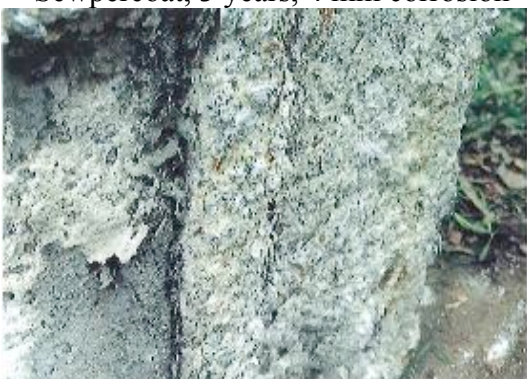
Water impermeable membrane, 3 years, 15 mm corrosion

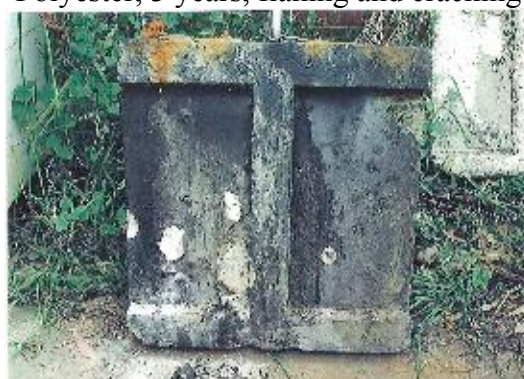
Epoxy coal tar, 3 years, blister, 10 mm concrete corrosion

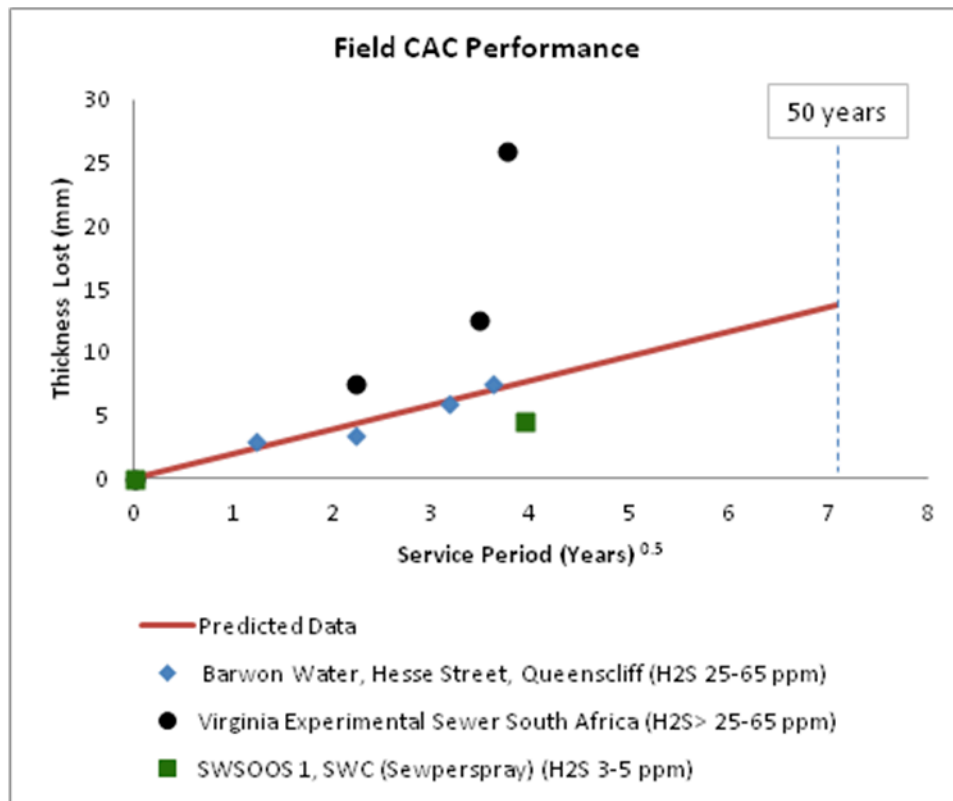
coating. Similar field test result from Virginia experimental sewer in South Africa (Goyns 2008) and in SWSOOS1, SW are included in Figure 4. The lower CAC thickness loss in SWSOOS 1 and higher loss in Virginia sewers are consistent with the H<sub>2</sub>S concentrations in these sites. SWSOOS1 typically has between 3-5 ppm of H<sub>2</sub>S and although Virginia sewer conditions were not reported, the higher material loss suggest the H<sub>2</sub>S here is > than 25-65 ppm experienced in Barwon Water. At the Virginia site, OPC was corroding 4 times faster than CAC at the rate of 7.5 mm/yr. The two interesting features of these results are one the early performance of CAC in SW and Virginia sewer and their close fit to the low rate of material loss in Barwon Water. This suggests that CAC could reasonably provide adequate protection within 12-13 years when H<sub>2</sub>S concentrations are at least below 65 ppm. The later performance, particularly in Virginia shows rapid corrosion, indicative of the challenge in using early data to predict the long term performance of CAC. The rapid

corrosion is attributed to CAC conversion. The conversion of CAC, which is inevitable, converts its mineralogy to the more reactive phase.
