# Home Survey

Address: 57 Oak Ridge Rd, Pleasantville, NY 10570  
Survey Date: March 15, 2023  
Surveyor: Jane Smith

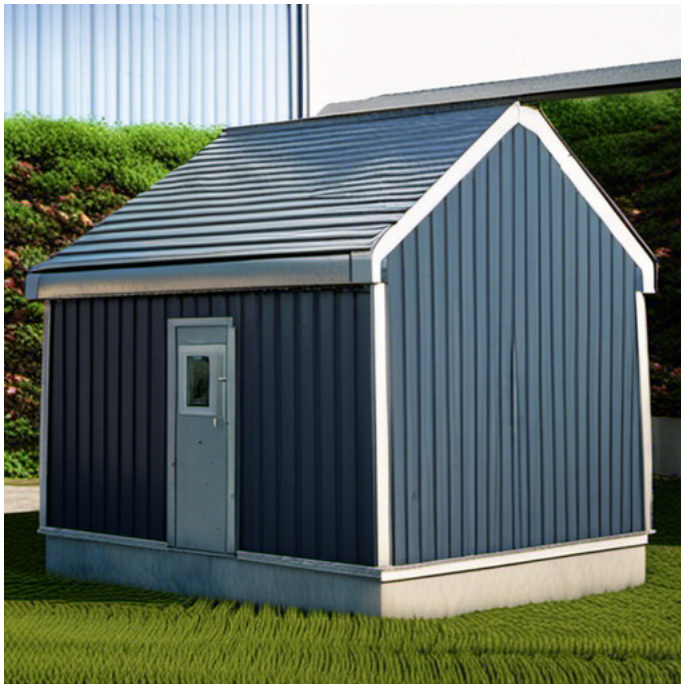
### Roof

Type: Metal  
Estimated Age: 15 years  
Condition: Good  
Notes: No visible defects.

The roof may need replacement in the next 5-10 years based on its age.

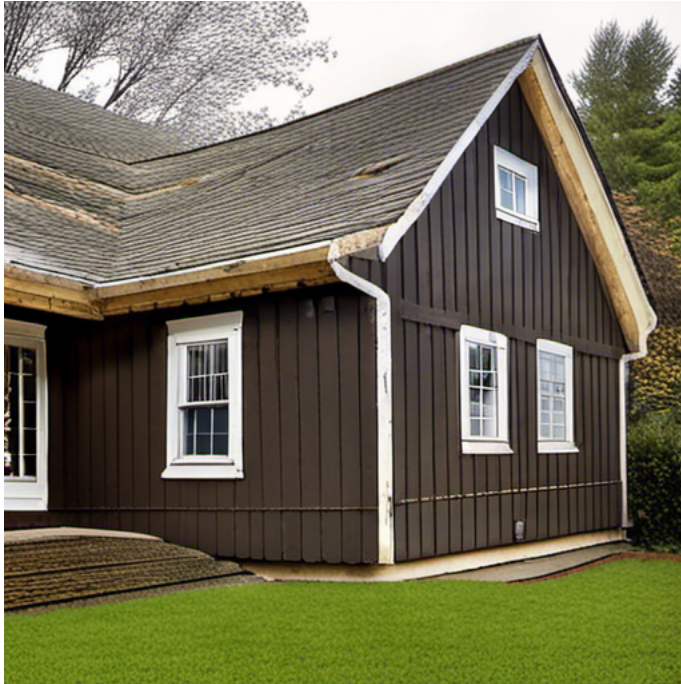
## Siding

Type: Wood

Condition: Poor

Notes: Extensive rot, paint peeling in many areas.

- Repair basement crack and inspect for moisture
- Replace wood siding
- Replace windows
- Upgrade electrical system
- Replace HVAC system
- Refinish hardwood floors
- Replaster cracked walls/ceilings
