# Home Survey

Address: 123 Main St, Anytown, CA 12345  
Survey Date: June 1, 2023  
Surveyor: John Doe

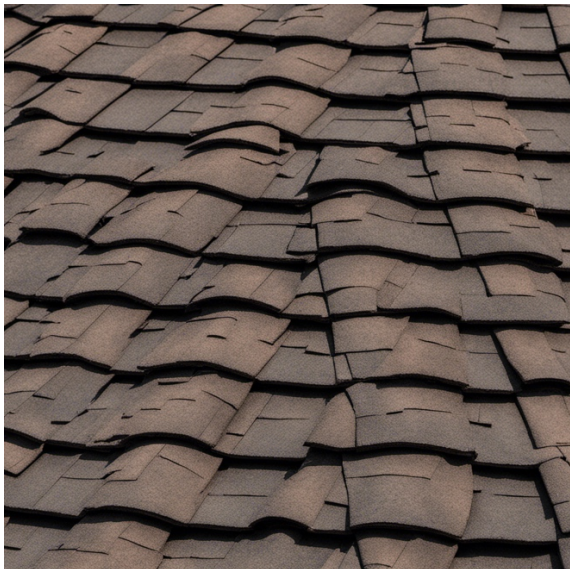
### Roof

Type: Asphalt shingles  
Estimated Age: 8 years  
Condition: Good  
Notes: A few missing shingles on the southwest corner.

- Repair/replace missing roof shingles
- Replace cracked/buckling siding
- Upgrade ungrounded outlets
- Service HVAC system
- Investigate kitchen ceiling water stain
- Plan for eventual deck replacement

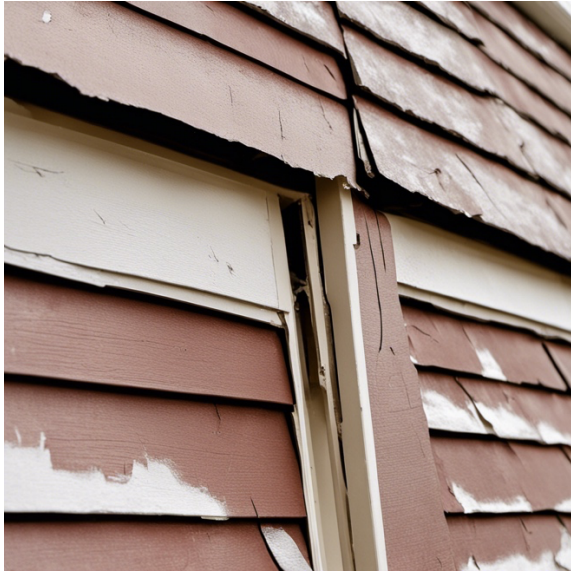
### Siding

Type: Vinyl

Condition: Fair

Notes: Several areas with cracked or buckling siding.
