Home Survey

Address: 17 Maple Ave, Springfield, IL 62702

Survey Date: April 10, 2023

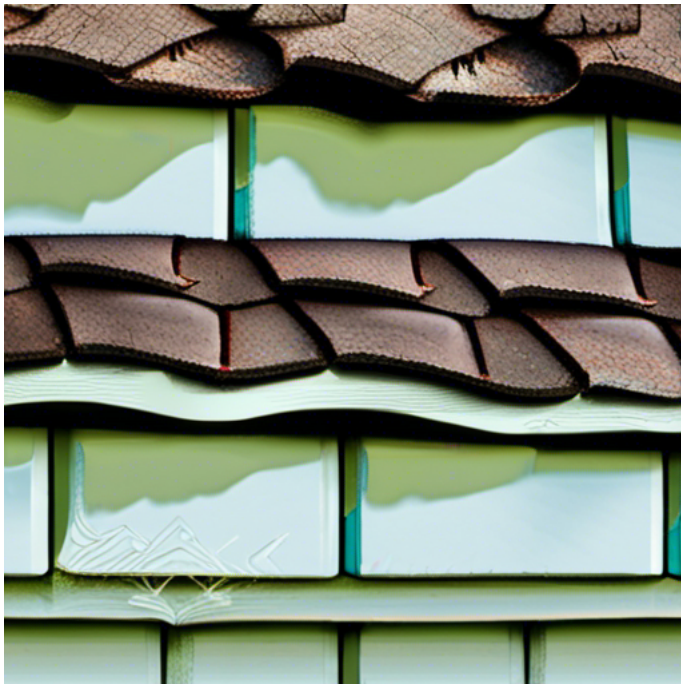
Roof

Condition: Poor

Notes: Shingles are curling/losing granules, likely needs replacement soon.

- Plan for roof replacement soon
- Replace foggy windows
- Service/repair HVAC system
- Replace swollen/cracked flooring
- Repair drywall cracks
- Investigate garage leak and repair
