Full Corrosion Inspection Report

Report Type:	Automated Corrosion Inspection
Inspection Date:	January 12, 2026
Inspection Time:	12:07 AM
Total Evaluations:	3
System:	RustVision AI (YOLOv11)
Generated By:	Automated Detection System

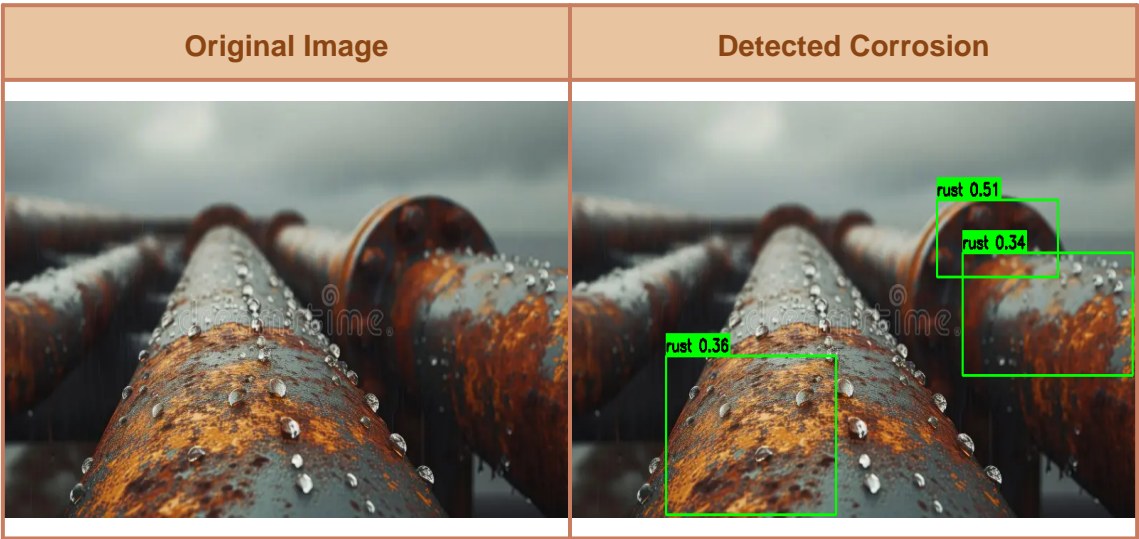
Inspection #1

Detection Class:	Corrosion/Rust
Confidence Level:	84.0%
Severity Rating:	Medium
Status:	Requires Review

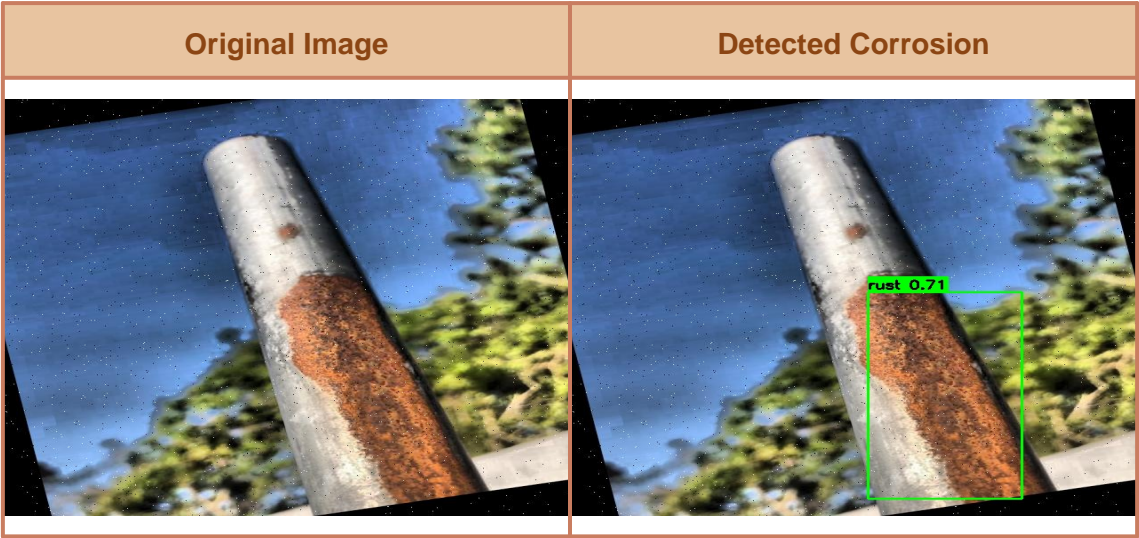
Inspection #2

Detection Class:	Corrosion/Rust
Confidence Level:	85.0%
Severity Rating:	Medium
Status:	Requires Review

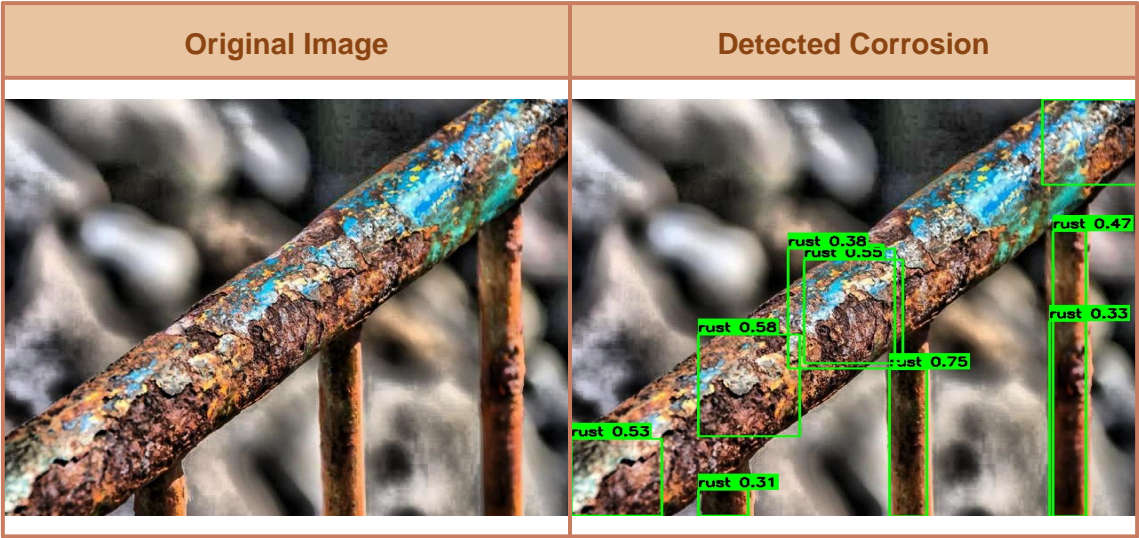
Inspection #3

Detection Class:	Corrosion/Rust
Confidence Level:	79.0%
Severity Rating:	Medium
Status:	Requires Review
