## No. 51/09 Marine Version 3

### Transmittal

**Title: Introduction of Leaffield GIST hose assembly, c/w bayonet termination at both ends. Applies only to new build and Non-Operationally Packed new build liferafts.**

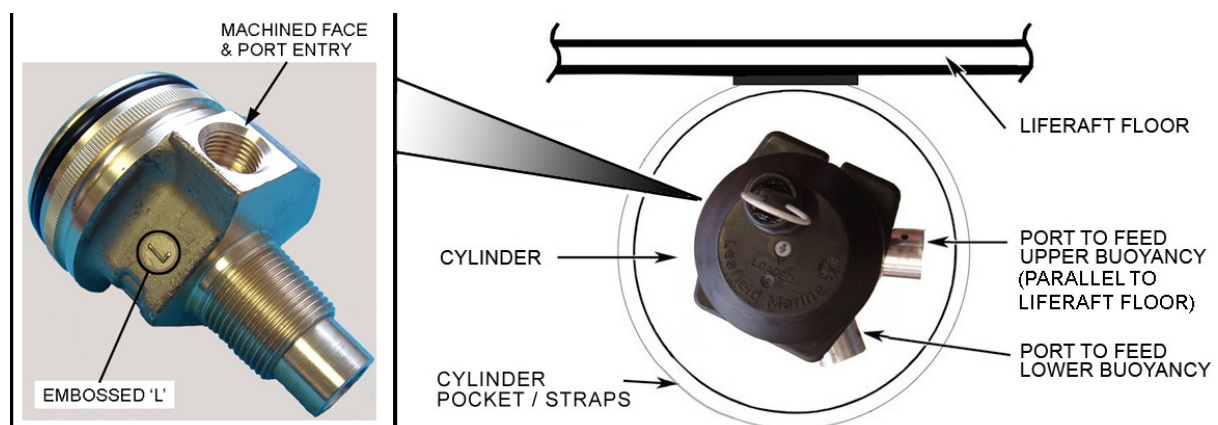
Documented procedures for the operational packing of MkIII and MkIV liferafts specify the position of the cylinder valve/hoses relative to the liferaft floor, (FIGURE 01), and container, (FIGURE 02). These procedures ensure the serviceability of the inflation equipment during operational packing and use.

**FIGURE 01**  
**Cylinder and hose positioned correctly in relation to liferaft floor**

5.1.9 Continue with the documented assembly procedures. At all times, ensure the cylinder is orientated so that the upper buoyancy hose runs parallel to the liferaft floor, (FIGURE 01). The lower buoyancy hose will be automatically in the correct position, (FIGURE 06).

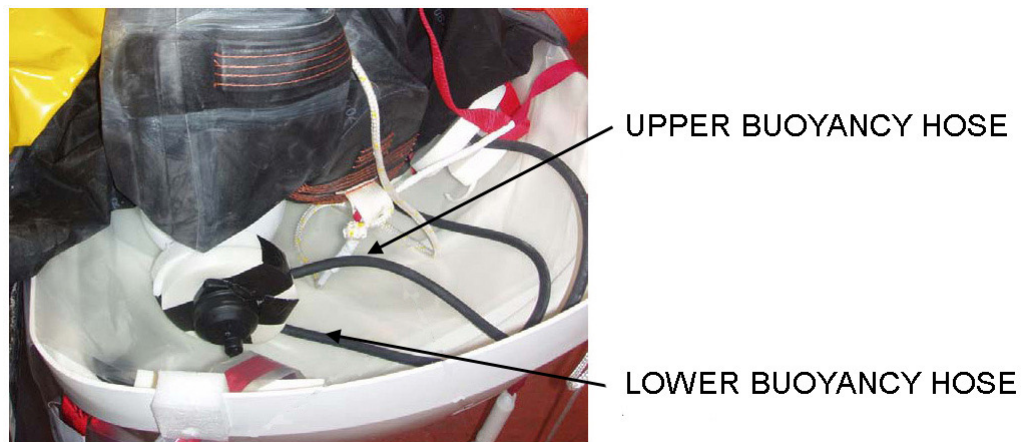
**FIGURE 02**  
Correct orientation of cylinder head in relation to container

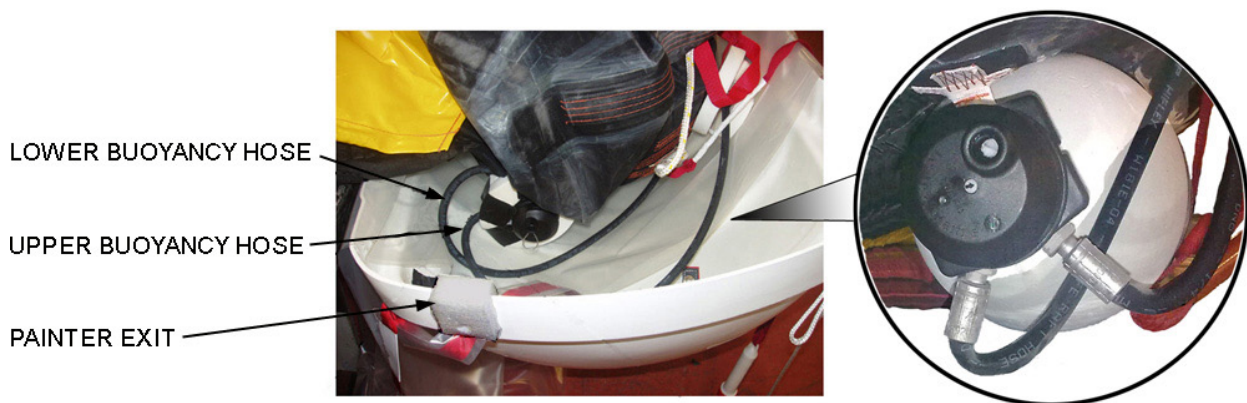
It is possible to position the cylinder within the container so that the hose to the upper buoyancy is unsuitably aligned, relative to the raft hull and container, (FIGURE 03). An incorrectly arranged upper buoyancy hose would also place the lower buoyancy hose in a potentially unsafe position, which could result in the lower buoyancy hose becoming damaged.

**FIGURE 03**  
Incorrect orientation of cylinder head/hoses in relation to container

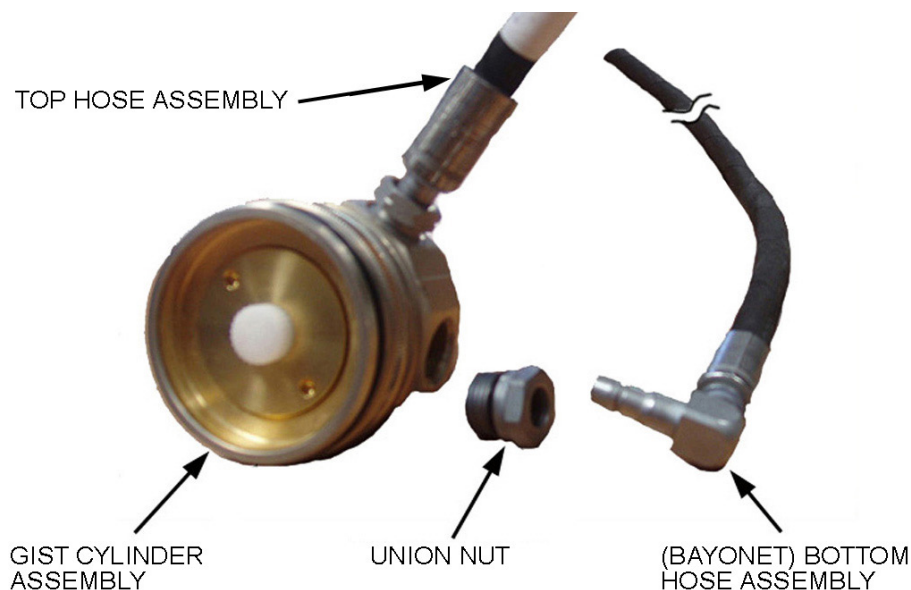
**FIGURE 05**  
**Cylinder and hose assembly**  
**(exploded view shown for clarity)**

5.1.6 Insert the union nut/hose assembly into the appropriate threaded outlet port of the cylinder valve, (FIGURE 05).

5.1.7 Tighten the Union nut to the cylinder valve using the correct torque value of 19 Nm  $\pm$  1 Nm.

5.1.8 The new hose assembly c/w double bayonet fittings is shown in, (FIGURE 05). It is connected to the cylinder valve via a new Union nut c/w O-ring.

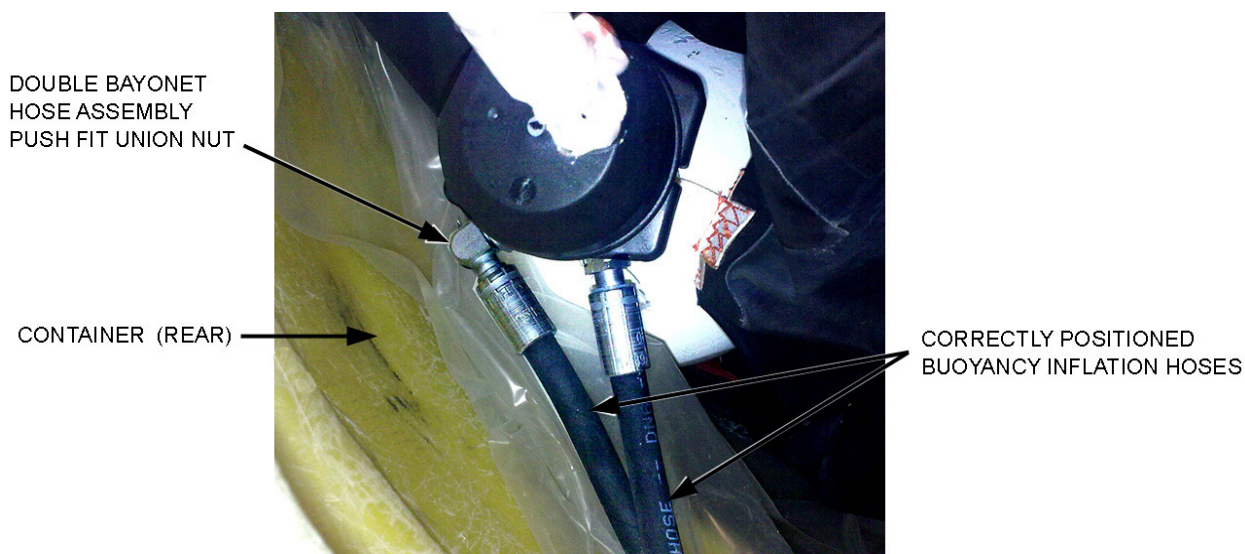
**FIGURE 06**  
**Correct alignment of new hose assembly**
