## New Machine Setup Report

Machine	: Laser Marking	Reference No.	: CMR-S1609-902-003
Section	: CP PX Line	Report By	: Zulhisham Tan
Control No.	: -	Date	: 30th Sept '2005
Subject	: Control Point	Sheets	: 1

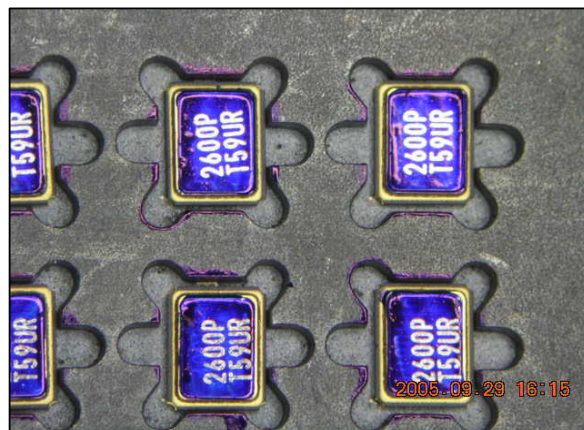
1. **Magazine Unit** - Cause Marking Shift  
The operators are require to have proper handling when loading the Tray into the Magazine due to the gap exist between the workpiece and the tray.

In order to address the item No. 1 ~ No. 3. The Tray tolerance needed to be reduce in order to prevent Marking Shift without additional care on human handling.

- 1.) Special Tray for Laser Marking Machine.
- 2.) Modify the machine in order to operate in Semi-Auto mode.
- 3.) Modify the machine in order to add in the Work Piece Aligner unit.

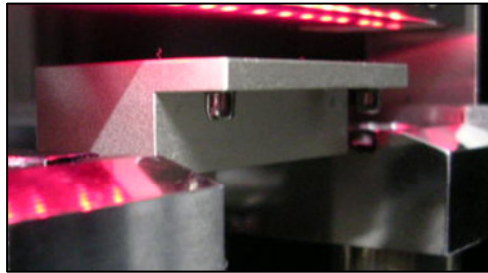
2. **Transportation Unit** - Cause Marking Shift

The operator were required to fully load the tray into the magazine unit. Otherwise, the Puller unit may hit the Tray and cause the workpiece shift at the Tray.

The speed of the Air Cylinder is another factor.

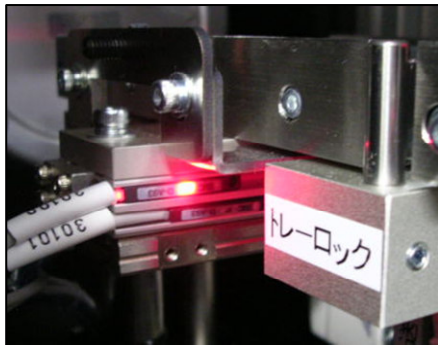
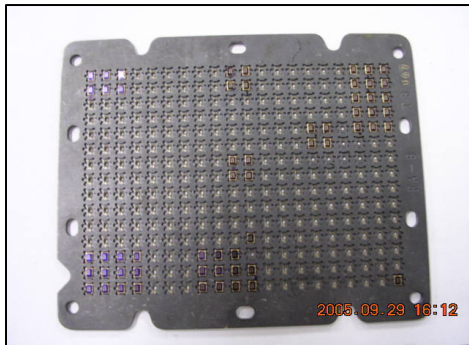
3. **Tray Lock Unit** - Cause Marking Shift

The Alignment and the Air Cylinder Speed adjustment is critical issue since the unit having direct contact to the tray.

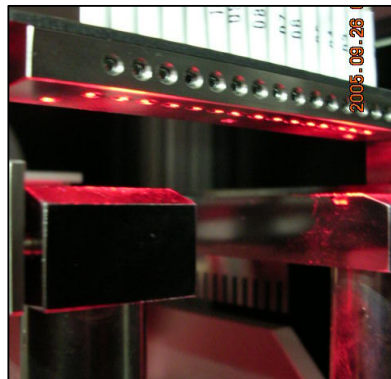
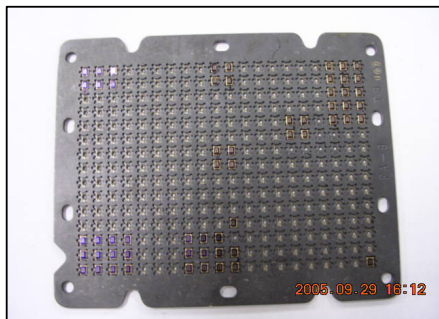
4. **Workpiece detection sensor** - Cause No Marking

The sensor are used to detect the workpiece at the Tray. The idea is, the Shutter of the Laser will not 'ON' when there is no workpiece at the Tray.

However, thing was not happened as expected. The Laser is shooting in random sequence.

The cause of the problem was not identified yet.

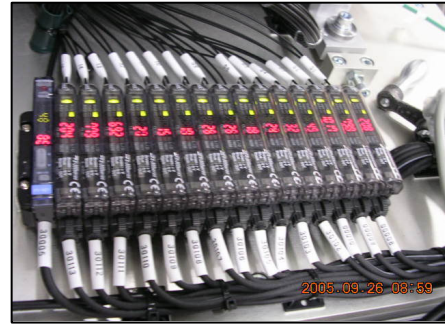
The sensitivity of the sensors and the Sensor CAM Adjustment may cause miss detection.

Miss detection will cause no marking, the operators are required to do 100% re-inspection and re-do marking for miss detected work piece.
