Home Inspection Report

**Address: 518 N Stoneman Ave, Alhambra, CA
91801**

**Inspector: Tyler Molloy
Agent: Not Applicable
Report Number: TM01102424
Date of Inspection: 10/24/2024**

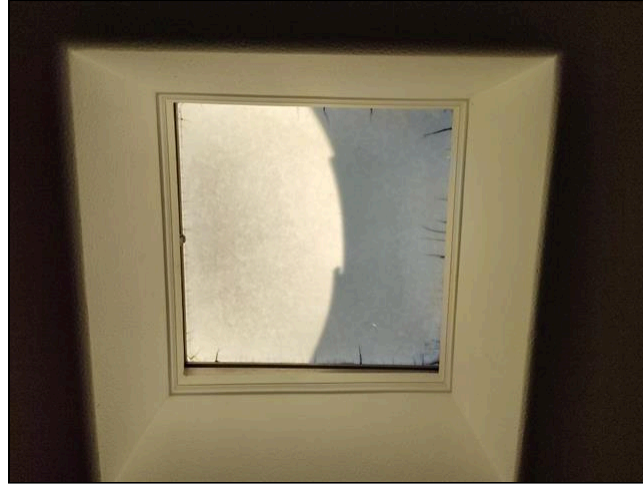
1.5 Item 1(Picture)

Cracks observed skylight above 2nd level hallway This condition could lead to water intrusion. Recommend replacement.

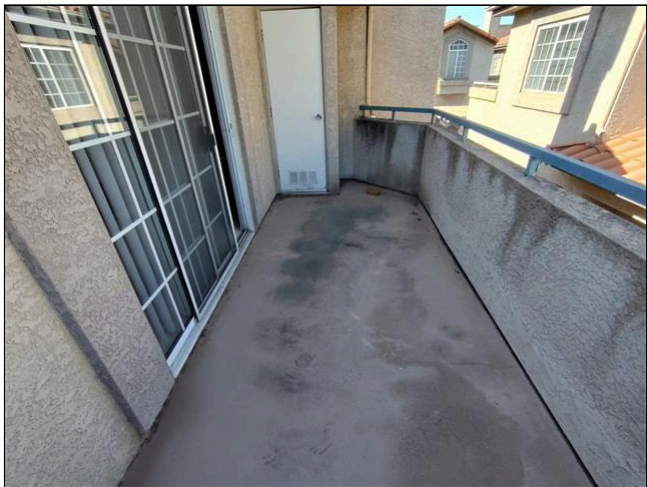
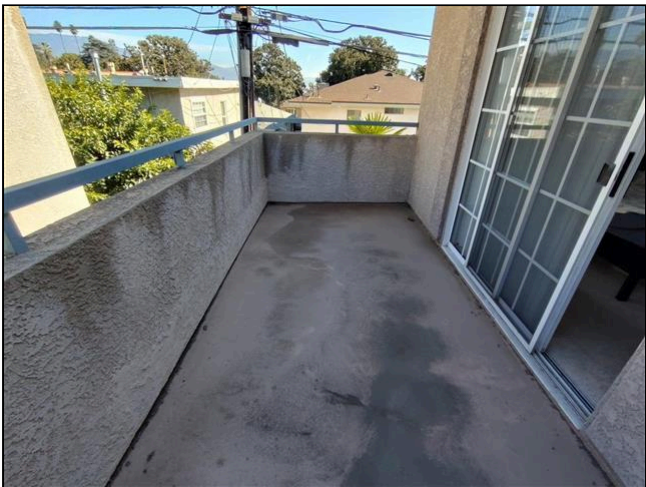
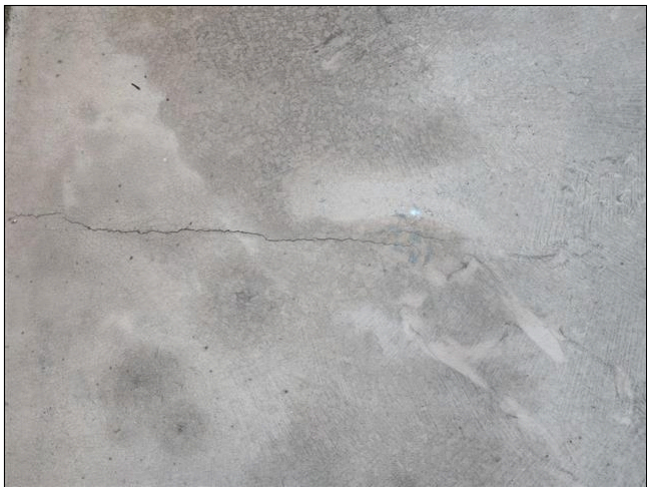
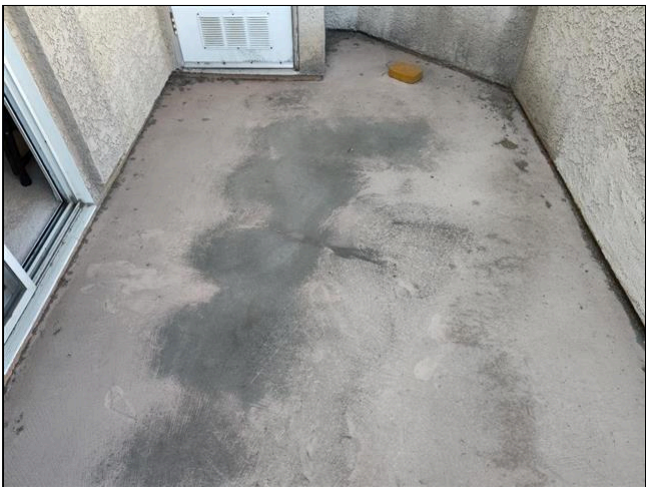
Deteriorated decking/sealant observed at front balcony; evidence of inadequate drainage observed at front balcony. This condition could allow water to leak into the unit below balcony. We recommend further review by a qualified contractor.

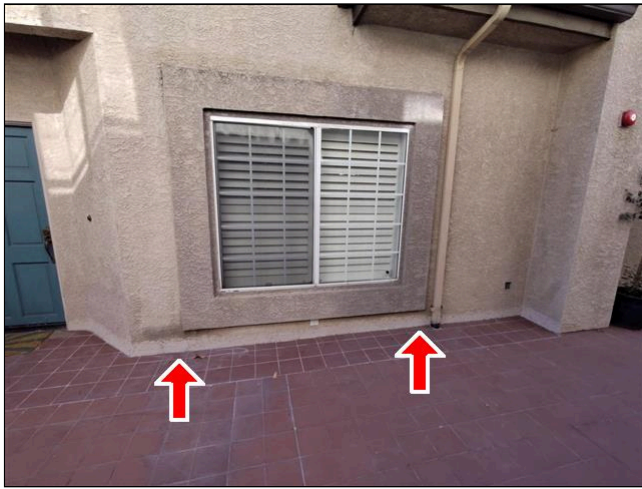
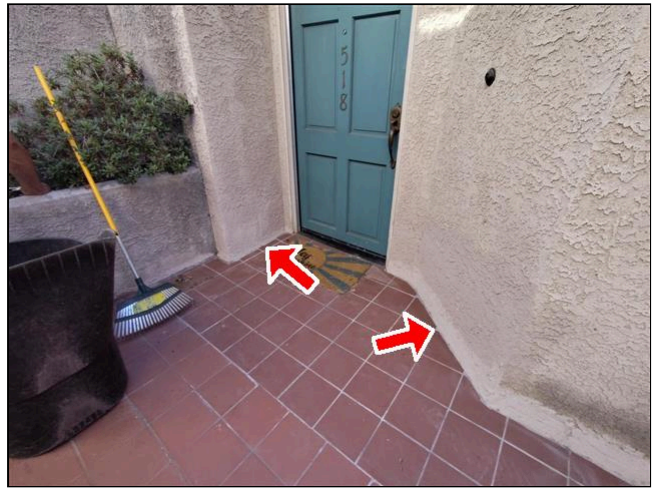
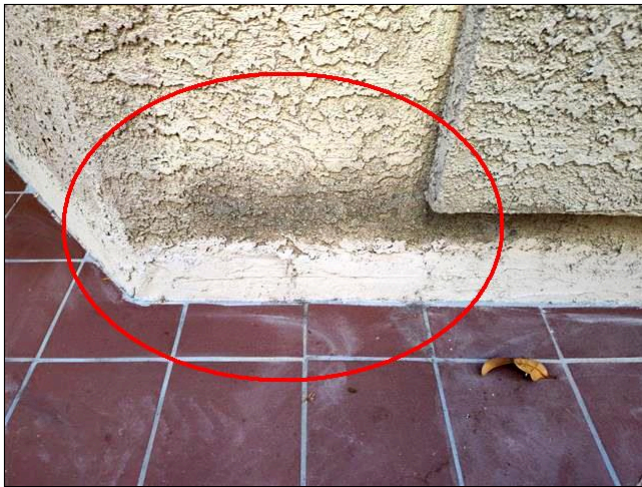
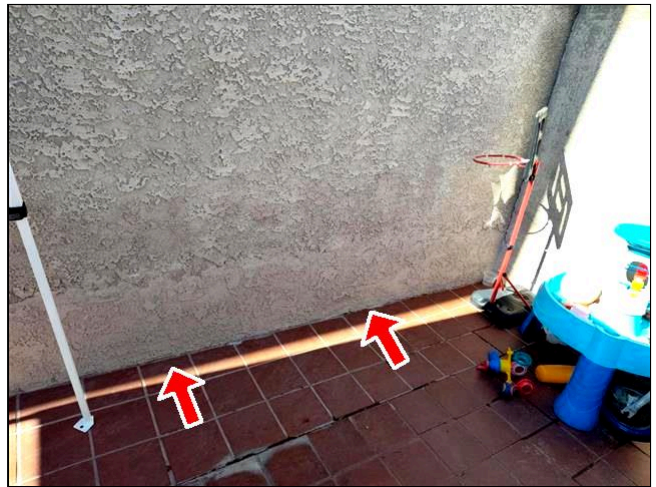
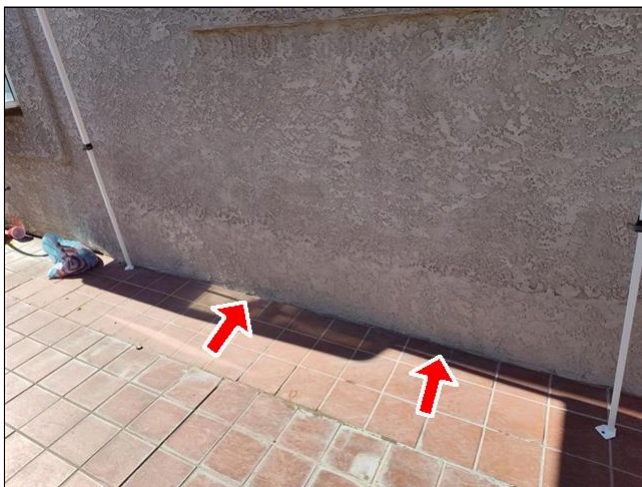
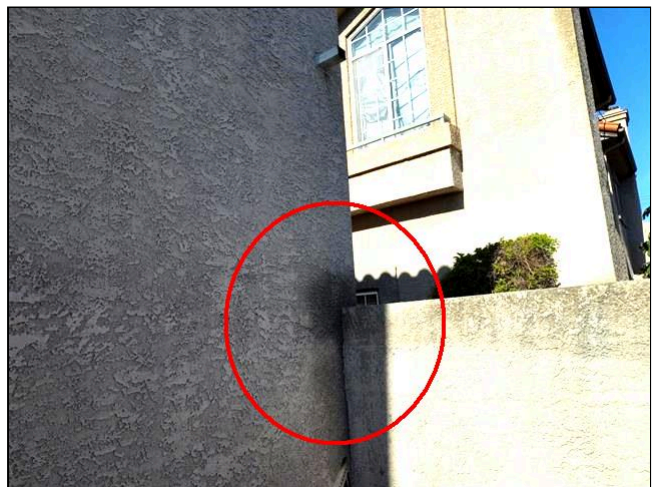
(1) Discoloration/dark stains observed at front and left side of the unit; weep screed flashing is covered along the bottom of the stucco wall cladding at front and left side of the unit. This condition does not allow water to drain from behind wall cladding and can lead to water intrusion of the unit. Recommend correcting.

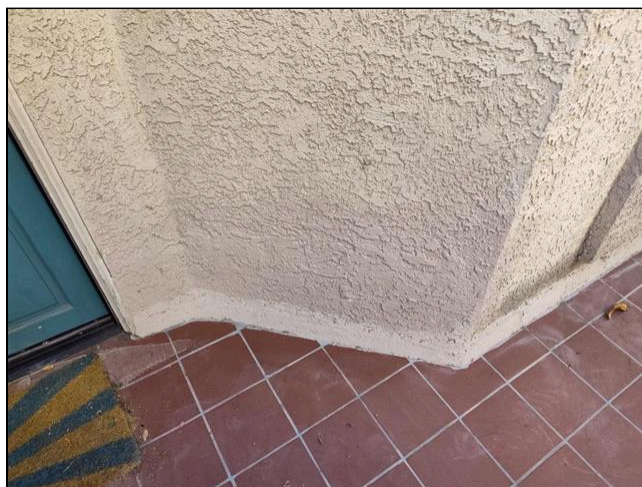
2.2 Item 7(Picture)

(3) We observed evidence of repairs in a number of location(s). However, we are unable to determine the cause or effectiveness of these repairs.

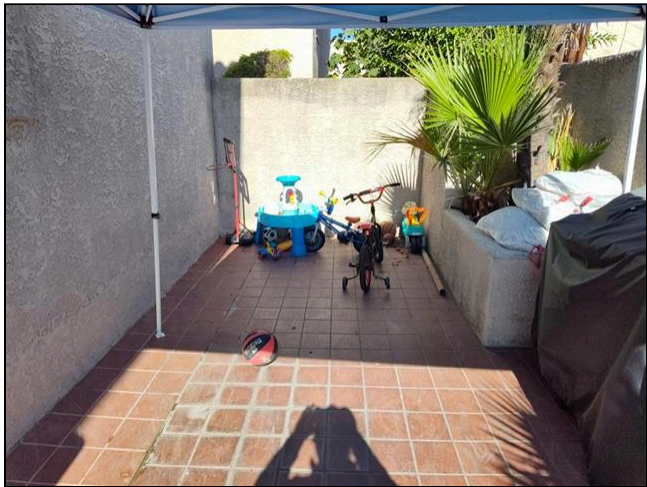
2.4 Item 1(Picture)

(1) Grading and drainage is inadequate at the left side of the building. This condition could allow water to pool at base of wall cladding and lead to water intrusion into the unit. We recommend further evaluation by a drainage contractor.

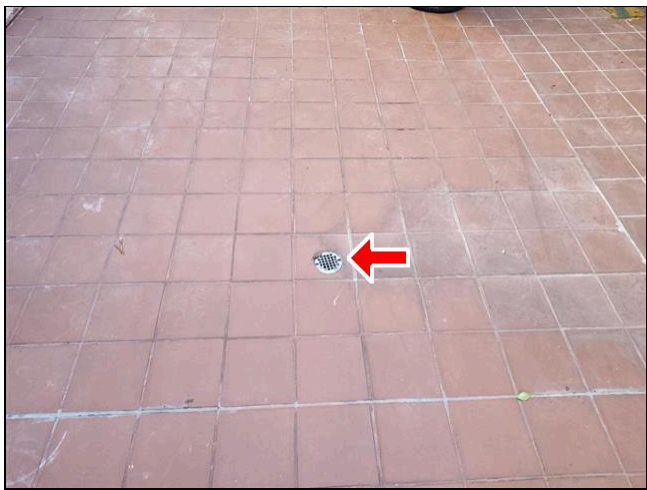
2.4 Item 2(Picture)

(2) Sub surface drainage observed on property. We advise the client to verify the overall condition with a qualified drainage contractor.

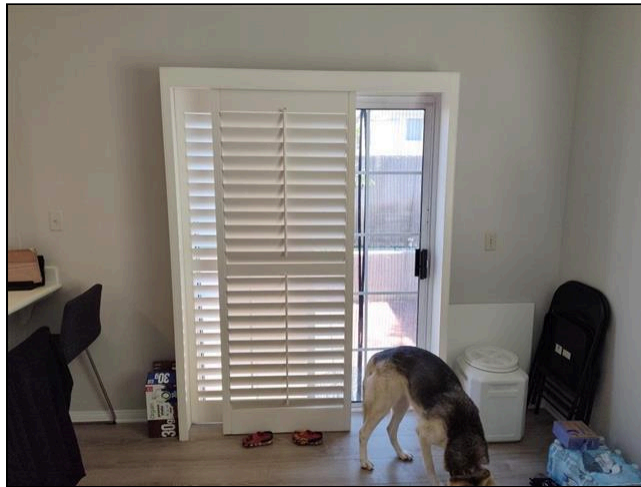
2.5 Item 1(Picture)

Sliding glass door at kitchen does not open/close smoothly. Suggest servicing if door.

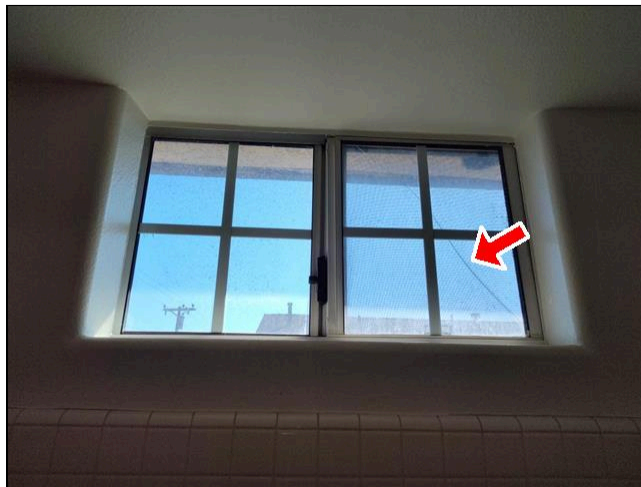
2.6 Item 1(Picture)

(2) Window is cracked/broken at 2nd level ensuite bathroom. Recommend repair.

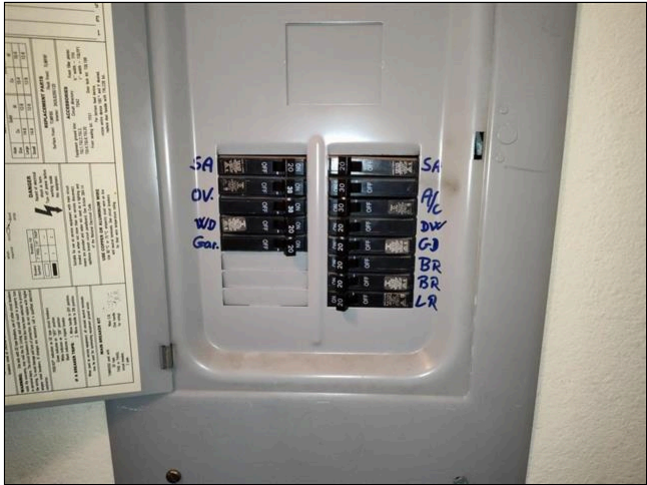
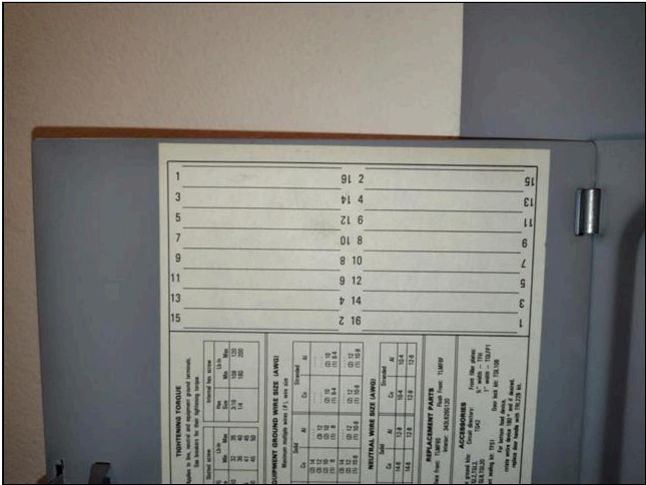
(1) Circuits breakers are not labeled clearly. Recommend correcting.

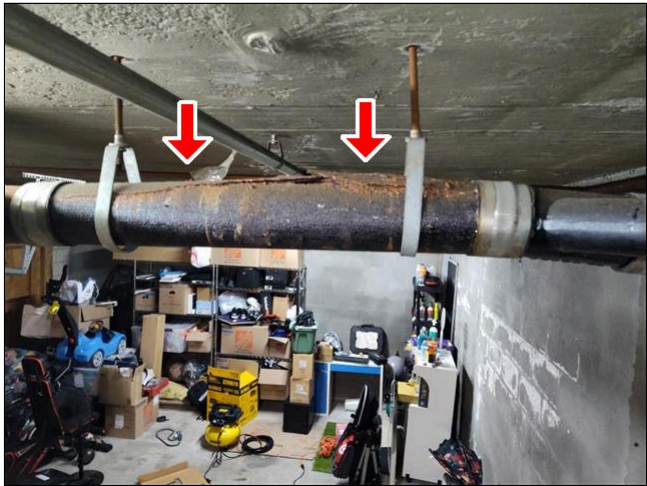
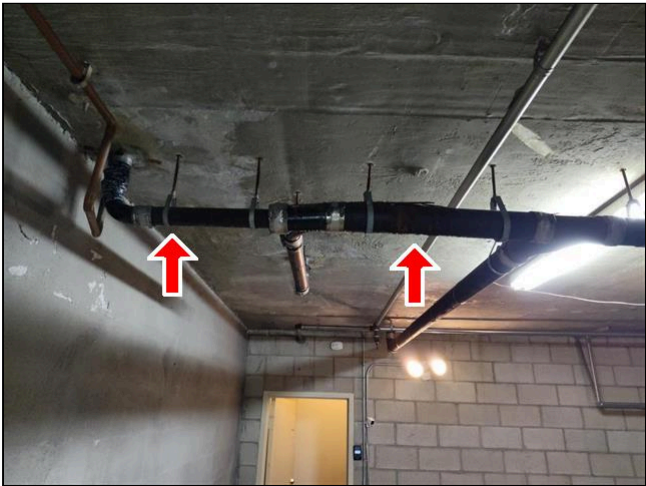
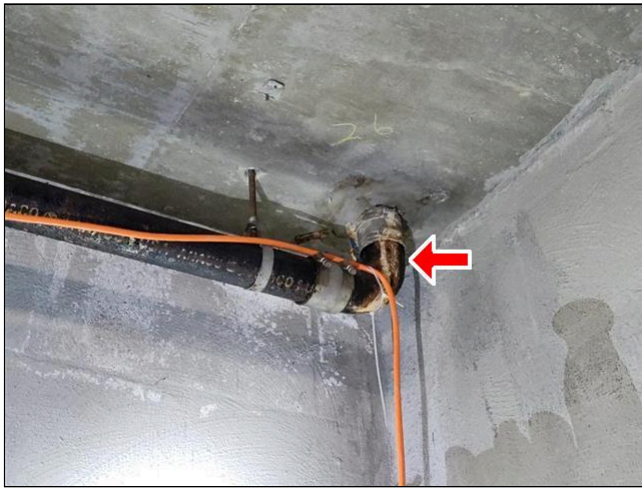
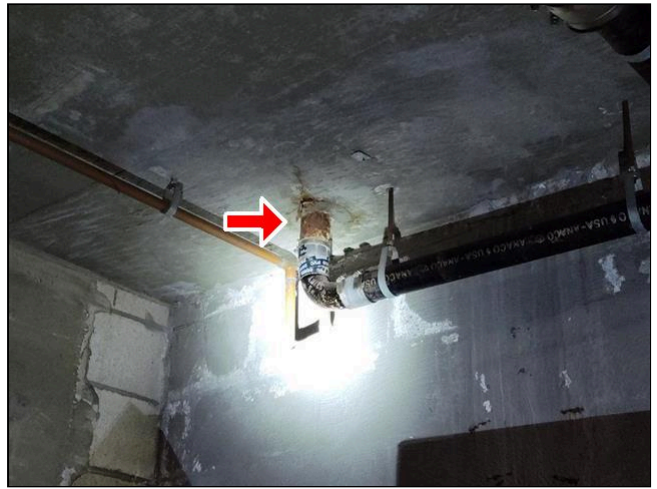
(1) Rust/corrosion and inadequate slope of drain line observed in garage. This condition could lead to leaking. We recommend further review by a qualified plumber.

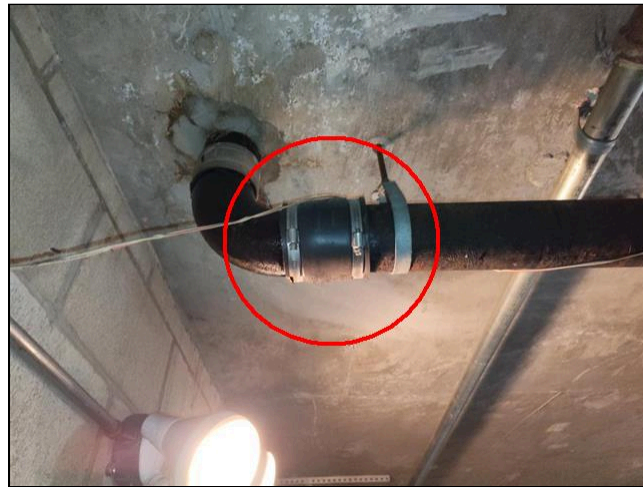
4.2 Item 5(Picture)

(2) Incorrect coupling type observed at garage drain line. The rubber coupler is for cast iron drain line to plastic connection. No hub couplings should be used for cast iron to cast iron connections. This condition could lead to leaking. Recommend correcting.

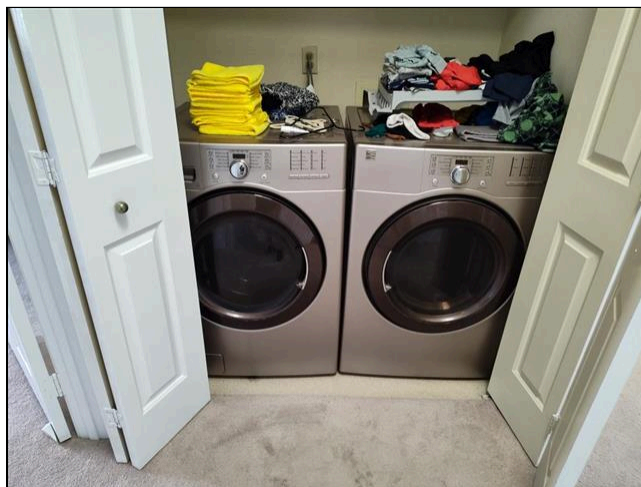
4.4 Item 1(Picture)

(2) Drip pan with drain line is not installed underneath the 2nd level washer. Recommend installing.
