Blue Ribbon Property Inspections  
300 E Bennett Ave., Unit 8  
Glendora, CA 91741  
(626)223-5571  
Inspected By: Tyler Molloy

Inspection Date: 10/24/2024  
Report ID: TM01102424

Customer Info:	Inspection Property:
James Burbank  Customer's Real Estate Professional: Not Applicable	518 N Stoneman Ave Alhambra CA 91801

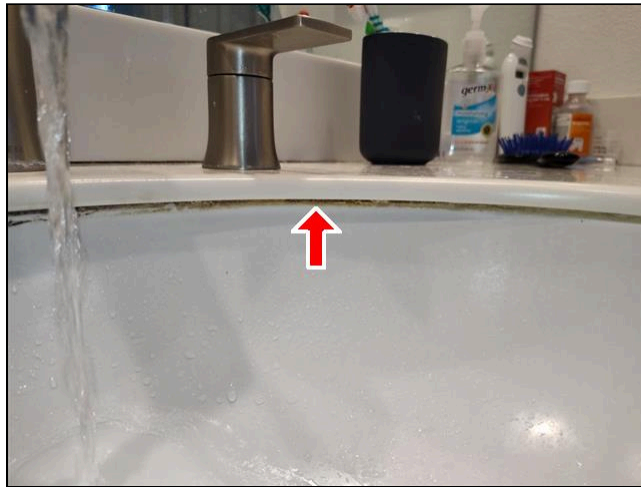
10.7 Item 1(Picture)

(1) Caulking/grout at 2nd level master bathroom sink is deteriorated. Recommend repair.

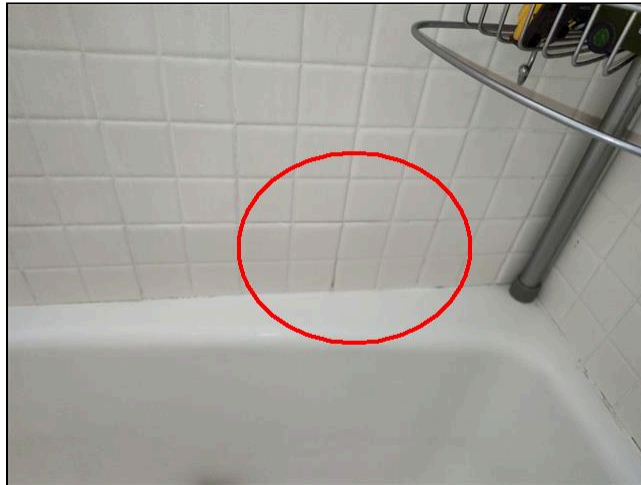
10.7 Item 2(Picture)

(2) Cracked/missing grout observed at 2nd level ensuite tub/shower surround. Recommend repair.
