## Silicon identification

This errata sheet applies to the revision A of the STMicroelectronics STM32F101xF/G access line and STM32F103xF/G performance line XL-density products. These families feature an ARM™ 32-bit Cortex®-M3 core, for which an errata notice is also available (see [Section 1](#) for details).

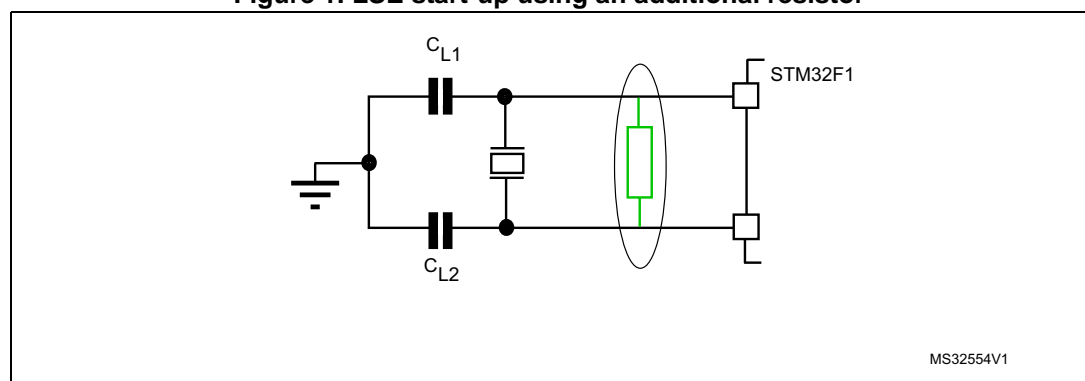
**Figure 1. LSE start-up using an additional resistor**

### Description

The LSE (Low Speed External) oscillator system has been designed to minimize the overall power consumption of the STM32F1 microcontroller. It is extremely important to take specific care in the design of the PCB to ensure this low power oscillator starts in harsh conditions. In some PCB designs without coating, an induced low leakage may prevent the LSE to start-up, regardless of the 32.768 KHz crystal used. This phenomenon is amplified in humid environments that create frost on the OSC32\_IN/OSC32\_OUT tracks. This unwanted behavior may happen only at the first back-up domain power-on of the device.

It is recommended to mount an additional parallel feedback resistor (from 16 M $\Omega$  to 22 M $\Omega$ ) on board to help the oscillation start-up in all cases (see [Figure 1](#)). For more details on compatible crystals and hardware techniques on PCB, refer to AN2867 application note.
