MECH 428: INTRODUCTION TO AEROSPACE ENGINEERING

Investigation of TWA Flight 800 Boeing 747 Crash

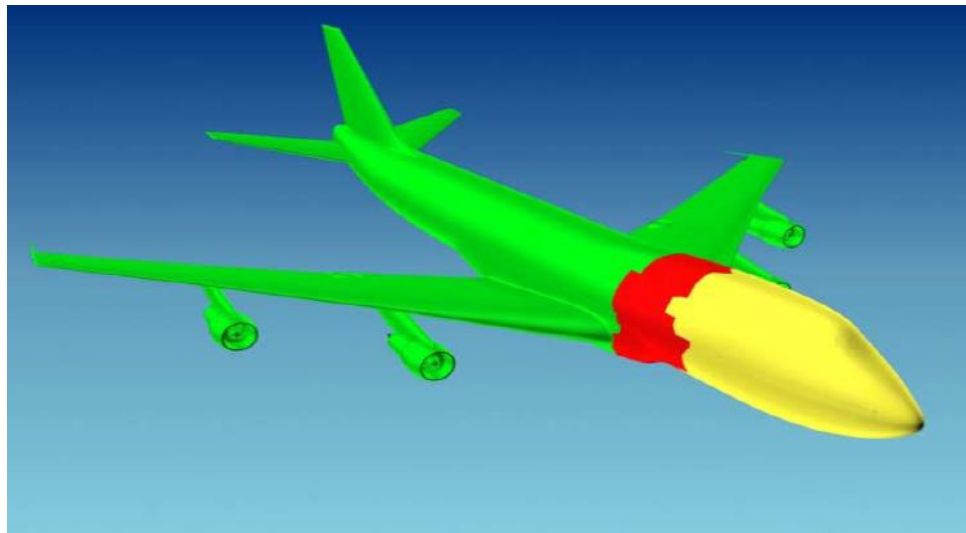
According to the reports, the planes had several structural failures. The failure started from the fuel tank at the center wing. The breakout of the tank happened due the overpressure event. The Sequencing Group came to the conclusion that the breakup started because “spanwise beam 3 fractured at its upper end and that overpressure within the CWT caused it to rotate forward about its lower end.” [9] Although this statement is the first of many structural damages that occurred, the events that led to the overpressure and started the sequence of failures will be extensively discussed in Section 3. Besides, the investigation was continued at Bruntingthorpe Airfield, in England. They found that an explosion in the fuel/air tank can create enough pressure for structural breakdown, so it is verified that the crash happened due to the explosion in the fuel/air tank. The question then becomes, what led to the overpressure and what was the reason of ignition within the fuel tank? To understand these and to be able to comment

Figure 4: Failure point shown in the Simulations [9].

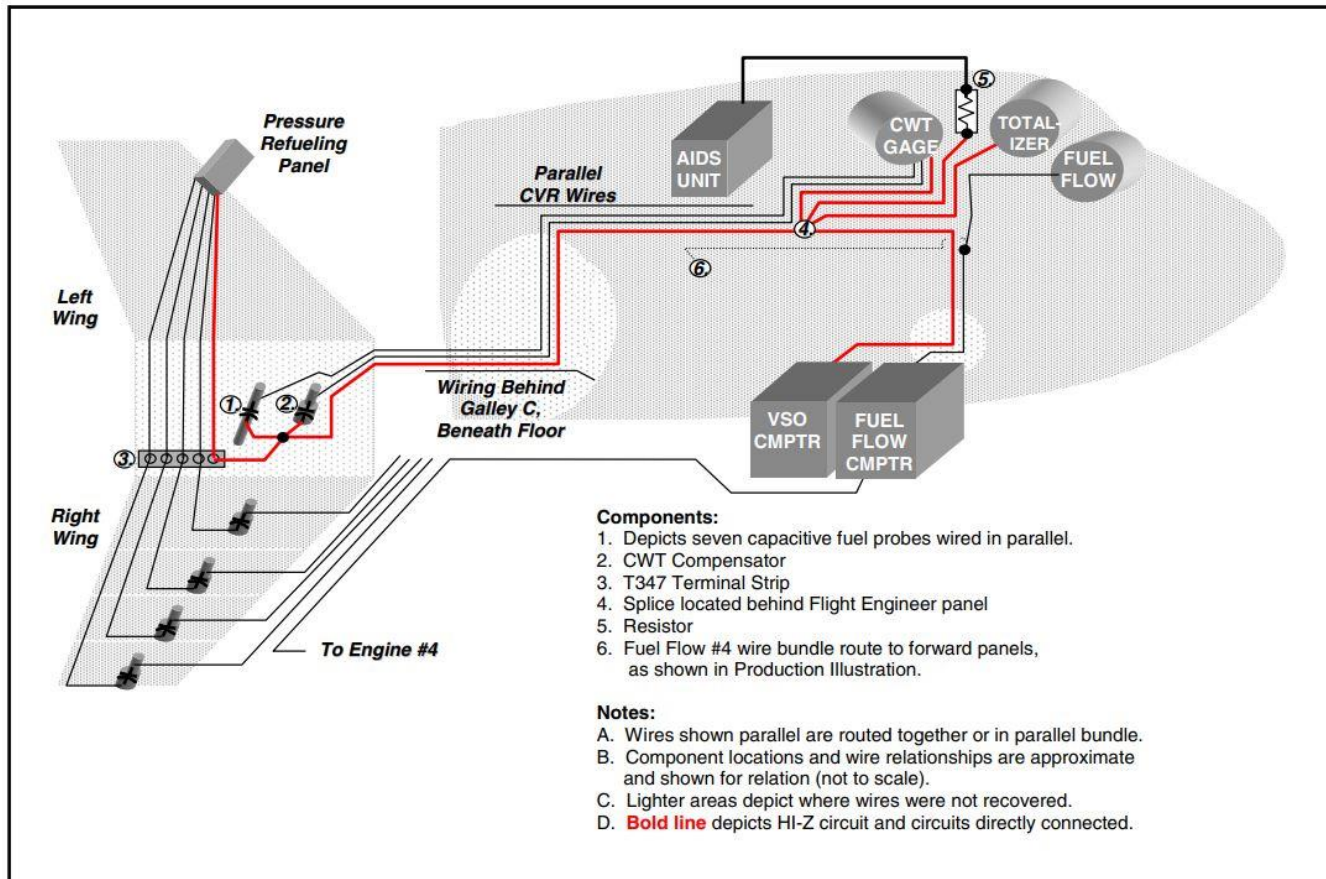
Figure 13: Wiring System Schematized [9]

To elaborate on the possibility of a short circuit event, the findings revealed that the wiring systems on the airplane had damaged insulators. Wires with damaged insulators are more prone to short-circuiting and the damage was not directly associated with the accident, but it was noted that at least some of the damage could have existed prior to the explosion. Arcing was also detected in some of the wirings including ones going to the right main wing tank fuel flow gauge and right wing FQIS wiring that all would've been involved with the central wing fuel tank at point 3 in the figure above. The authorities deemed any short circuiting involving these parts would indeed be able to carry the necessary ignition energy into the FQIS. As a result of the physical evidence coupled with the electrical anomalies reported by the captains shortly before the explosion, the Safety Board determined that the high energy released into the central wing fuel tank fuel quantity indication system must have been caused by a short-circuiting event in one of the aircraft's systems. [9]

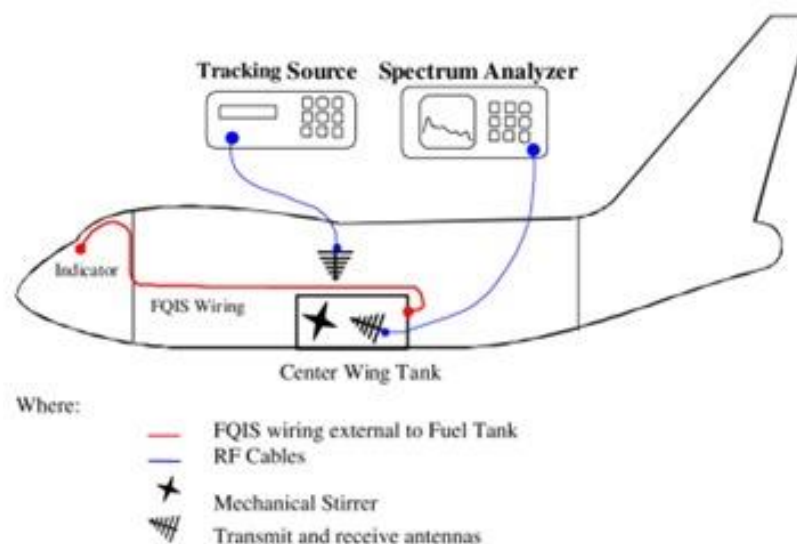
Damage due to mechanical contacts or cold flow exposed wires on FQIS wiring that is in the fuel tank. These exposed conducting wires can easily create an electric arc, which will be the source of all the destruction happened. The electric arc inside the fuel tank can cause the ignition of the vapor of air-fuel mixture. The same mechanism of ignition inside the fuel tank is suspected to be the cause of CWT explosion for the 1990 Philippine Airlines 737 crash and the 1972 Navy C-130 crash. The collected pieces had only very small fraction of the CWT FQIS wiring, therefore it was not possible to assess the degree of damage on the wiring before the explosion. On the other hand, examination of other 747 aircrafts' CWTs resulted that some of the 747s has damaged CWT FQIS wirings. Also, damage occurred before the accident was found by the investigators, which includes exposed conductors, inside the wing tanks of TWA800 flight. The arcing on the FQIS elements could have also occurred due to the other conductive components, which is present in the fuel tanks, for example safety wires or metal shavings. The investigations could not show clear and certain evidence in the recovered pieces, the damage caused by the explosion and fire is most likely the reason we couldn't find such evidence, due to its severity.

Figure 14: The relative locations of the CWT and FQIS [18]

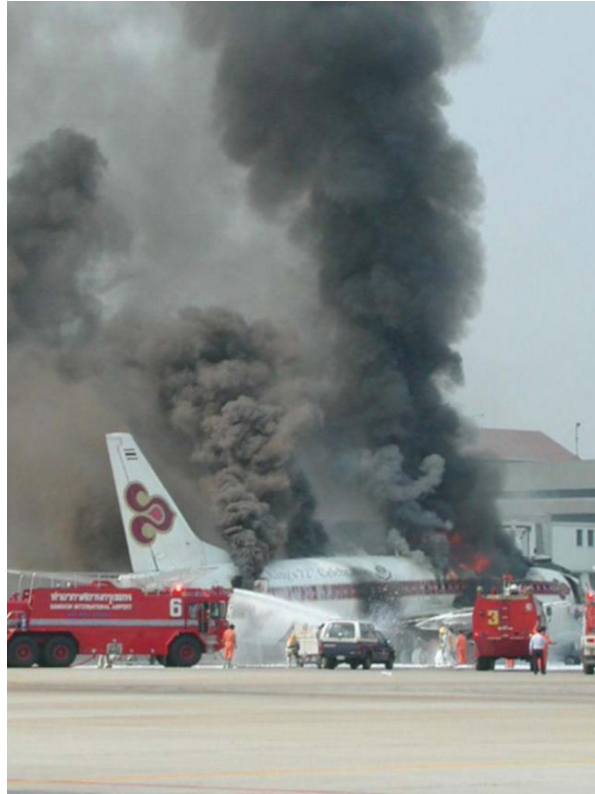
Figure 15: State of the Aircraft After the Accident [11]

As a result of the investigation, the AAIC concluded that the root cause of the explosion of the central wing fuel tank cannot be pinpointed. Although the explosion can be linked to the ignition of the flammable fuel/air mixture just as TWA Flight 800 Boeing 747, the exact reason of the ignition still holds ambiguity. However, the prevailing understanding is that there is a decent chance that the explosion took place because the central wing fuel pump was run alongside metal shavings and the fuel-air mixture. [11]

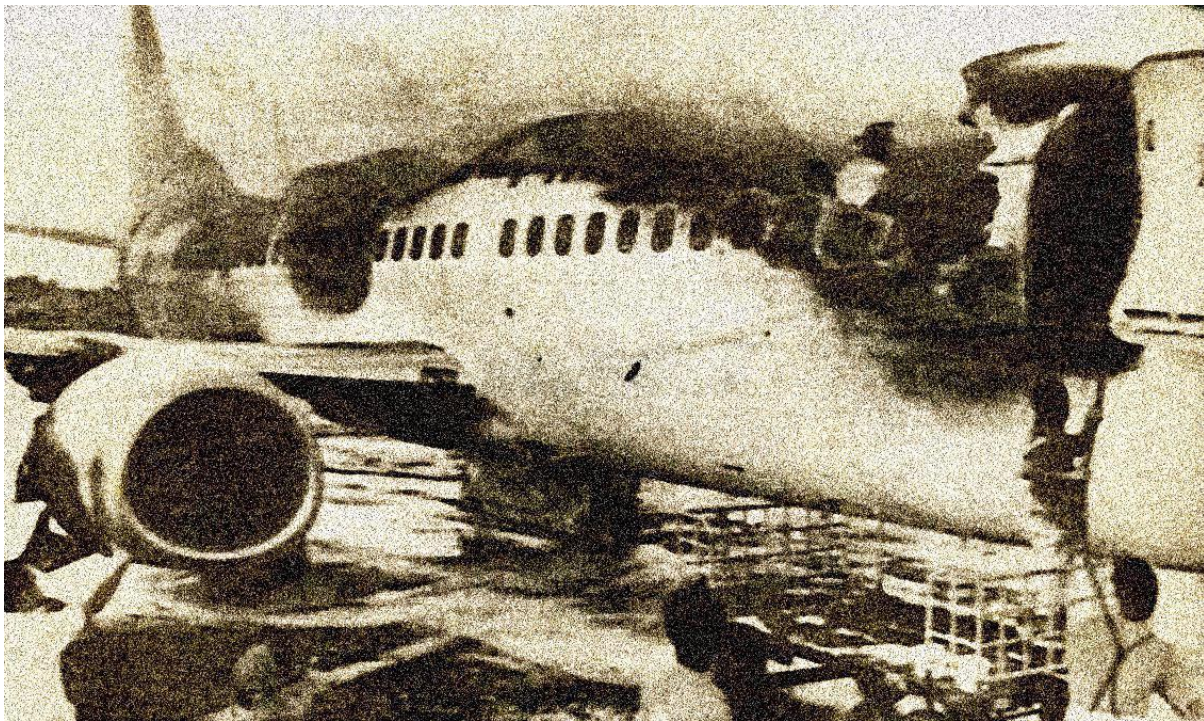
After receiving the aircraft from the factory, the airline decided to add logo lights to the plane. Unfortunately, they have damaged the vapor seals by doing so as it required passing additional cables and wires through the fuel tank vapor seals. [17]

Figure 17: Image of the Aircraft After the Accident [16]

The National Transportation Safety Board (NTSB) suggested to the FAA that an “Airworthiness Directive” to be created for inspections of the fuel boost pumps, float switch, and wiring looms as there were signs of chafing on the wiring looms and fuel boost pumps. An Airworthiness Directive was not issued by the FAA at the time. [17]
