MSP430F5342 Device Erratasheet

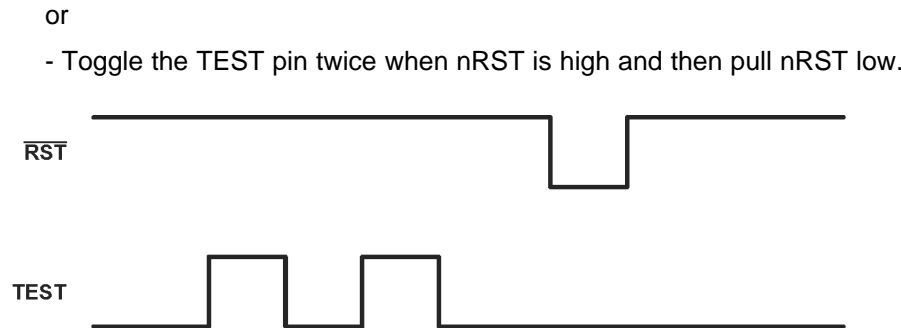
JTAG20 ***JTAG Module***

Function BSL does not exit to application code

Description The methods used to exit the BSL per MSP430 Programming Via the Bootstrap Loader ([SLAU319](#)) are invalid.

Workaround To exit the BSL one of the following methods must be used.
- A Power cycle

Note: This sequence is not subject to timing constraints and the appropriate level transitions are sufficient to trigger an exit from BSL mode.
