Damage to monumental masonry buildings in Hatay and Osmaniye following the 2023 Turkey-Syria earthquakes: the role of wall geometry, construction quality and material properties

Abstract This paper reports on the findings of an investigation on 29 historic stone masonry buildings located in the cities of Hatay and Osmaniye following the recent Turkey-Syria earthquakes. The earthquake couplet on 6 February (with moment magnitudes 7.8 and 7.5) and the following aftershocks (including an event on 20 February with a moment magnitude of 6.3) resulted in significant damage to the buildings. To understand why, the examined buildings were assigned an EMS-98 damage level (ranging from 1 to 5) and descriptive response categories (masonry disaggregation, local mechanism and global response). Overall damage statistics indicated that masonry disaggregation was common and coterminous with local mechanism response. Wall geometry and construction quality indices were then investigated to explore why these were the dominant damage mechanisms. Wall geometry indices highlighted insufficient amount of walls to resist the local seismic demands, particularly in the transverse (e.g. short) direction of

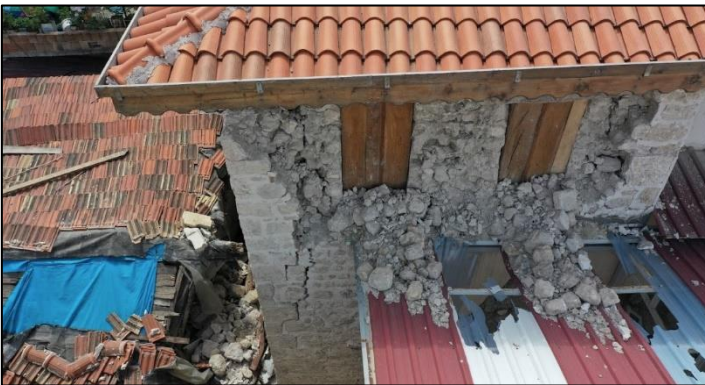
(a)

For the buildings examined, multiple response types had to be assigned as disaggregation was often observed alongside local or global response mechanisms. Fig.2a shows an instance where a local response mechanism involving the separation of building façades is seen alongside disaggregation. In Fig. 2b, the upper part of the disaggregated and leaning wall appears to have initiated a local response leading to vault collapse due to spreading supports. The EMS-98 DG and building response type are listed in Table 2.

Fig.2 Partially disaggregated masonry walls and local response mechanisms from a) R1 and b) C8.

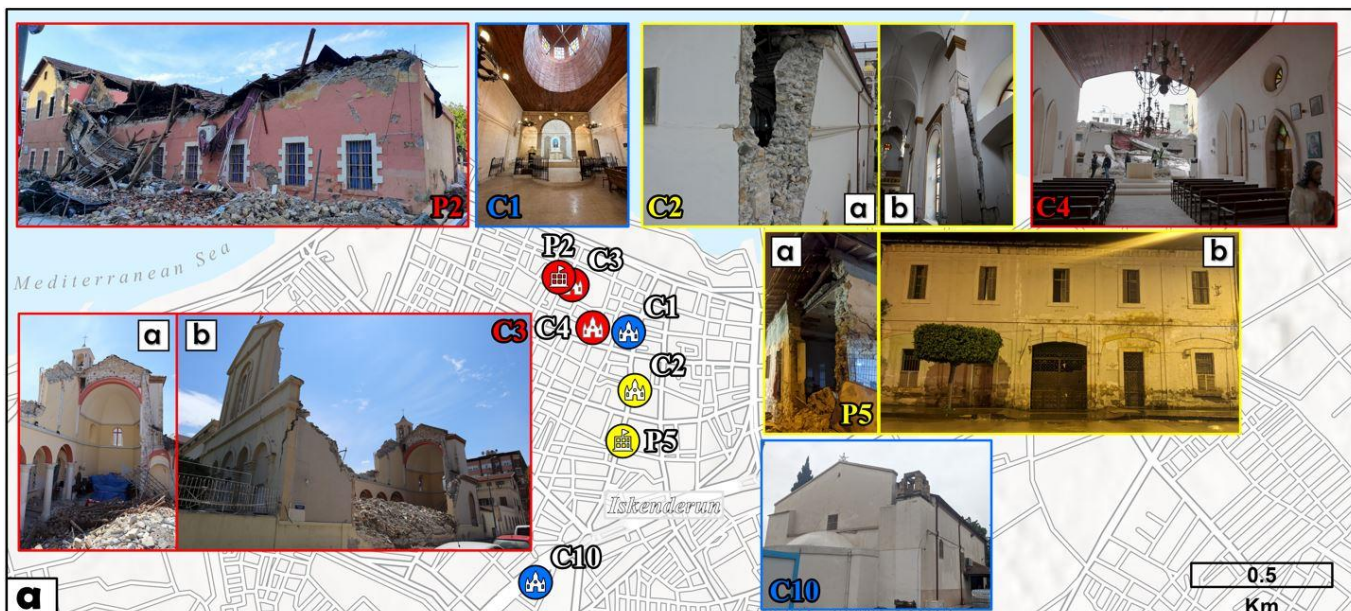
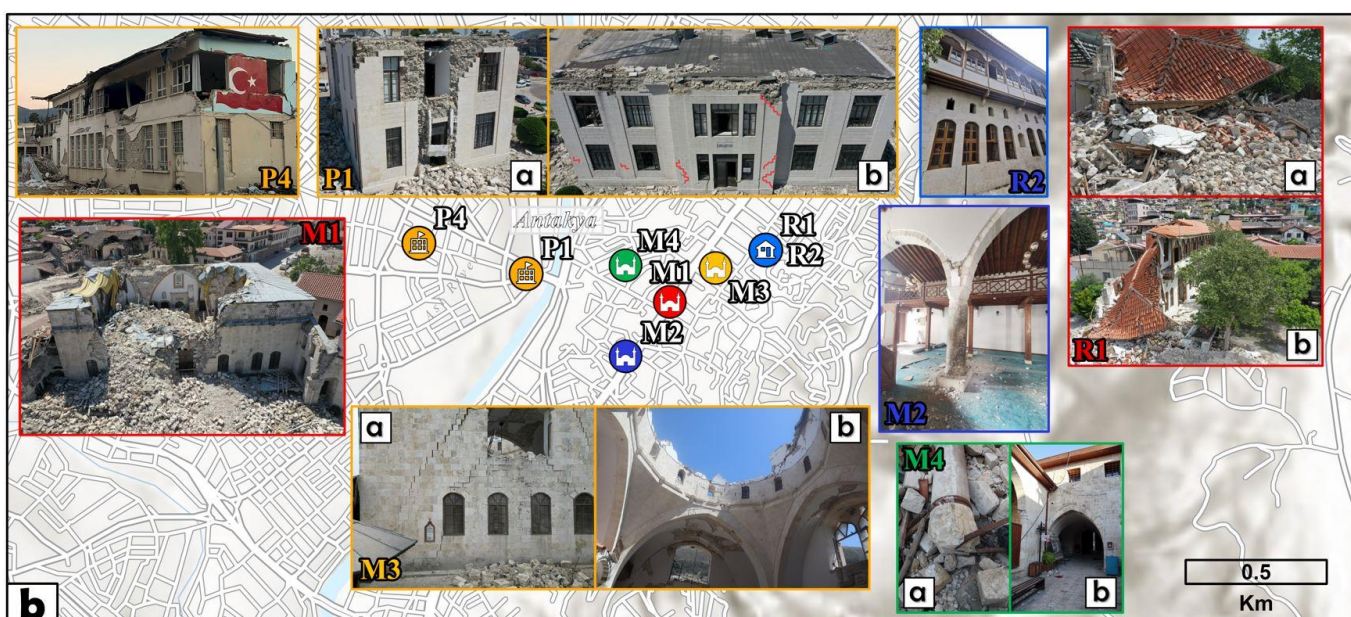
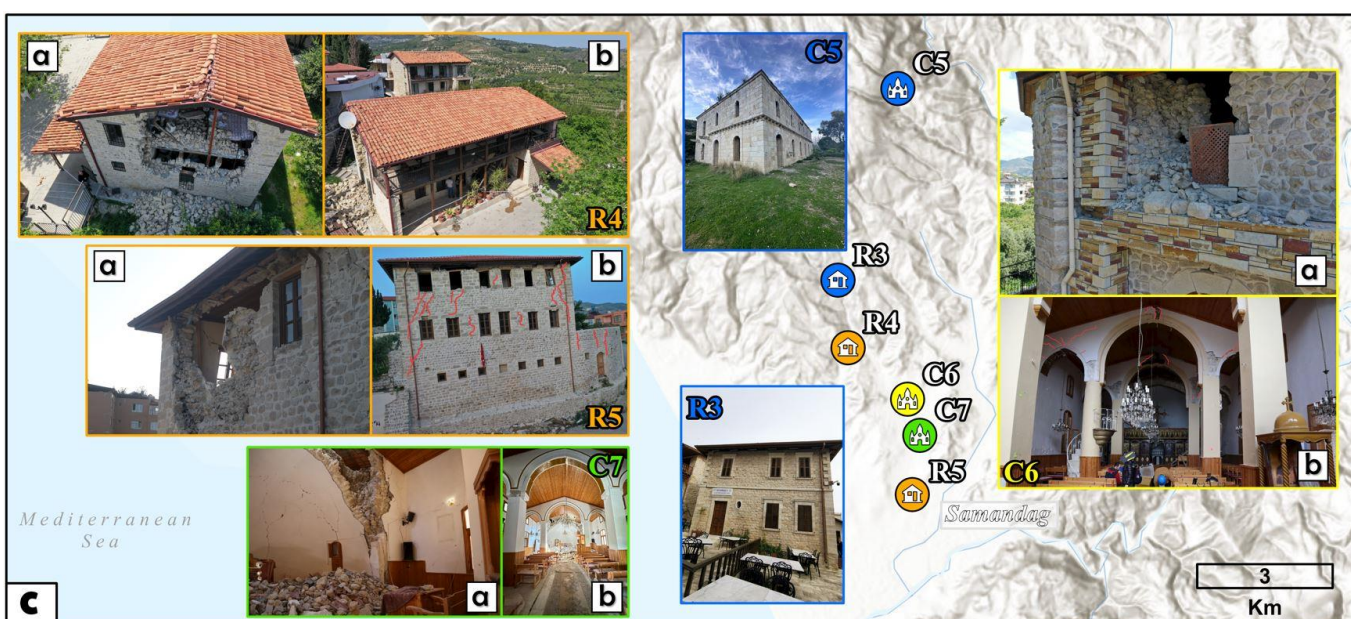
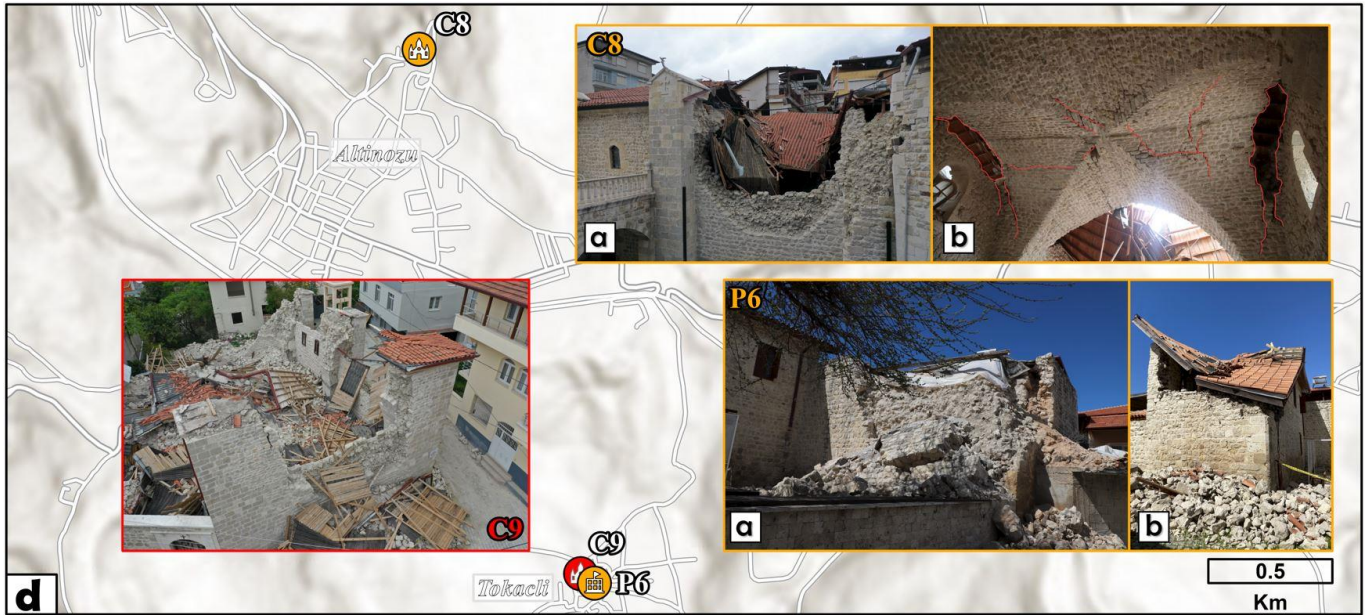
EMS-98 DGs provide an indication of damage level. To discuss the types of damage encountered in the field, another classification (Borri et al., 2020) is useful. In this classification, masonry building response is classified under three categories: i) masonry disaggregation, ii) local response, and iii) global response. Masonry disaggregation refers to the detachment of masonry units and mortar when subjected to strong ground motions. It is generally observed when weak mortar is used alongside irregular small stones (see Figs.2a-b). The second classification, local response, refers to the presence of mechanisms featuring one or more structural components. It generally involves out-of-plane motion. For instance, the overturning of the entire façade (e.g. C4 in Fig. 3a) or the first storey walls and the roof of a building in its transverse (e.g. short) direction (e.g. P2 in Fig. 3a) are classified as local response. The third classification, global response, is expected for structures with good construction quality and effective load transfer between masonry walls. Global response classification implies in-plane damage, such as flexural and shear cracking, concentrated around wall openings (e.g. P1 in Fig.3b, M5 in Fig.3e). The absence of visible structural damage in the walls was taken as global response (e.g. C1 in Fig. 3a, C5 in Fig. 3c).

Fig.3. Location, EMS-98 DGs and photographs of the investigated buildings from (a) Iskenderun (b) Antakya (c) Samandağ (d) Altınözü (e) Osmaniye

(including C3, M1 and P2) was due to local mechanism formation and out-of-plane motion of walls in the building transverse direction (see Fig. 3). To evaluate the vulnerability of walls to overturning instability during out-of-plane motion, Fig.4d explores the relationship between λ_o and PGA. According to Fig.4d, only 5 of the buildings have unsafe walls, indicating that the walls of structures were, in general, sufficiently thick to prevent out of plane instability. However, several building walls in the safe zone of Fig.4d (including C3, M1 and P2) collapsed in the out-of-plane direction.

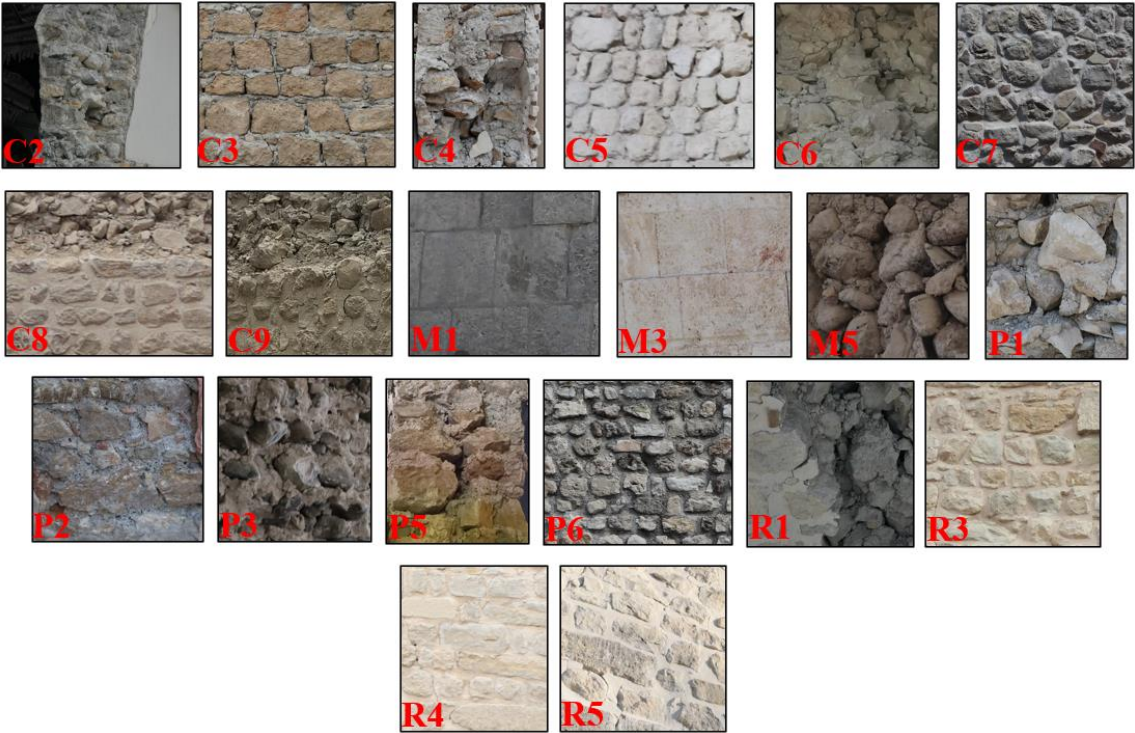
Fig.5. Representative zoom-in views of typical walls investigated in Table 6

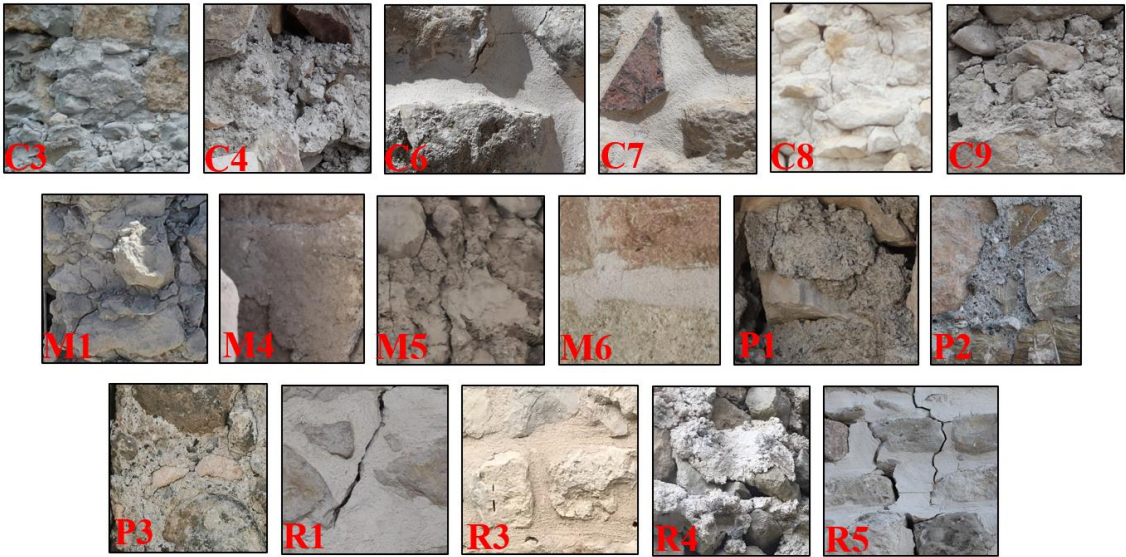
Fig.6. Representative zoom-in views of mortars investigated in Table 7

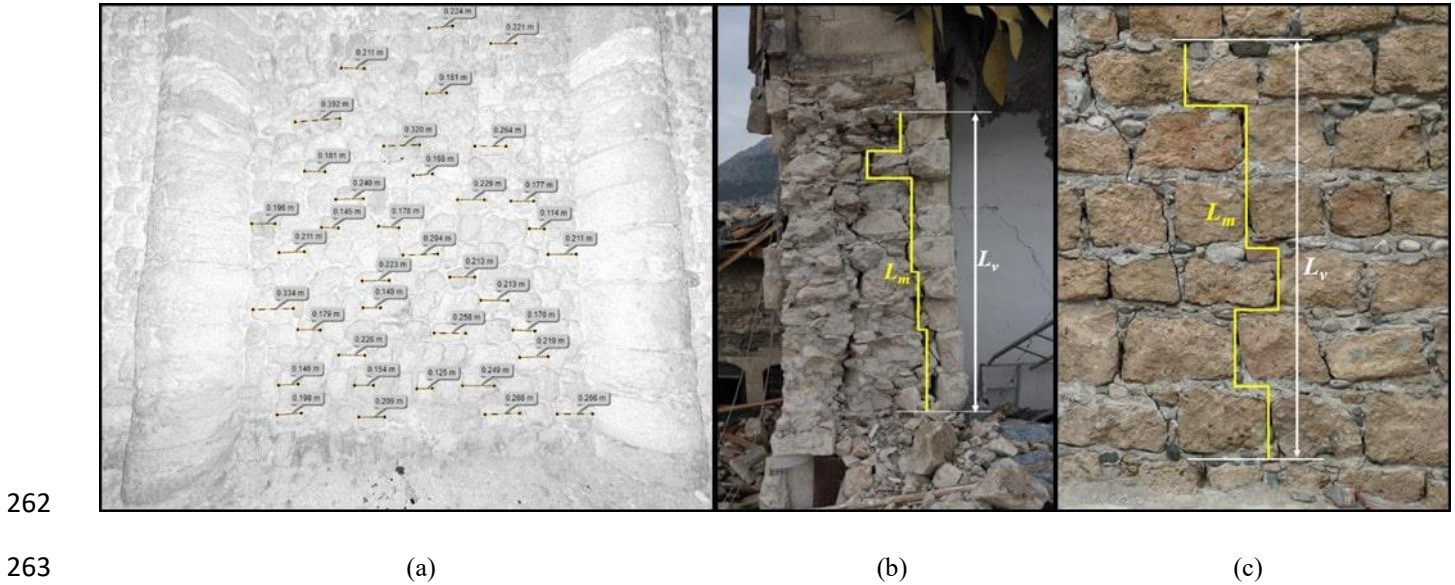
264 Fig.7. a) Stone dimension measurements from a point cloud (Building: C5), b) photograph of a through thickness cross-section
 265 of a disaggregated wall used for *WC* calculation (Building: M1), and c) an exposed wall surface used for *VJ* calculation (Building:
 266 C3)

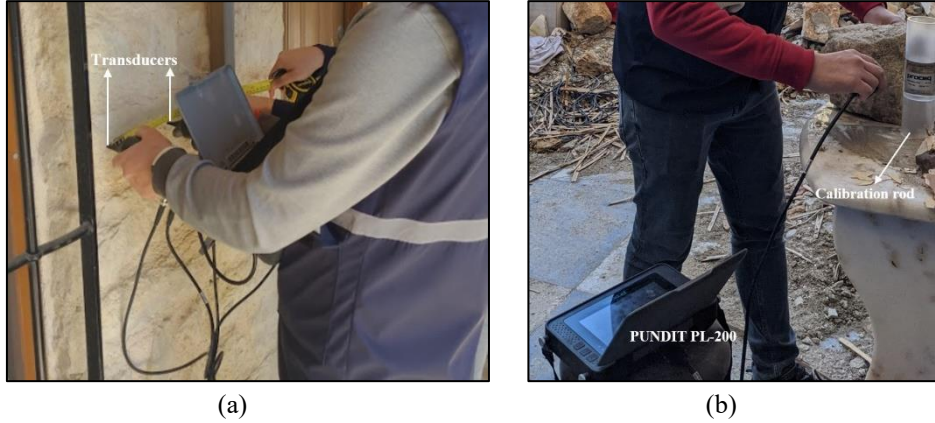
Fig.8. a) Indirect UPV measurement on a an in-situ stone from R4, and b) direct UPV measurement on a disaggregated stone from C3

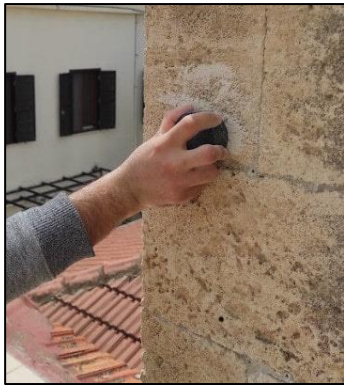
373 (a)

375 Fig.9. a) Preparing phase of a stone for SRH test in building C2 b) SRH measurement on a stone from a collapsed wall of M1

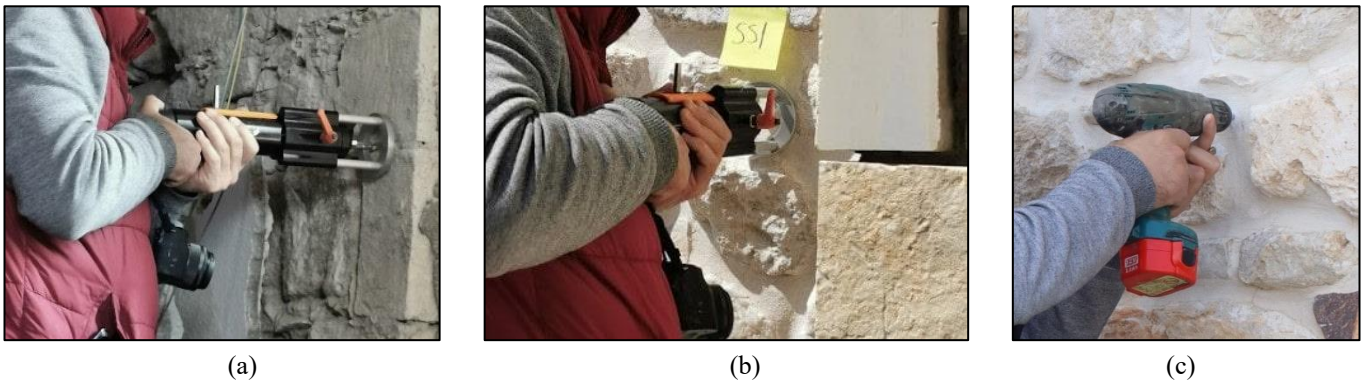
Fig.10. a) MP test for a thin mortar between corner cut-stones b) MP test for a thick mortar between irregular rubble stones (building: C6) c) drilling of an access hole to perform an internal MP test on a thick mortar
