**RENAULT Twingo**

41 NEW POSITION OF BATTERY*Other sub-section concerned :***42****Basic manual : M.R. 306**

41 SPECIAL POINTS FOR VEHICLES EQUIPPED WITH AN AIRBAG**Basic manual : M.R. 306**

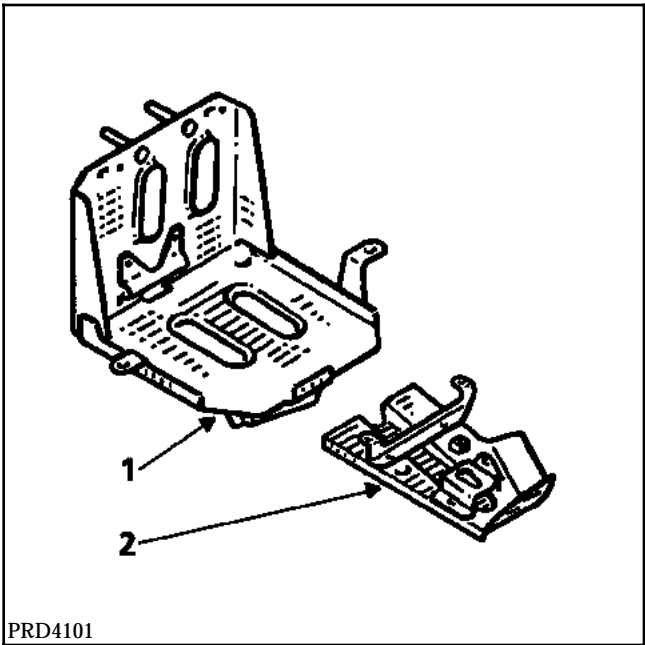
1 - Battery tray consisting of:

- tray base
- side section of tray
- stop
- base reinforcement
- nut and soldered studs

2 - Assembled cowl side member tray

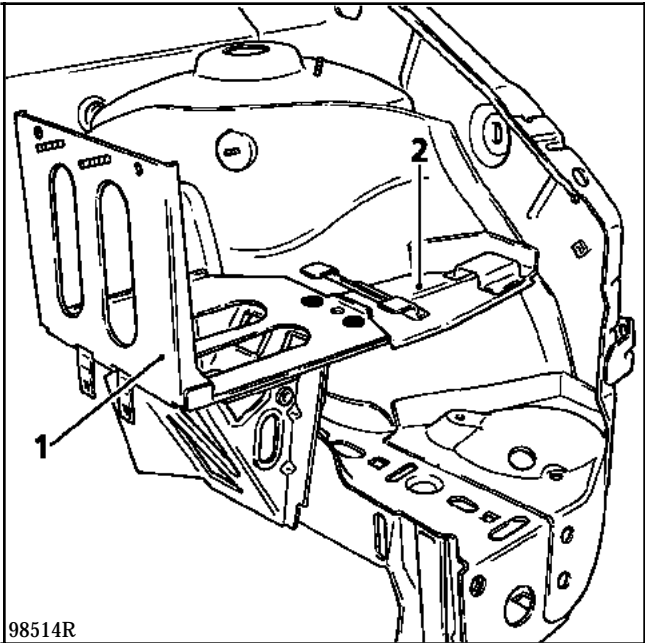
4 CONNECTION WITH COWL SIDE MEMBER TRAY

2 electric spot welds ground down to two thicknesses (0.70 + 1)

NOTE: 2 spot welds ground down to 3 thicknesses:
0.7+1+1

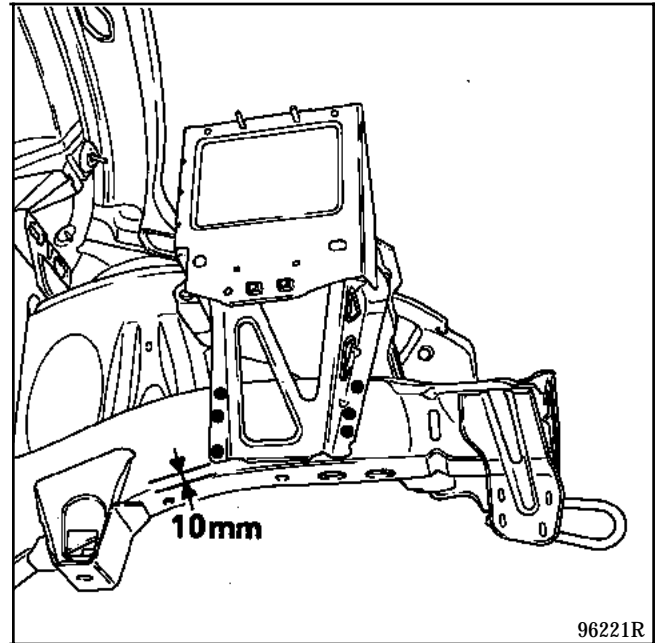
Position on old vehicles.

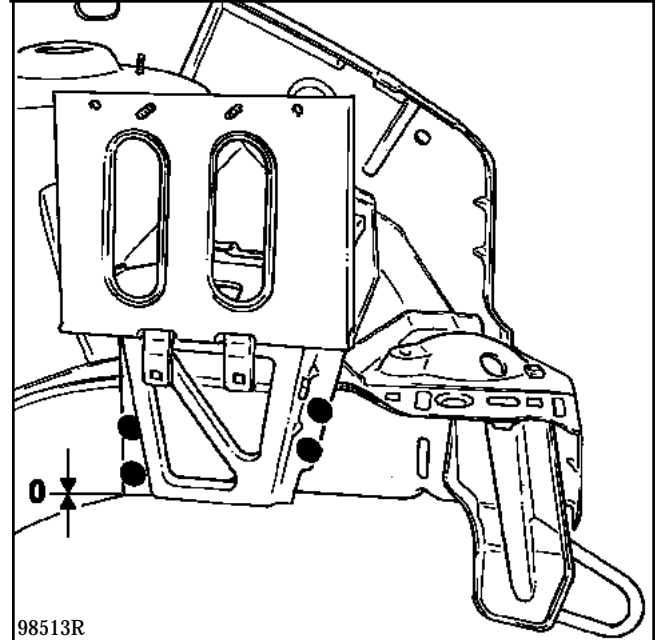
Position on new vehicles.

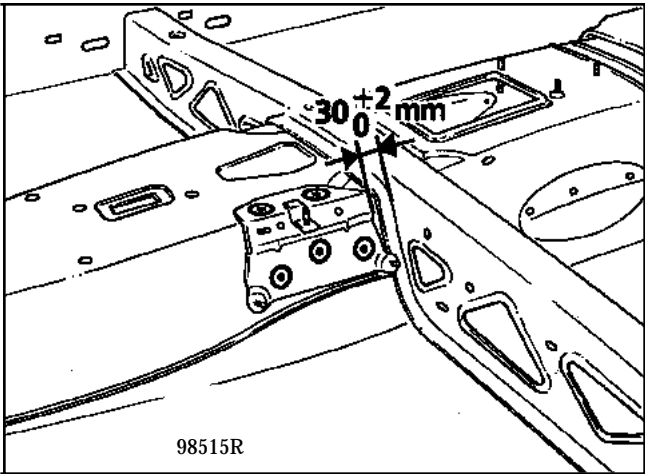
1 CONNECTION WITH CENTRAL FLOOR PANEL

The part cannot be used again.

NOTE: When carrying out a complete bodywork replacement, the connection can be made using **4.8 mm** dia. sealed-type rivets **10 mm** long.
