PIC32MK General Purpose and Motor Control (GP/MC) Silicon Errata and Data Sheet Clarification

The PIC32MK General Purpose and Motor Control (GP/MC) family of devices that you have received conform functionally to the current Device Data Sheet (DS60001402E), except for the anomalies described in this document.

The silicon issues discussed in the following pages are for silicon revisions with the Device and Revision IDs listed in [Table 1](#). The silicon issues are summarized in [Table 2](#).

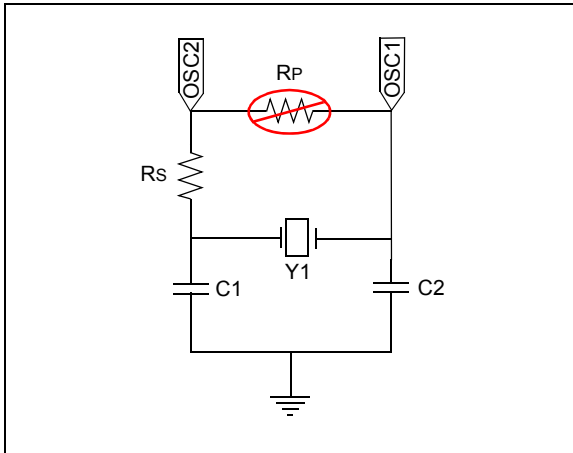
FIGURE 1: Posc CRYSTAL CIRCUIT

The Posc supports only specific crystal operation, as provided in [Table 1](#).

The Primary Oscillator (Posc) has been characterized to operate at 8 MHz and 12 MHz when the circuit shown in [Figure 1](#) is implemented and the operating conditions provided in [Table 1](#) are met.

Crystal Frequency (see Note 1)	Series Resistor Rs	Posc Gain Setting POSGAIN<1:0> (DEVCFG0<20:19>)	Posc Boost Setting POSCBOOST (DEVCFG0<21>)
8 MHz	2 kΩ	'0b00 (GAIN_0)	'0b1
12 MHz	1 kΩ	'0b00 (GAIN_0)	'0b1
24 MHz ⁽³⁾	0	'0b00 (GAIN_0)	'0b1
