Property Visual Documentation Report

Property Address: 123 Main Street Columbus, OH 43228

Report Reference ID: SC-2026-001

Property Name: Sample Commercial Property

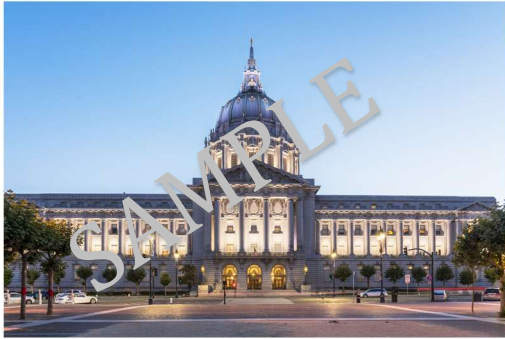
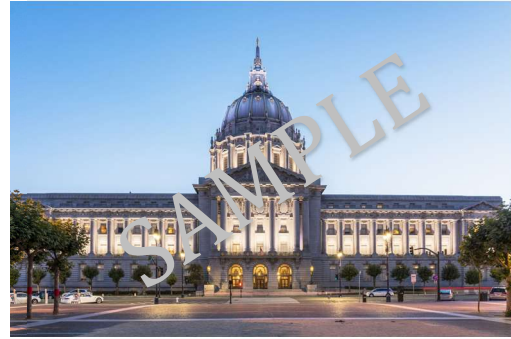
Image 1 - Main Entry -1/5/2026

A visual difference is present between the referenced documentation dates, including cracking visible in the masonry units at the main entry.

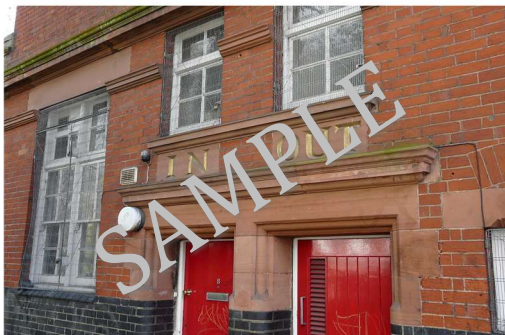
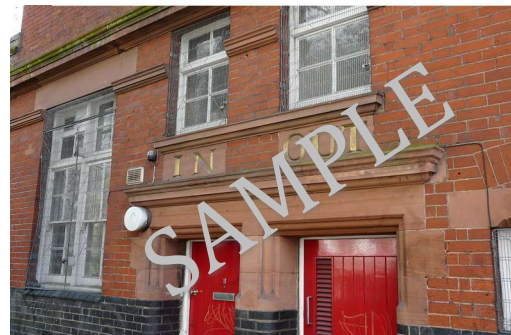
Image 12 - Side Entry -1/5/2026

No visually apparent differences were observed between the referenced documentation dates.
