## **Evaluation of the Tank Bottom Corrosion and CP Effectiveness at a Saudi Aramco Crude Oil Tank Farm**

Xianming (Andy) Yu  
Saudi Arabian Oil Company  
P. O. Box 4151  
Ras Tanura, Saudi Arabia 31311  
Fax: +966 3 6733143  
Email: [xianming.yu@aramco.com](mailto:xianming.yu@aramco.com)

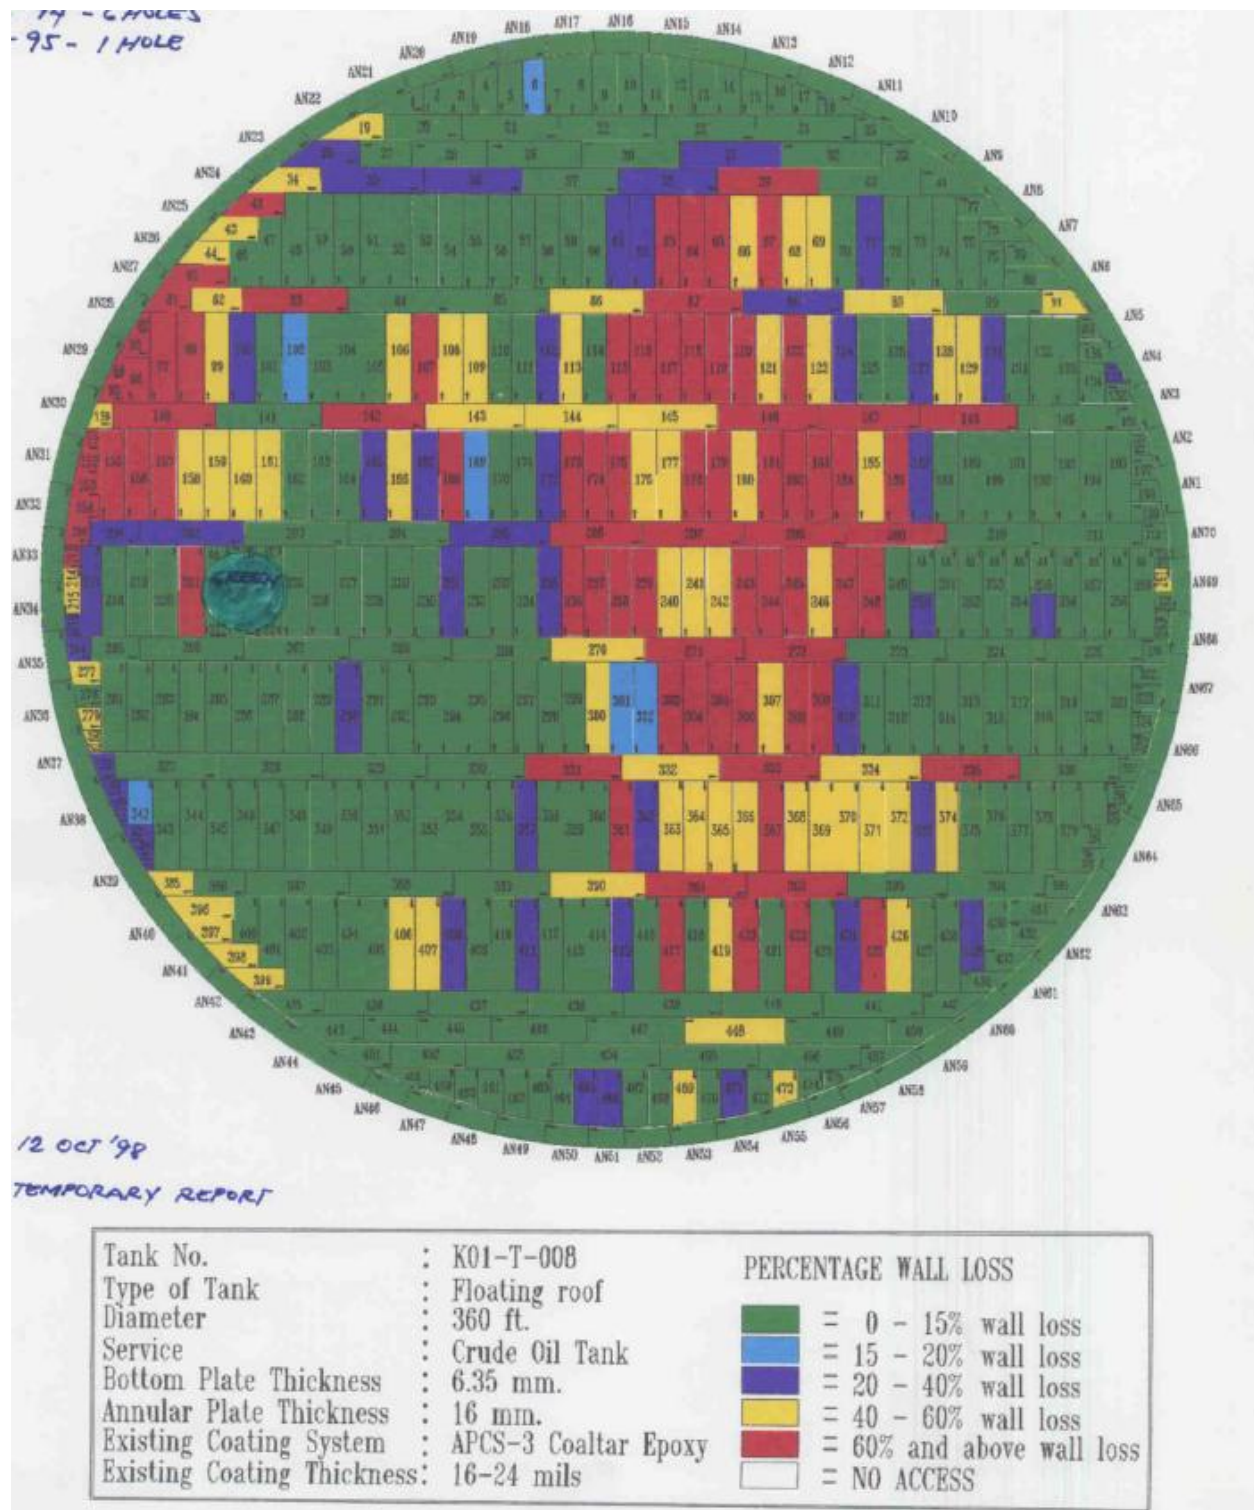
The last Test and Inspection (T&I) of T-08 was conducted between 1998 and 1999 and during which a 100% Magnetic Flux Leakage Test (MFLT) was carried out on the tank bottom to inspect for underside corrosion. The MFLT results indicated 83 inboard and sketch plates (nominal thickness: 6.35 mm) had corrosion features with 60% and above metal loss including eight (8) holes and 71 plates had corrosion features with 40-60% metal loss (Figure 2). A total of 338 locations on the sketch/inboard plates on the bottom of T-08 were repaired by replacement or patch-on methods as per API 653. However, no investigations were performed on the bottom corrosion.

Figure 2 – MFLT Report during the T&I of 1998-1999

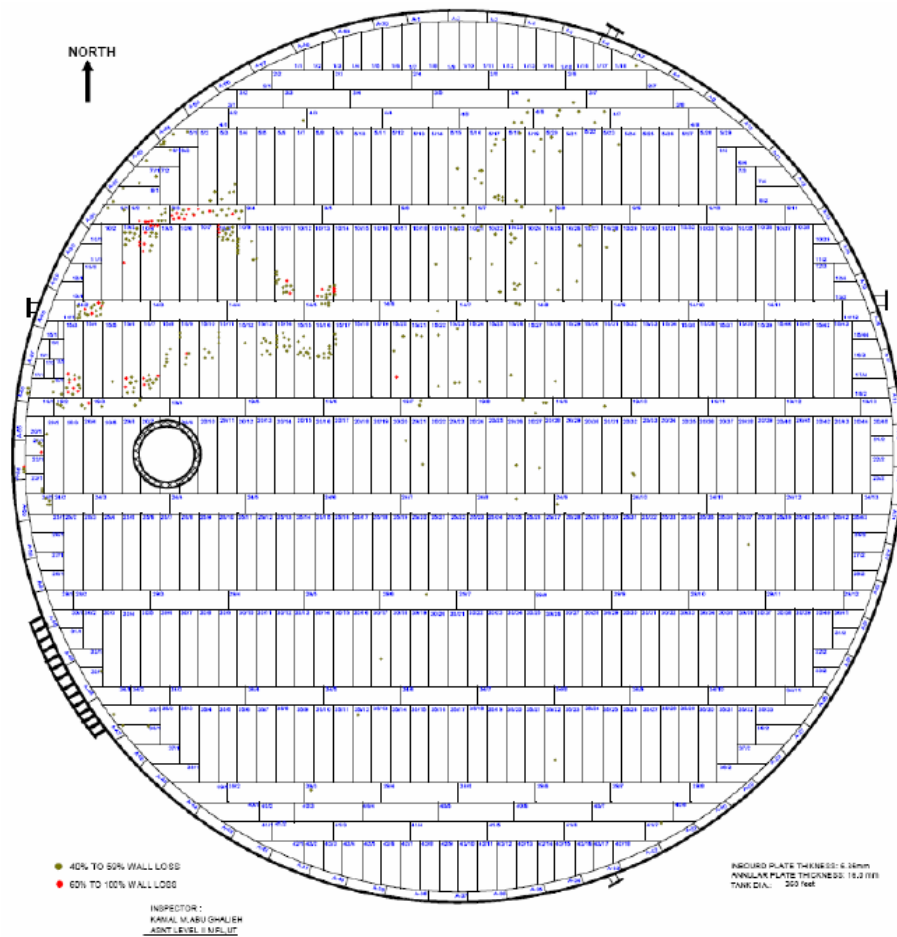
The 2<sup>nd</sup> MFLT was performed by another vendor in July 2009. 19 sketch and inboard plates with 60% and above metal loss were reported including 39 holes. 89 sketch/inboard plates had corrosion features with 40-60% metal loss (Figure 3). Also, two deep corrosion pits with 84% metal loss were identified on the annular plates (nominal thickness: 16 mm).

2. The major corrosion on the tank bottom was from underside attack (pitting and corrosion lakes). Most severe corrosion was identified in the northwest quadrant of the tank bottom by MFLT (Figure 3). There were 1, 8 and 3 holes on the cut-out samples #1, #2 and #3, respectively. The holes were made by hammering on the locations with very low UT readings (< 2 mm) during the MFLT. No oil leaks were found at the cut-out locations.

**Figure 3 – MFLT Report in July 2009**

- 2 Replace the bottom plates where the metal loss exceeds 60% and above of the plate thickness to reduce the number of patch-on repairs. Also, replace the 8" thick oily sand layer with sweet sand at the same time.

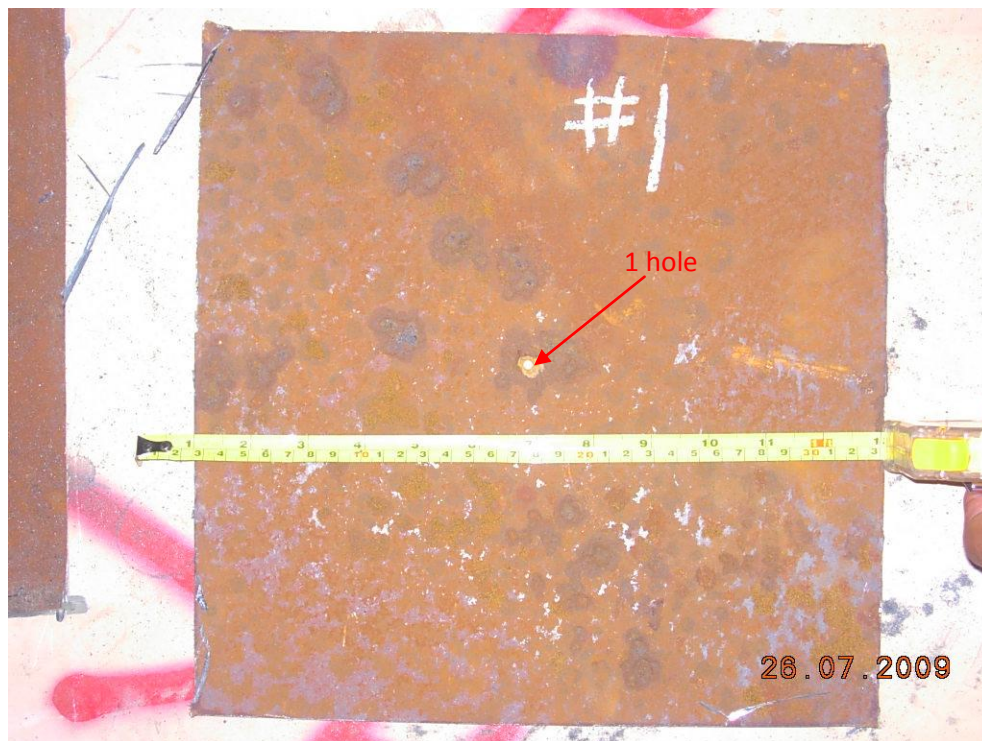
**Figure 4** – Underside of Sample #1 after Cutting

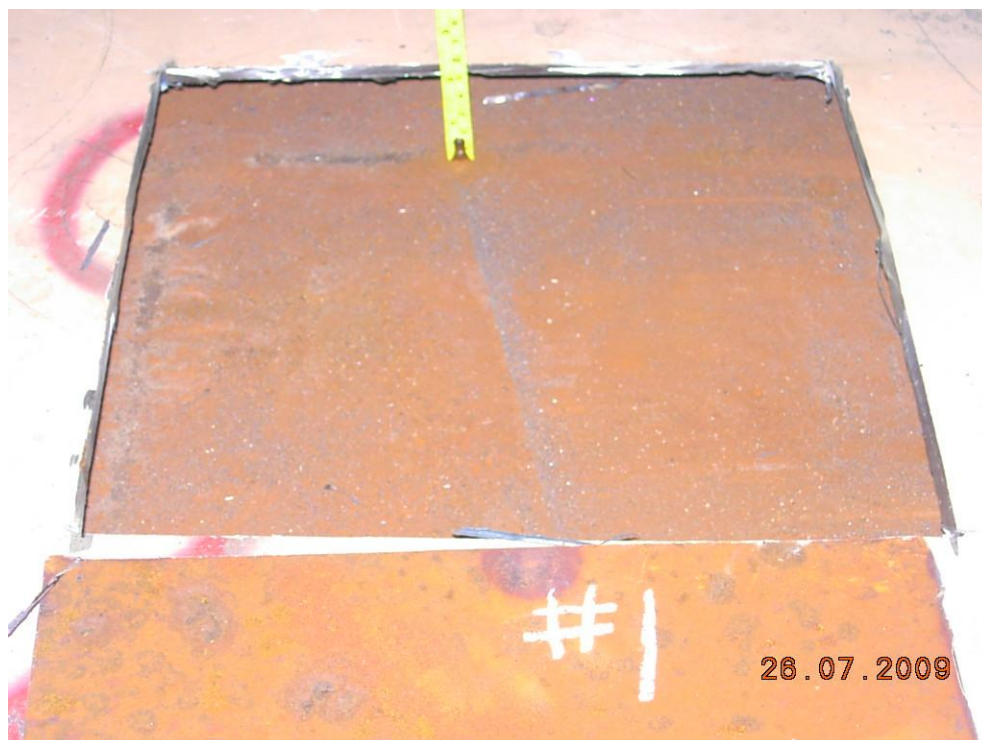
3. The underside surface of the tank bottom was supposed to be protected by the existing CP systems. However, some big air gaps between the tank bottom and soil (1-2 inch thick) were identified underneath the tank bottom at the locations with severe underside corrosion (see Figures 5, 9 and 11). The gaps blocked the CP current resulting in corrosion. CP needs good contact between the soil (electrolyte) and the bottom plates, which allows the current flow through the soil back to the protected metal surfaces. Poor or no contact means inadequate or no CP. The gaps in the central areas should be closed when the tank is loaded. However, some gaps far away from the tank center are believed to be present even when the tank is full of crude oil.

**Figure 5** – 2" Thick Air Gap between Bottom Plate and Soil at the Location of Sample #1

- 5 Inject vapor phase corrosion inhibitor (VpCI) into the gaps between the bottom plates and the soil. This is a cost effective method. VpCIs are special corrosion inhibitors (organic amines or carboxylates) which can be transported in a closed system to the site of corrosion by volatilization and diffusion from the source. VpCIs are adsorbed onto the metal surface with a thin film to mitigate corrosion.

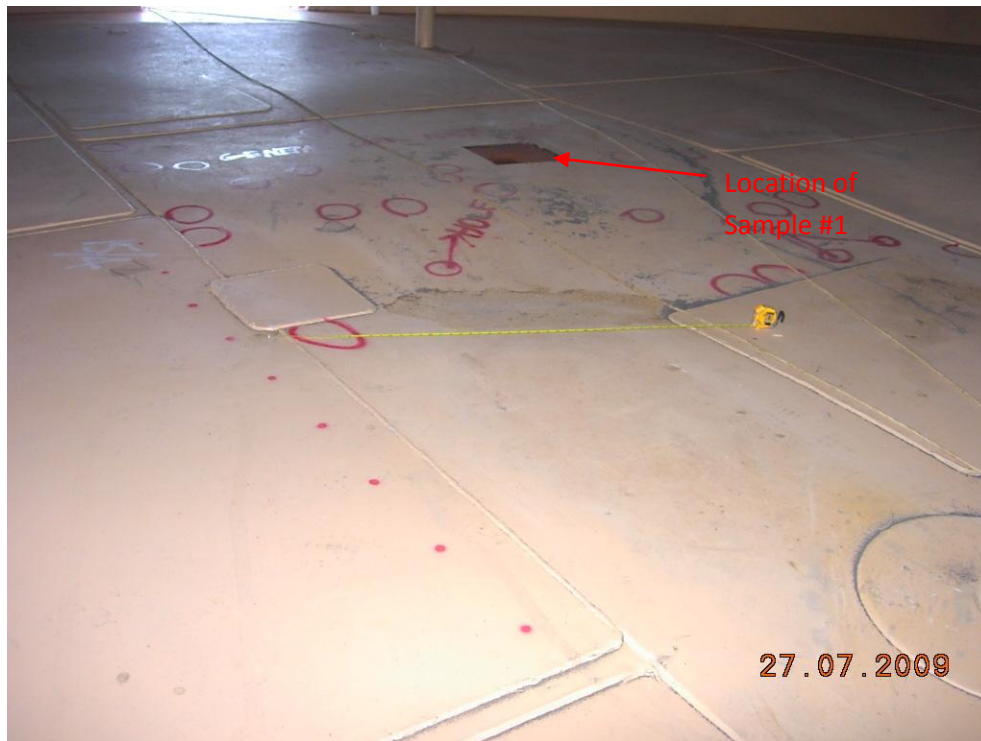
4. Major underside attacks were concentrated on the areas where the bottom plates severely buckled. The buckling of the tank bottom could come from the tank filling/unloading/re-filling cycle. It may also result from the uneven distribution and high density of the repair patches on the bottom plates in certain areas (Figure 6). The buckling of the bottom plates led to the formation of the gaps.

**Figure 6 – Severe Buckling of Bottom Plates around Sample #1**

- 1 Remove the severely buckled sections of the bottom plates and replace the oily-sand layer with sweet sand to ensure good contact between the new bottom plates and the soil.

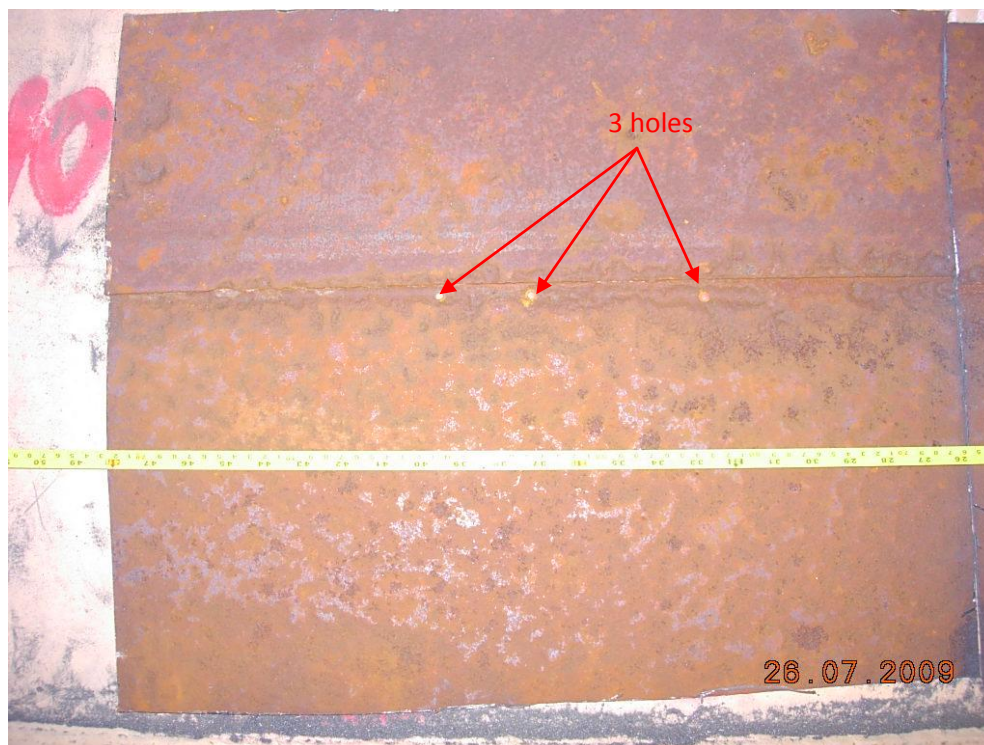
**Figure 7 – Underside Corrosion of Sample #2 (1<sup>st</sup> Half) after Cutting**

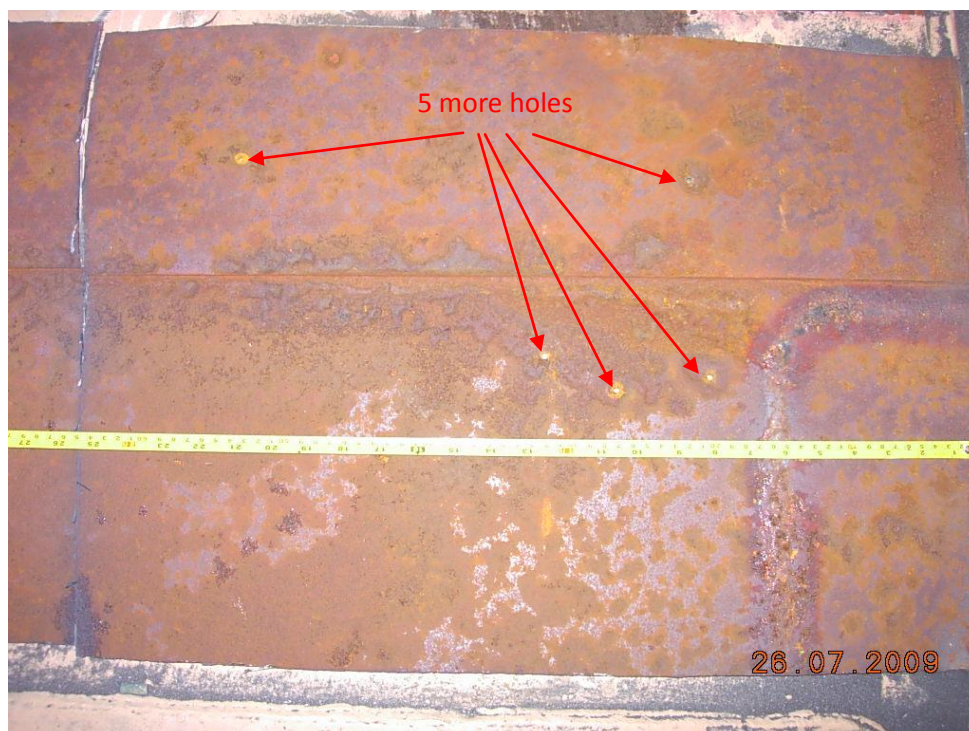
**Figure 8** – Underside Corrosion of Sample #2 (2<sup>nd</sup> Half) after Cutting

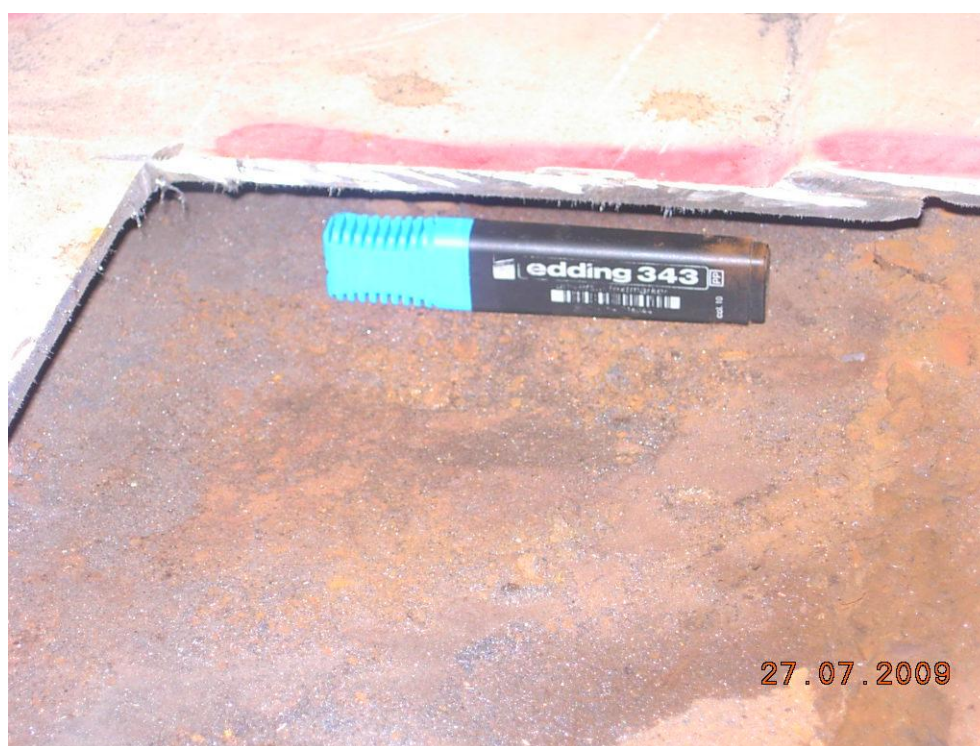
**Figure 9** – 2” Thick Air Gap between Bottom Plate and Soil at the Location of Sample #2

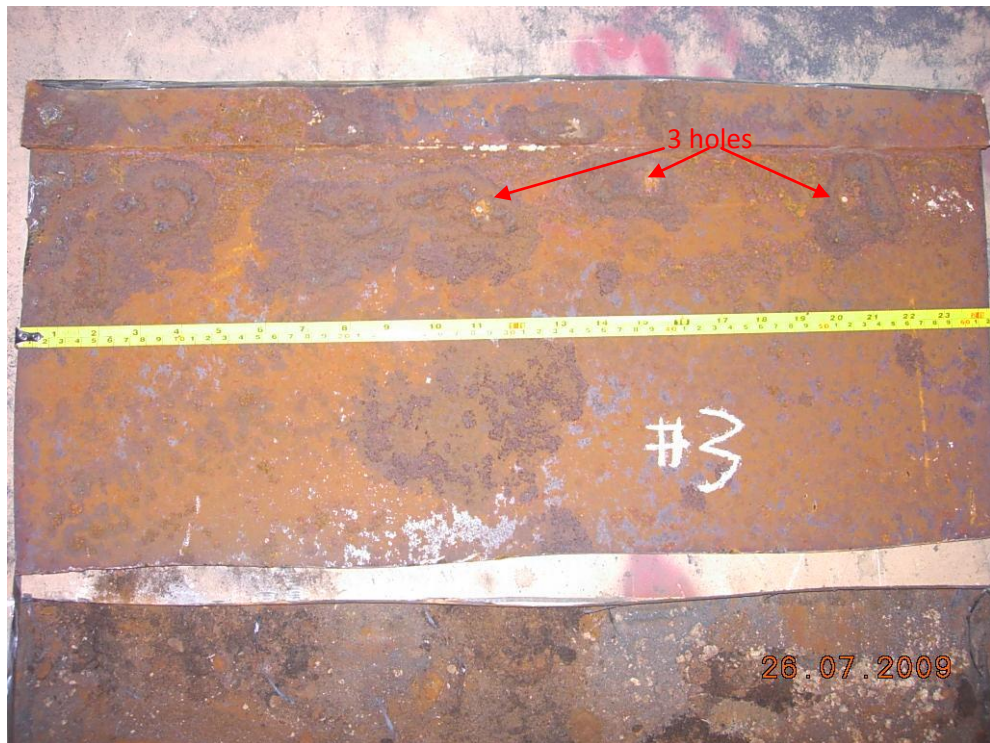
**Figure 10** – Underside Corrosion of Sample #3 after Cutting

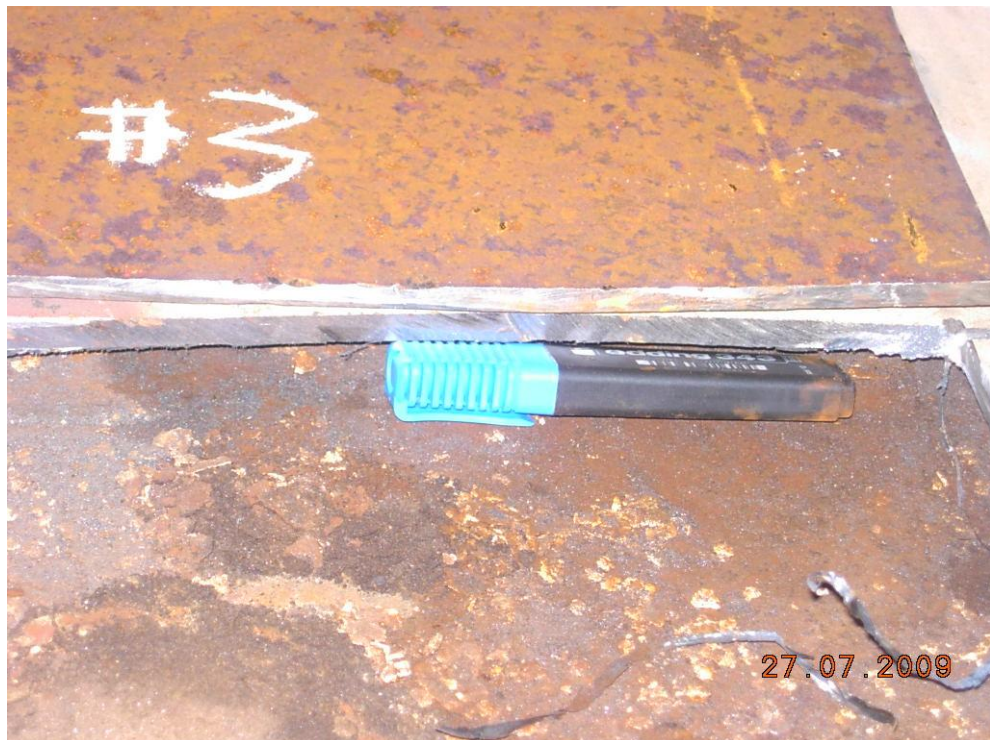
**Figure 11** – 1" Thick Air Gap between Bottom Plate and Soil at the Location of Sample #3

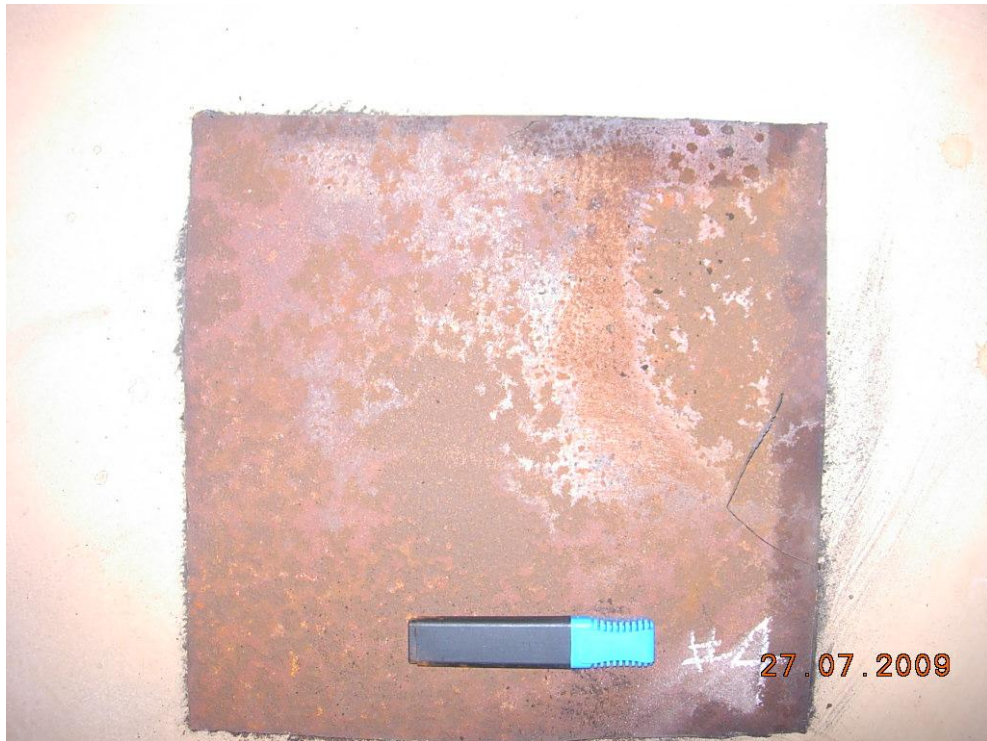
7. Sample #4 was removed from a near-central location with no reported corrosion by MFLT. The bottom plate was well contacted with the soil (no air gaps). The CP readings were satisfactory. Only minor general corrosion was identified on the underside of the cut-out sample (see Figure 12).

**Figure 12** – Underside Mild General Corrosion of Sample #4 after Cutting

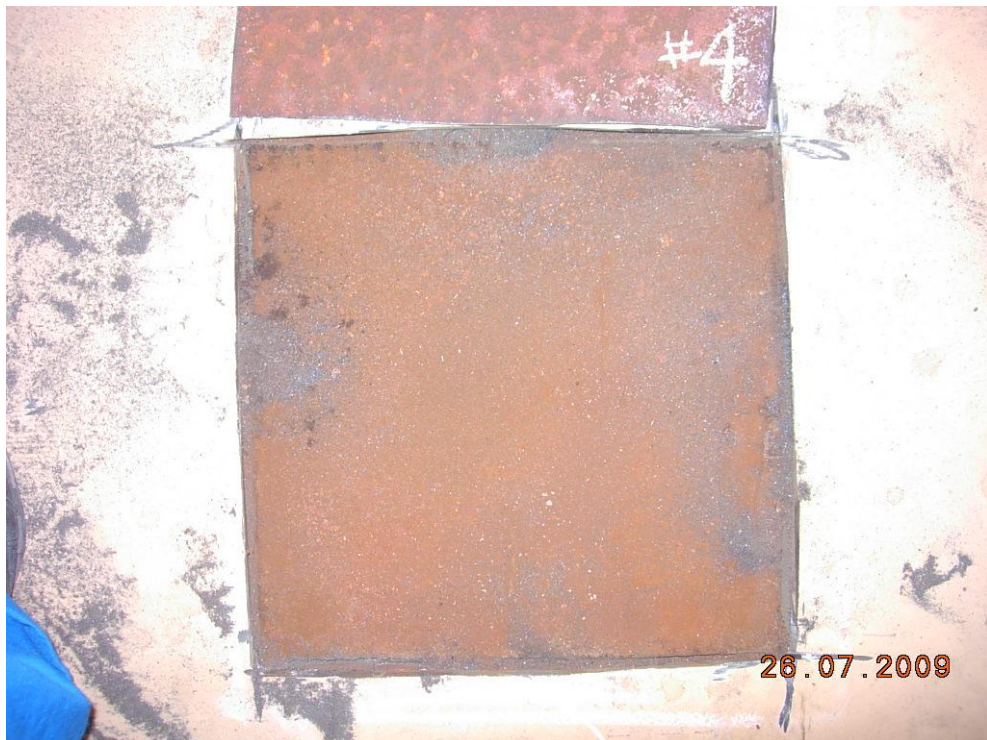
**Figure 13** – No Air Gaps between Bottom Plate and Soil at the Location of Sample #4
