# C2020-15065

## Comparison of VCI and CP Performance Using Floor Scan Data from Several 10-Year Old AST Floors

Tim Whited  
MESA  
4445 S. 74th E. Ave.  
Tulsa, Oklahoma 74145  
Tim.Whited@mesaproducts.com

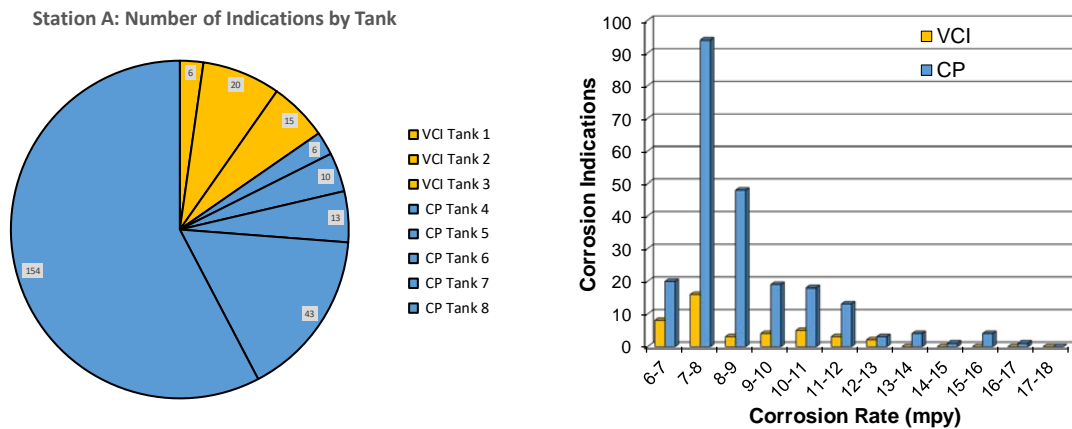
**Figure 1. (a) Station A total number of corrosion indications per Tank. (b) Total number of corrosion indications per corrosion rate segments of Station A tank floors.**

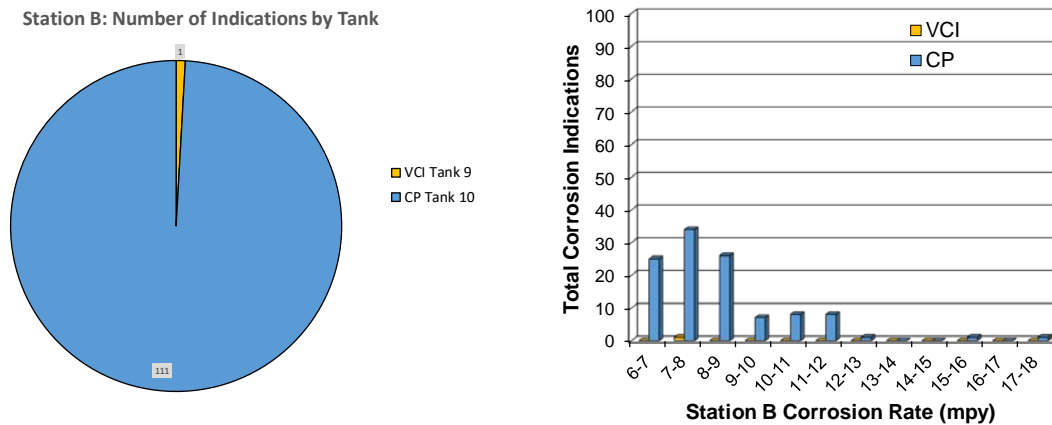
**Figure 2. (a) Station B total number of corrosion indications per Tank. (b) Total number of corrosion indications per corrosion rate segments of Station B tank floors.**

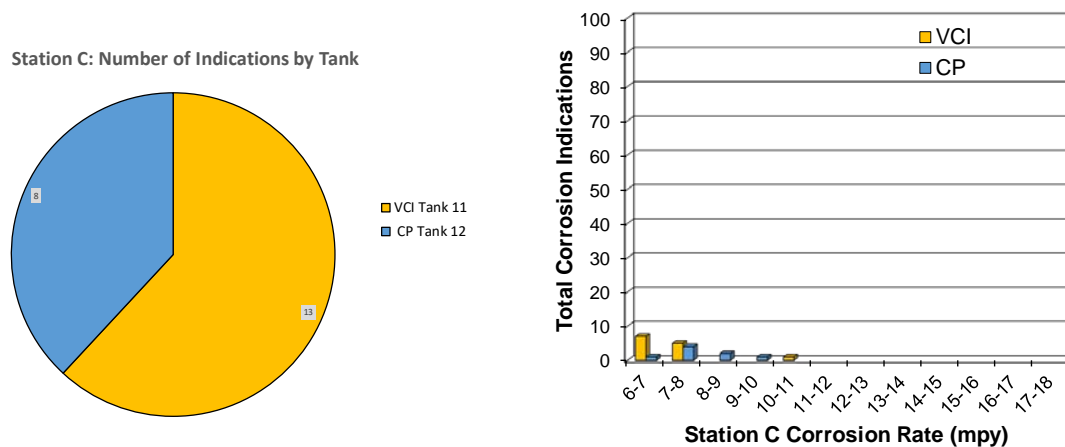
**Figure 3. (a) Station C total number of corrosion indications per Tank. (b) Total number of corrosion indications per corrosion rate segments of Station C tank floors.**

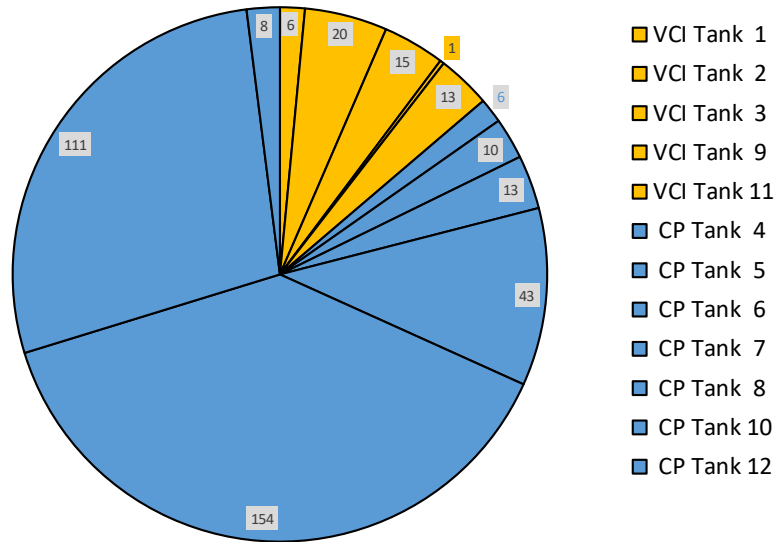
**Figure 4. Total number of corrosion indications per all (12) tanks**

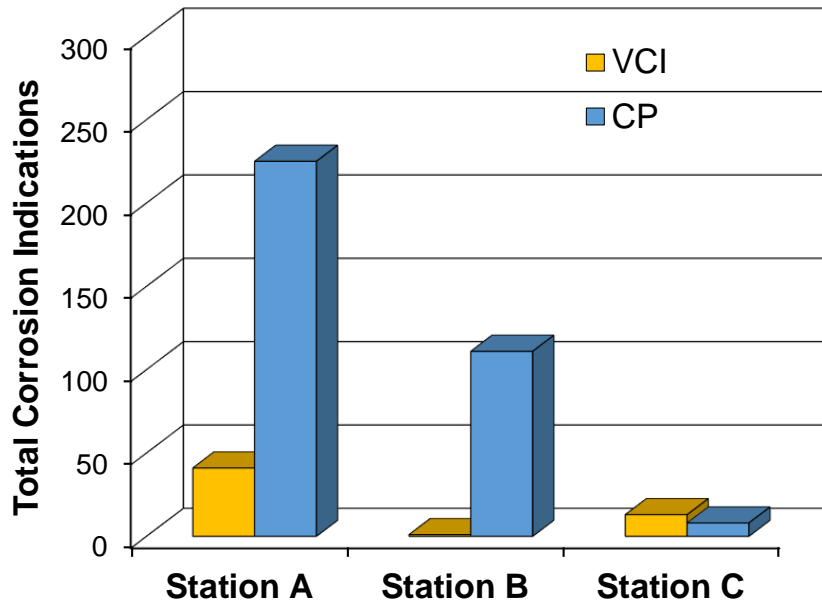
**Figure 5. Total number of corrosion indications per each Station**

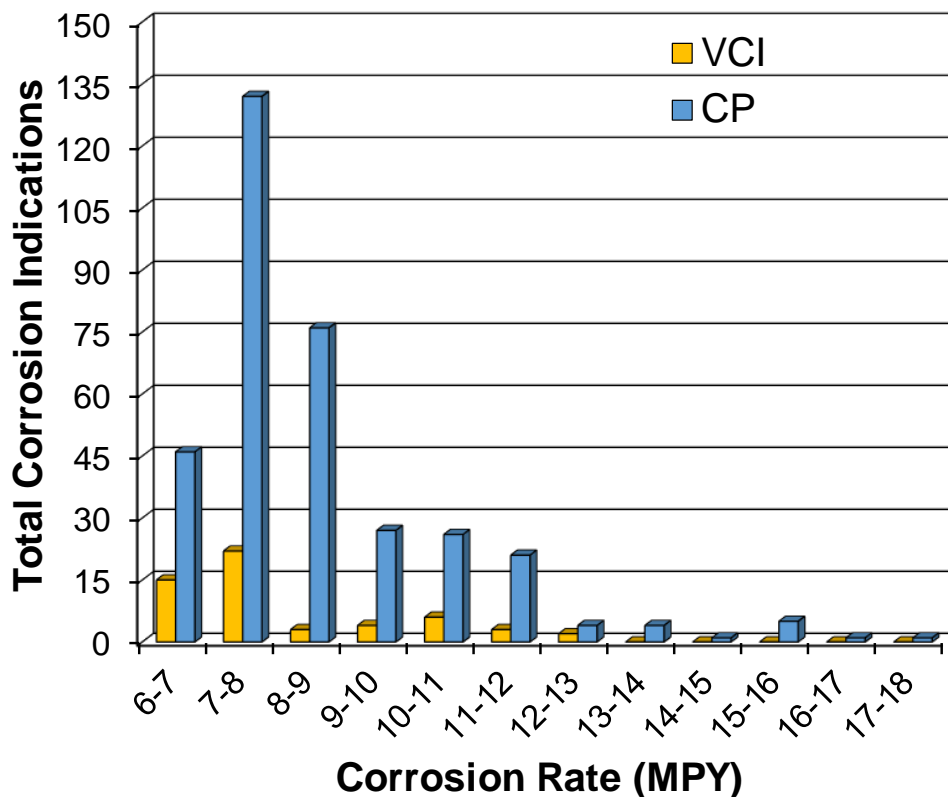
**Figure 6. Total number of corrosion indications per corrosion rate segments of all (12) tank floors.**
