FAILURE ANALYSIS OF BOTTOM PLATE OF POTABLE WATER TANK, PH-II, MEDINA-YANBU PLANTS¹

¹ Issued as Troubleshooting Technical Report No. TSR 3804/04014 in February 2005.

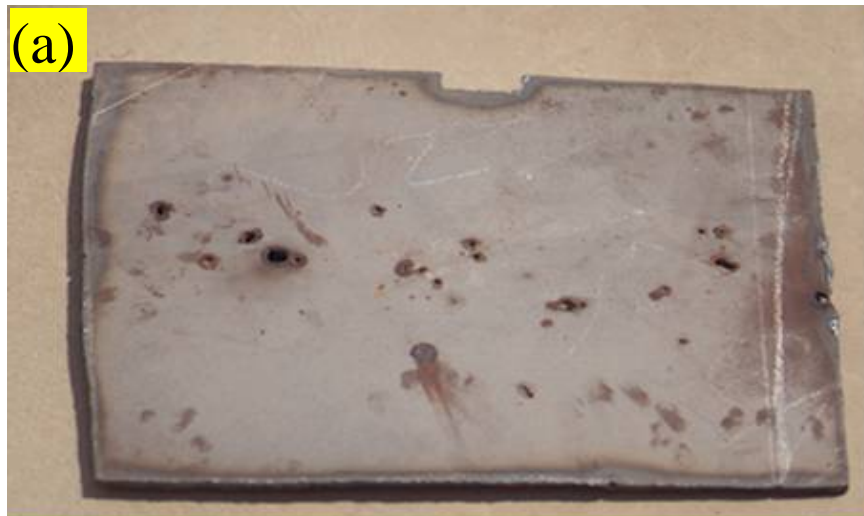
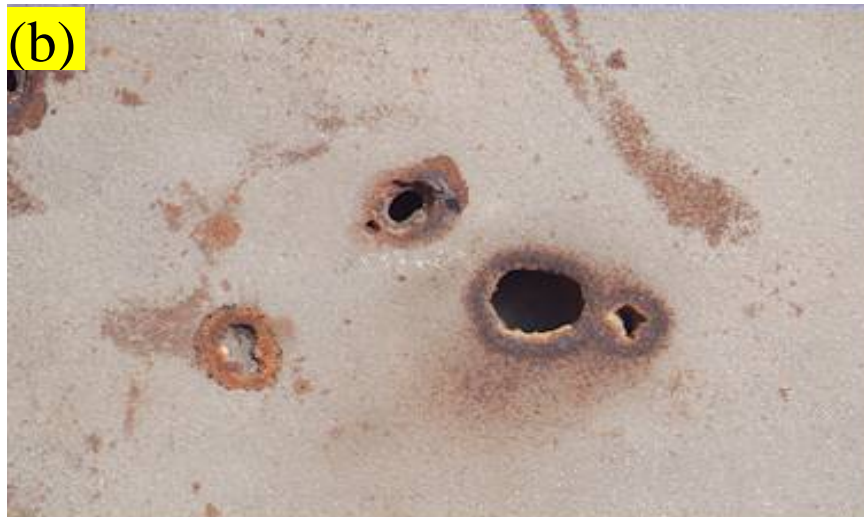
Figures 1 to 3 show two samples of bottom plate in the as received condition. A visual examination of the inner surface (water side) of the plate, cut from a location near the annular plate, showed holes and deep pits of varying depth (Fig. 1). The external surface (soil or underside) of the plate was found to be heavily corroded (Fig. 2). Figure 3 shows the bottom plate sample cut from a location away from the annular plate. Initiation and propagation of pits from water side can be seen. However, the external surface of bottom plate sample does not show any corrosion. A detailed inspection of the bottom plate revealed that pits and holes were confined within 1 meter area of the junction of annular and bottom plate and mainly concentrated over and/or near weld junction of two bottom plates. The bottom plate of the tank facing the neighboring tanks (south-east and south-west) was found to be more affected. A gap between the two overlapping section of bottom plates was also noticed. At certain locations some gap between soil surface and the bottom plate was also visualized.

Considering the corrosion on the inner side (water side) of the plate, the holes and deep pits are caused due to the failure of epoxy coating applied over the inner surface of the bottom plate of the water tank. In the absence of the detailed examination of the failed coating and analysis of the cathodic deposits in the pits and blisters it is difficult to ascertain the actual cause of the coating failure at this stage of the investigation. However, the probable causes of the coating failure can be predicted. Coating and cathodic protection are both engineering disciplines with the primary purpose of mitigating and preventing corrosion. To obtain maximum corrosion resistance from the combination of a coating and cathodic protection, a number of factors, which have a basic influence on their combined effectiveness, must be taken into consideration. Any coating lacking resistance to alkalies, electroendosmosis, proper adhesion and optimum coating thickness is likely to fail by blistering under cathodic protection. The results of both laboratory testing and actual use of the combined system has shown that coating thickness and cathodic protection potential (CPP) are of real importance where a coating is to be used with cathodic protection [1]. The cathodic disbonding tests results have indicated that, in general, thicker coatings show better results. An increase in the value of CPP from – 850 mV vs Cu/CuSO₄ reference cell resulted in early blistering [2]. In another experiment, it has been shown that disbonding increased almost ten fold as the coating thickness decreased from the 65 mils range to 20 mils range [3].

Figure 1a. Inner surface of the bottom plate, cut from a location near the annular plate, in the as received condition b. A close-up view of the hole and pit

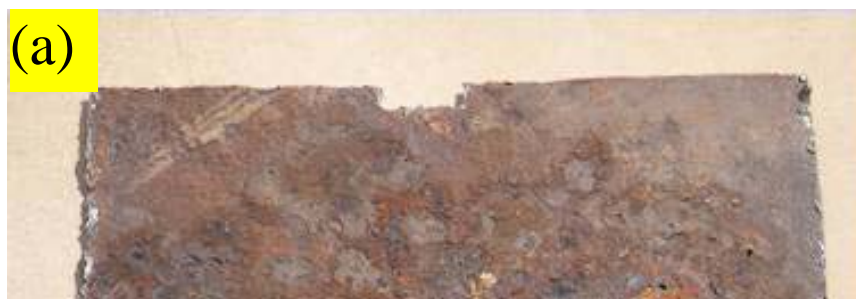
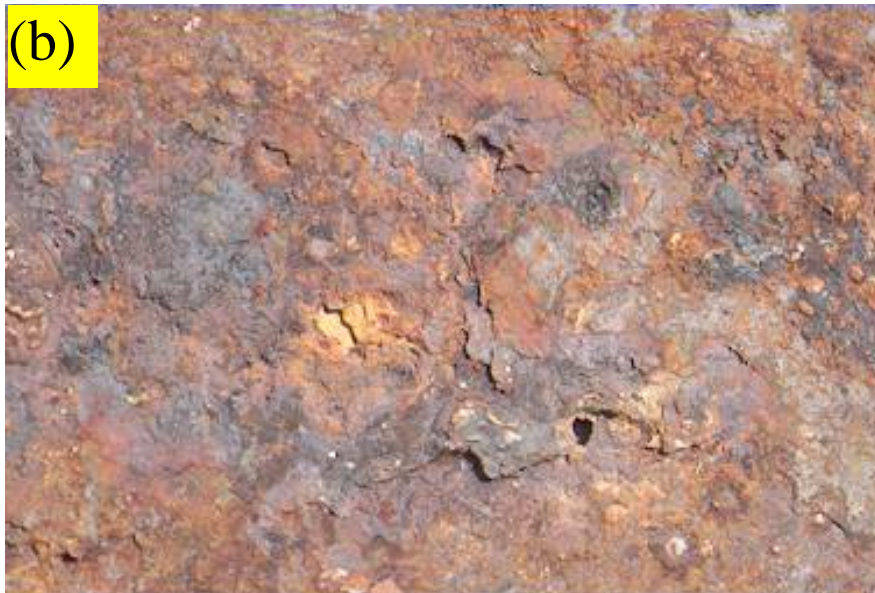
Considering the corrosion on the external side (underside) of the plate, the floor scanning report indicated heavy underside corrosion of the plates facing the neighboring tanks. The severity of underside corrosion is directly related to the corrosivity of the soil which depends upon a number of soil parameters e.g., pH; resistivity; redox potential; and moisture, sulfides, sulfates, and chlorides contents. However, the stray direct current (DC) or induced alternating current (AC) sources can also accelerate soil corrosion. Since the neighboring tanks have separate external impressed current cathodic protection systems, the possibility of stray DC effect in initiating and accelerating the underside corrosion can not be ruled out. Further, as a result of through holes in the bottom plate the high conductivity water came in contact with underside of the plate and caused heavy damaged over a period of time. The values of current densities and cathodic protection potentials for the external cathodic protection are calculated and listed in Table 2 and 3, respectively. The values of the current densities are higher than the typical current density required for the protection of buried underground steel structures [4]. This is a clear indication of some serious

Figure 2a. External surface (under side) of the bottom plate in the as received condition
b. A close-up view showing heavy corrosion

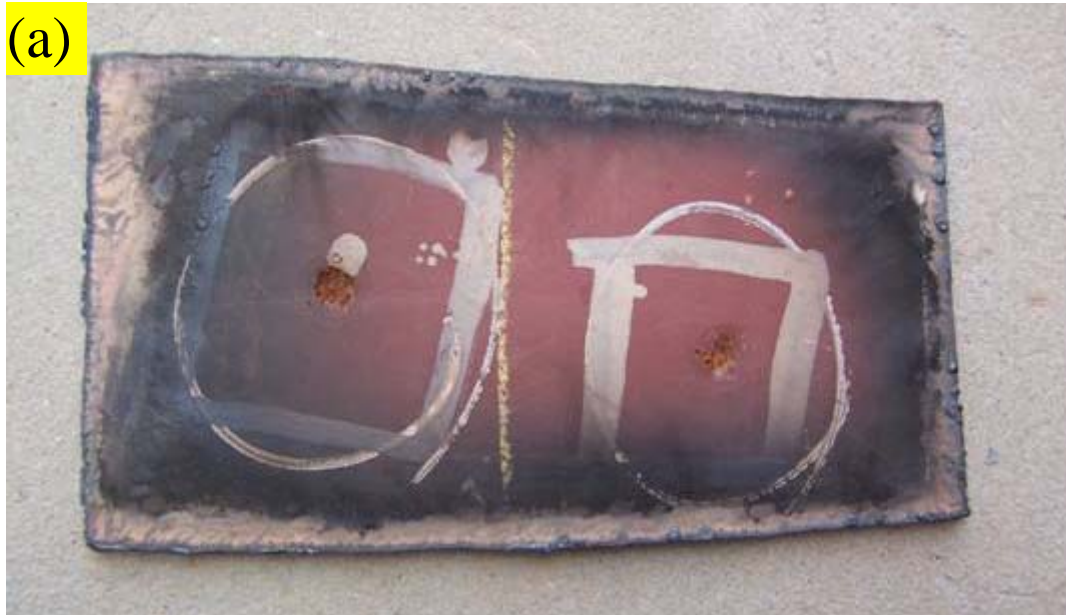
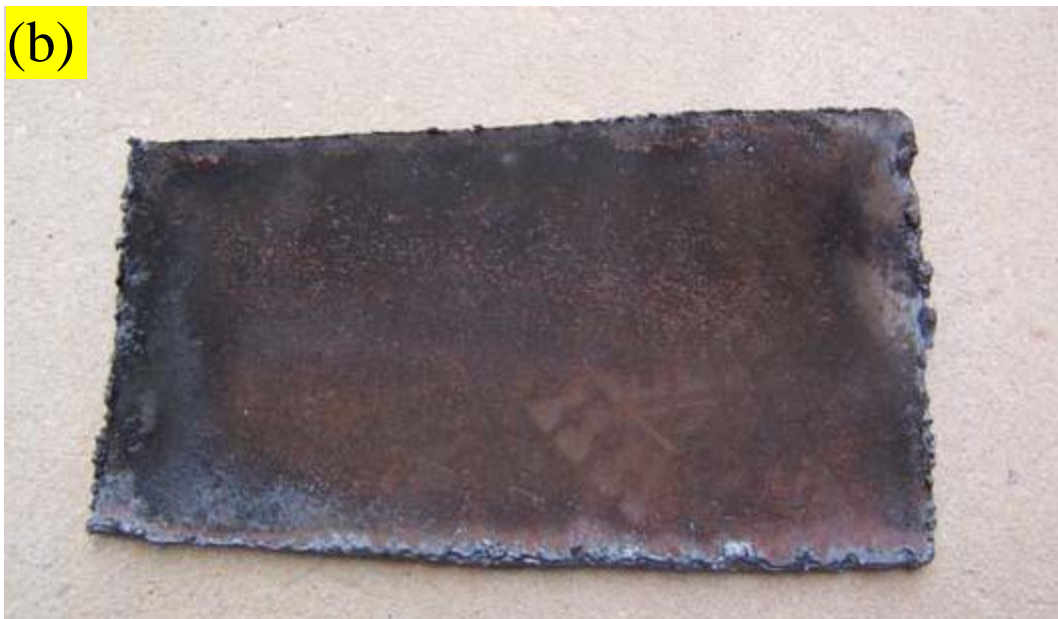
Figure 3(a). Inner surface of the bottom plate cut from a location away from annular plate showing only pits
(b) External surface (underside) of the bottom plate showing no corrosion

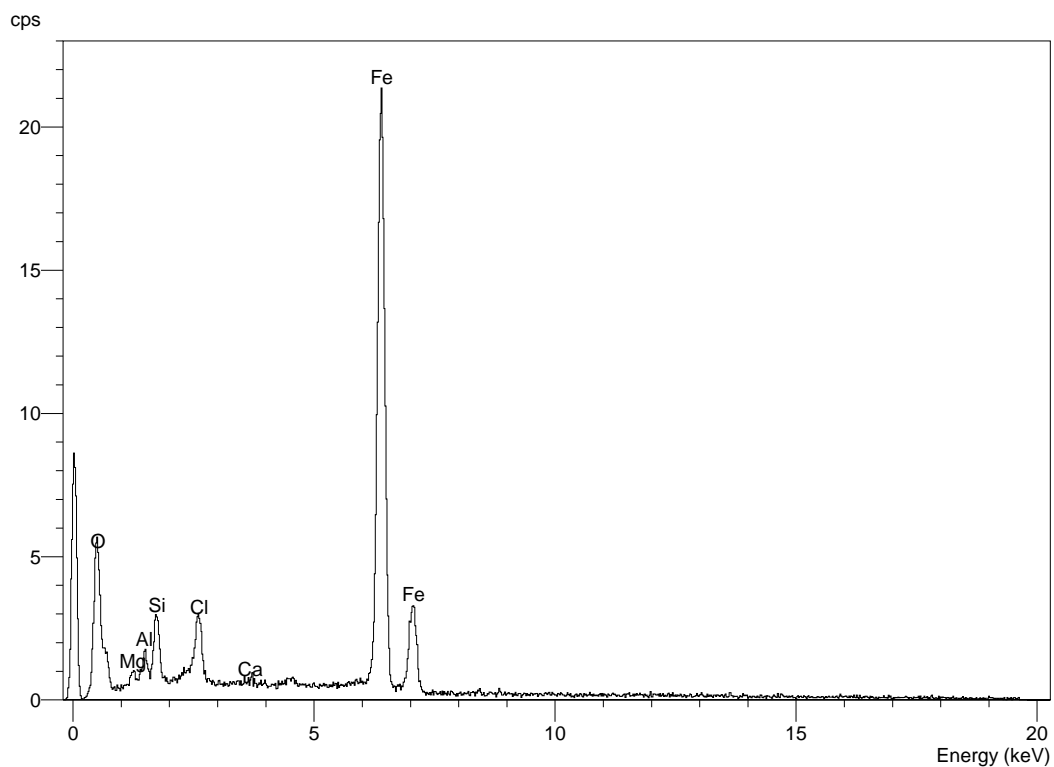
The EDX studies of the corrosion products on the surface of the pits and a location away from the pits show the presence of significant concentration of chloride even after sand blasting (Figs. 4 and 5). The EDX concentration profiles of the corroded external surface and corrosion flakes obtained from the soil side of the bottom plate show strong peaks of Fe and O with other impurities in small concentration (Figs. 6 and 7). The

Figure 4. EDX profile of the corrosion products on the surface of the pit

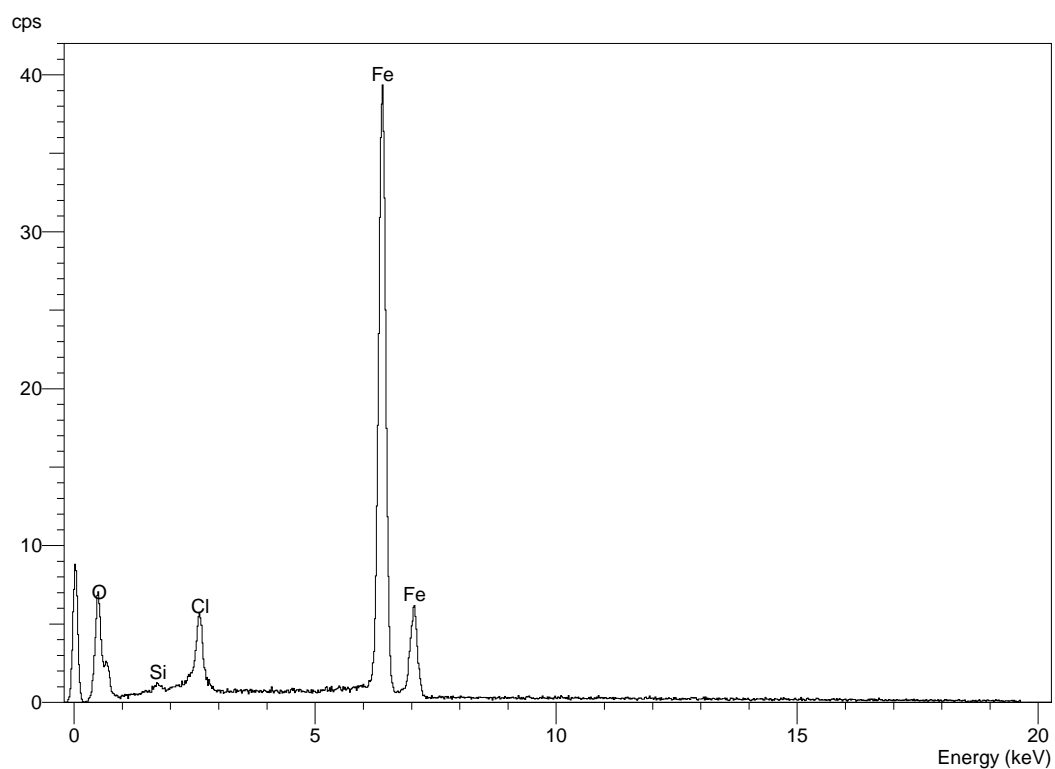
Figure 5. EDX profile of the corrosion products at a location away from the pit

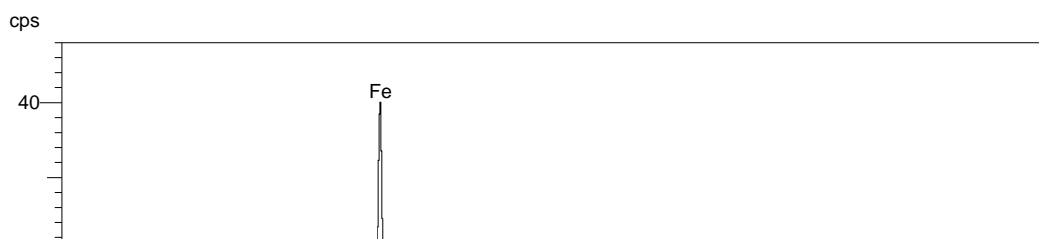
Figure 6. EDX profile of the heavily corroded external surface of the bottom plate having deep pit and holes

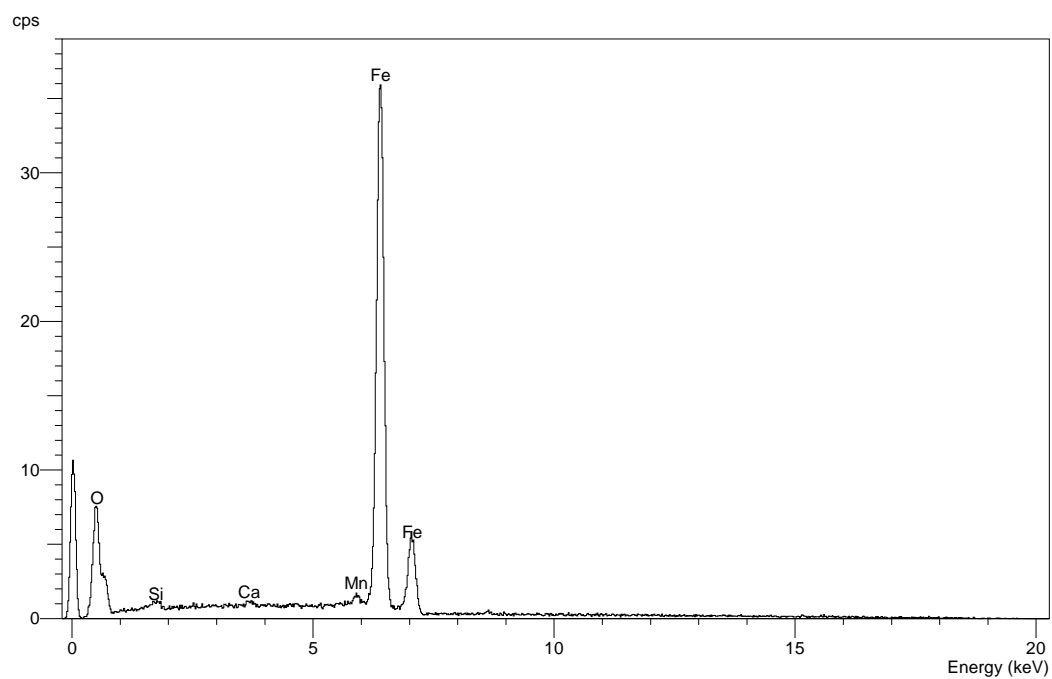
Figure 7. EDX profile of the corrosion flakes obtained from external side of the bottom plate having holes

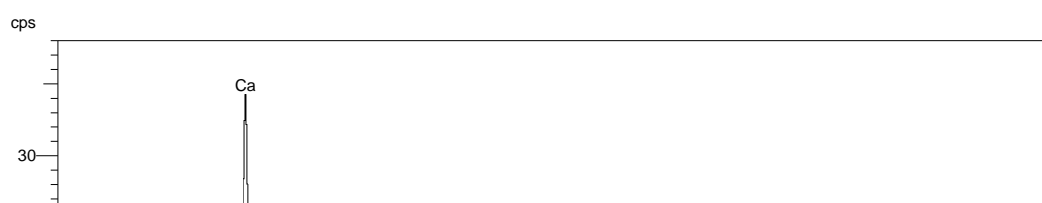
EDX concentration profile of calcareous deposit collected from the internal surface of the plate shows the presence of mainly Ca and O (Fig. 8).

Figure 8. EDX profile of calcareous deposit present on the inner surface of the bottom plate
