South Texas Project
Unit 2
Docket No. STN 50-499
Licensee Event Report 2-03-003 Revision 1
Standby Diesel Generator 22 Failure

LICENSEE EVENT REPORT (LER)

Standby Diesel Generator 22 Failure

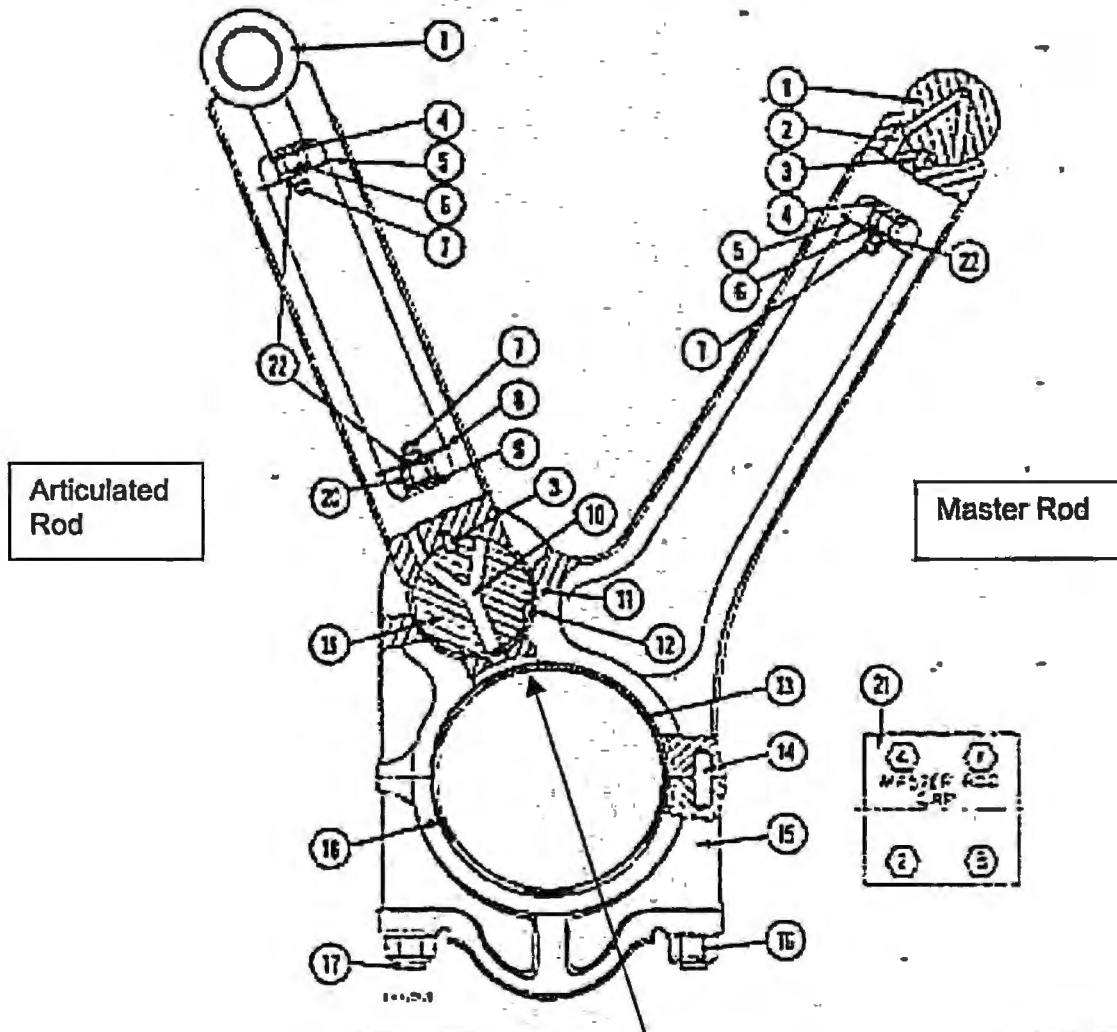
Attachment 1 Diagram of Connecting Rods

The crack initiated on the master connecting rod in the area (ligament) between the crankshaft bearing bore and the articulating rod bushing bore. The crack propagated through the section thickness (approximately 1") and then propagated across the width of the bore. One side of the

The root cause of the diesel engine failure was microcracks created on the position 9 master connecting rod during the manufacturing process. The microcracks propagated due to high cycle fatigue until the master connecting rod failed.

Site of crack Initiation (on the master rod under the bearing shell)
