NP-33-06-002-00

Licensee Event Report 2006-002-00
Ultrasonic Examination Identifies Axial Flaw Indication in
Reactor Coolant Pump Drain Line Weld
Davis-Besse Nuclear Power Station, Unit No. 1
Date of Occurrence – March 18, 2006

Ultrasonic Examination Identifies Axial Flaw Indication in Reactor Coolant Pump Drain Line Weld

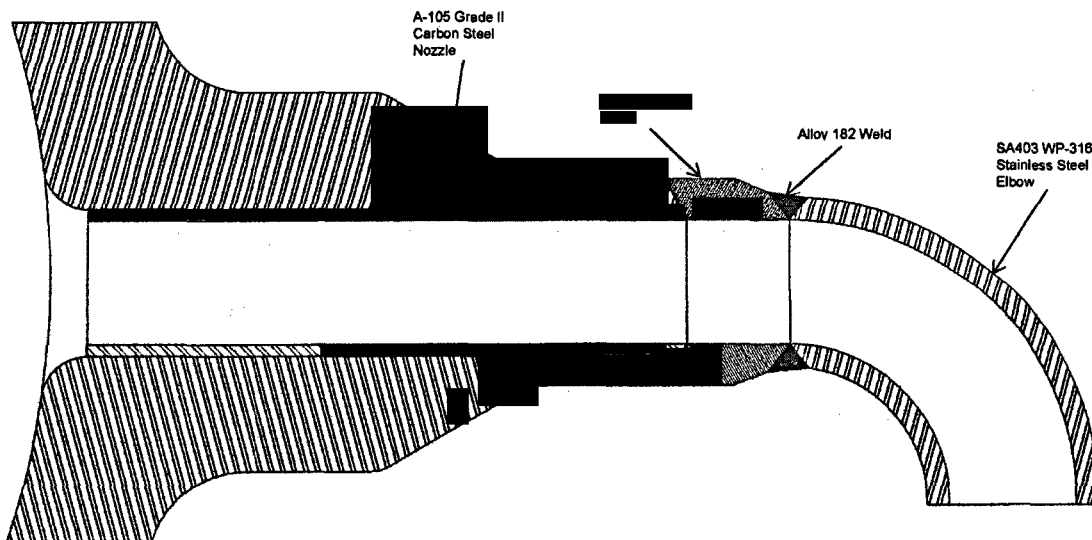
Figure 1: Reactor Coolant Pump 1-1 Cold Leg Drain Line Nozzle-to-Elbow
Weld Arrangement Prior to Weld Overlay

On March 18, 2006, with the Davis-Besse Nuclear Power Station (DBNPS) shut down for the fourteenth refueling outage and in Mode 6 (Refueling), ultrasonic examination of the 2-1/2 inch diameter Reactor Coolant Pump 1-1 cold leg drain line nozzle-to-elbow dissimilar metal butt weld [AB-NZL] detected an axial flaw indication at least 0.25 inches in length. Due to the configuration of the weld joint and lack of qualified depth sizing procedures for dissimilar metal welds, the length of the indication could not be accurately determined. Ultrasonic examination of the base material on both the elbow and nozzle sides of the weld showed no evidence of propagation, so the axial flaw indication was believed to reside solely in the Alloy 182 buttering and potentially the weld of the nozzle-to-elbow dissimilar metal in close proximity to the inside surface. No evidence of through-wall leakage was observed on the previous day when an Alloy 600 bare metal examination of the piping was conducted.

The 2-1/2 inch cold leg drain line nozzles were shop fabricated of A105 grade II carbon steel with Alloy 182 buttering on the weld end and internally clad with a minimum of 1/8 inch stainless steel filler material. The nozzle was butt welded with Alloy 82/182 filler metal to a 2-1/2 inch schedule 160 long radius 90 degree elbow made of SA-403 grade WP-316 stainless steel. Refer to Figure 1 at the end of this report for a diagram of this piping. During the fourteenth refueling outage, the Reactor Coolant Pump 1-1 cold leg drain line nozzle-to-elbow weld was examined by personnel and equipment qualified to the Performance Demonstration Initiative (PDI) generic procedure for manual ultrasonic examination of dissimilar metal piping welds. The axial flaw indication discovered on March 18, 2006, was located in the Alloy 182 buttering of the dissimilar metal weld. Alloy 600 and its associated Alloy 82/182 weld filler materials are used in nuclear power plants due to a thermal expansion coefficient that is intermediate between low alloy and stainless steels. The related weld filler materials are used to join Alloy 600 parts to the ferritic steel components and also as a bi-metallic weld joining ferritic base materials to austenitic stainless steel base materials. Alloy 82 is used in the automatic welding process and Alloy 182 is used in the manual welding process.

The probable cause of this axial flaw indication on the 2-1/2 inch diameter Reactor Coolant Pump 1-1 cold leg drain line nozzle-to-elbow dissimilar metal butt weld is less than adequate welding process during initial plant construction in 1975. Residual stresses from extensive localized grinding and repair of a crack, slag, and a lack of penetration resulted in a flaw in this weld. There are two possibilities for the resultant axial flaw indication. Either a latent construction flaw remained from several localized weld repairs and was hidden in the weld butter by the radiograph penetrometer, or the weld repairs resulted in a crack initiation site. The residual stresses from the construction weld repairs when combined with the conducive environment of the Reactor Coolant System, plus the susceptibility of Alloy 600 material established the presence of the three key elements for the development of primary water stress corrosion cracking in spite of the low susceptibility (lower operating temperature) of the cold leg drain lines. None of the other three cold leg drain lines required a localized repair of the nozzle-to-elbow butt weld involving repetitive grinding like the Reactor Coolant Pump 1-1 cold leg drain line nozzle-to-elbow butt weld during initial plant construction.

A repair consisting of a full structural weld overlay of the affected area was performed to mitigate any potential stress corrosion cracking. The finished weld overlay completely covered the indication with Alloy 52 based weld material that is highly resistant to primary water stress corrosion cracking. The weld overlay also induces compressive stress in the weld, thus impeding growth of any reasonably shallow cracks. Furthermore, the weld overlay was sized to meet all structural requirements independent of the existing weld, and to facilitate ultrasonic examination. An acceptable ultrasonic examination with no recordable indications was obtained for the weld overlay repair to the Reactor Coolant Pump 1-1 cold leg drain line. No remnants of the axial flaw indication were observed after the weld overlay; however, the intent of the ultrasonic examination after the repair was not to validate previous observations.
