NP-33-02-004-00

LER 2002-004
Davis-Besse Nuclear Power Station, Unit No. 1
Date of Occurrence – May 23, 2002

| TITLE (4) Containment Isolation Closure Requirements for RCP Seal Injection Valves MU66A-D | | | | | | | | | | |

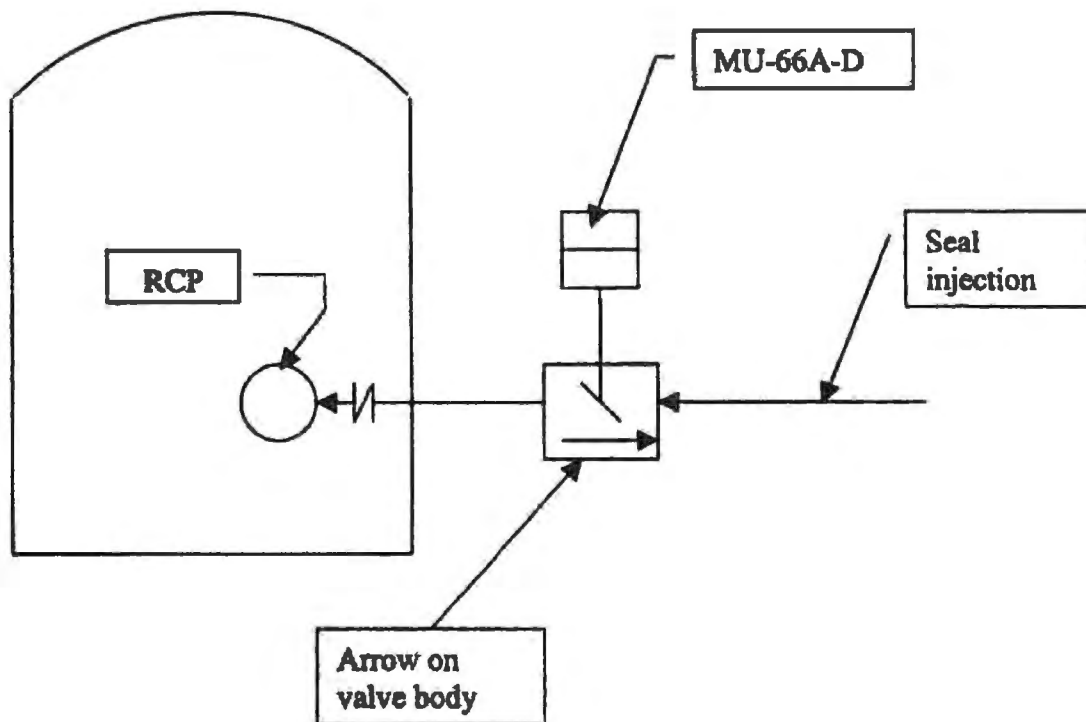
Figure 1

As described in USAR Section 9.3.4.3.3, the four RCP Seal Injection lines each contain a check valve inside containment and a solenoid actuated pneumatic valve outside containment in order to meet the containment isolation provisions of 10 CFR 50, Appendix A, GDC-55. Configuration of valves MU66A-D to meet their design bases assumes system flow under the valve disk during normal operation. During the postulated accident condition, the design bases assume RCS pressure acting on the top of the valve disk. The as-found configuration, shown in Figure 1, results in normal and accident system flow to be the converse of the design bases.

As part of the maintenance activity, one of the MU66 valves was disassembled and inspected. Its installed configuration was determined to be inconsistent with design assumptions. For a postulated accident situation resulting in an SFAS Level 3 containment isolation signal with the makeup pump not operating, the valves were intended to be installed such that RCS pressure would act upon the top of the valve disk, thus assisting valve closure when the valve is subjected to full differential pressure. In the as-found configuration, RCS pressure acts upon the bottom of the valve disk, thus acting to open the valve when subjected to full differential pressure.

The cause of the misorientation of the RCP Seal Water Injection Isolation Valves (MU66A-D) and RCP Seal Return Valve (MU38) appears to have resulted from confusion and/or miscommunication during original construction-phase installation of the valves. No documented information could be found related to the actual field instructions for installation of the valves. The valves were manufactured depicting a flow arrow on the body of the valve which would conform to normal generic system flow path for a globe valve (i.e., flow under the valve disk). The flow arrows shown on the installation drawing (pointing away from containment) were apparently intended to depict flow direction from the RCP seals assumed for postulated accident conditions without including any special notes or cautions on the drawing to explain or emphasize the intended valve configuration. The valves were installed such that the flow arrows on the valve bodies were matched to the flow arrows on the installation drawing which resulted in assumed post-accident RCS flow from the RCP seals to be under the disks for all the valves which is contrary to design intent. Documentation during and after plant construction indicates that the valves should be installed such that RCS pressure would act on the top of the valve disk. The installed configuration is inconsistent with this recommendation, USAR Sections 6.2.4 and 9.4.3.3, and the response to USAR Question 9.3.6.

MU66A-D As-Found Orientation

Valve configuration reflects vendor drawing and the installed condition with the normal seal injection flow on top of disc. The design intent was to install the valve in reverse of this configuration with any RCS back-pressure on top of disc.

An AOV Reliability Program is being implemented, in part, to ensure that AOV sizing and setpoints are reviewed to verify and document their adequacy. For valves MU66A-D, MU38, and all other Category 1 and 2 AOVs and their associated components; design basis requirements, including the correct installed orientation, will be established in accordance with the AOV Reliability Program Manual. The requisite engineering documents will be developed to implement any required changes. Any modifications needed to restore these components to their design requirements will be completed prior to plant restart. Post-modification testing will be performed to verify compliance with design bases.

Drawing 7749-M525-37-7 will be reviewed and revised to ensure that the actual configuration and the valve body arrow shown on the drawing are correct. This action is to be completed following the final design configuration determination based on the AOV Reliability Program requirements and prior to plant restart.
