South Texas Project Electric Generating Station P.O. Box 289 Wadsworth, Texas 77483

South Texas Project
Unit 1
Docket Nos. STN 50-498, STN 50-499
Supplement to Licensee Event Report 03-003
Bottom Mounted Instrumentation Penetration Indications

LICENSEE EVENT REPORT (LER)

Bottom Mounted Instrumentation Penetrations Indications – Supplement to LER dated 6/11/2003

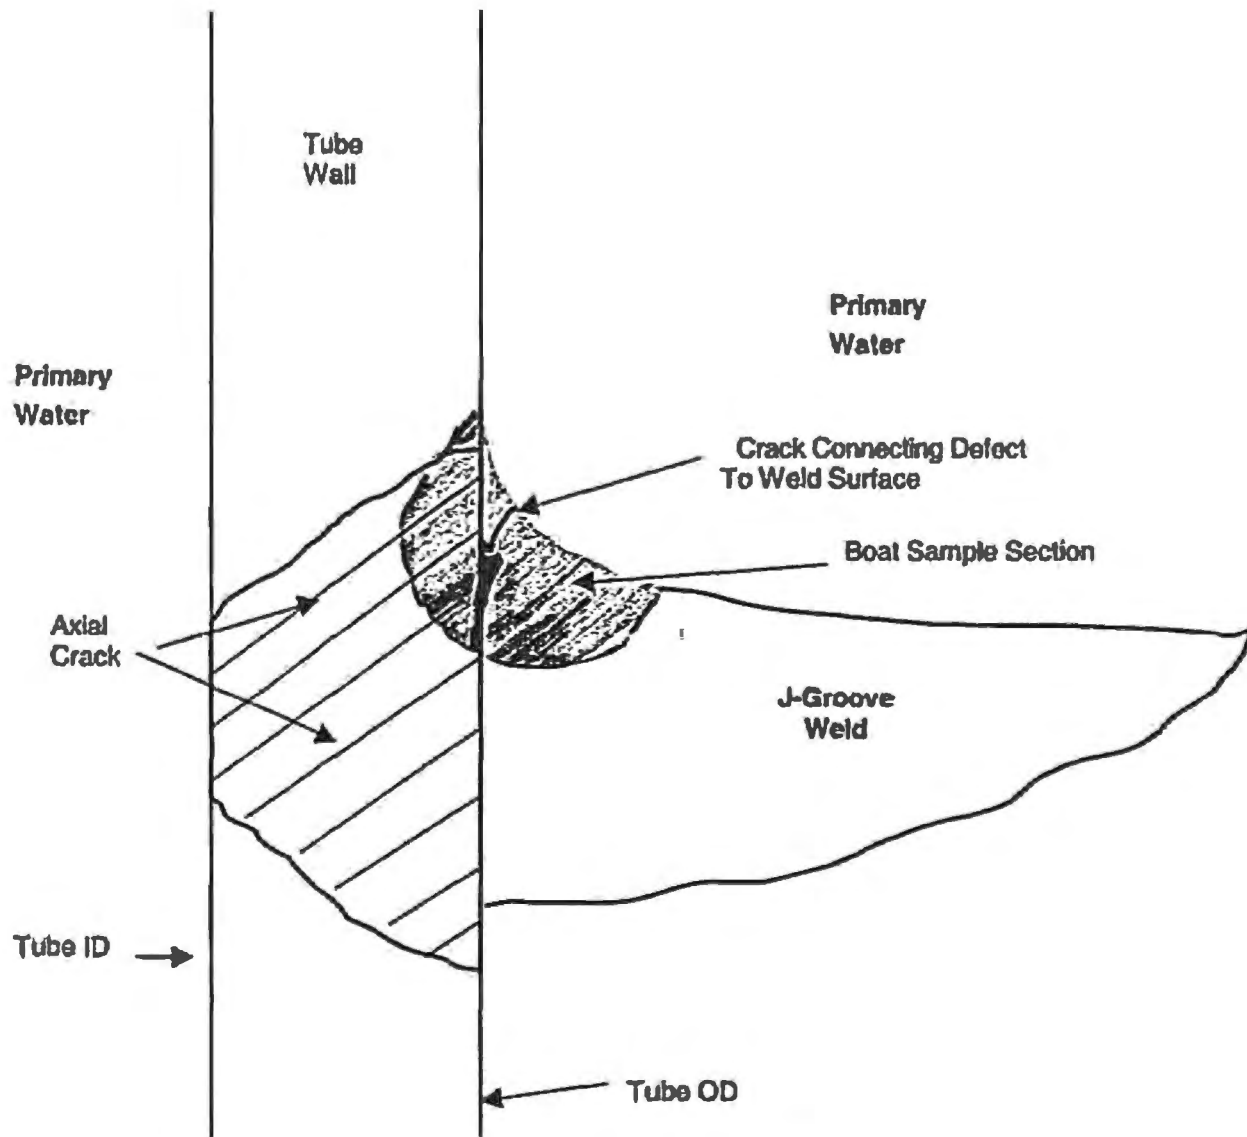
Composite Drawing Showing Axial Crack, Weld Flaw, and Weld Crack

The boat sample from Penetration #46 was designed to capture as much tube material as possible in an attempt to harvest a portion of a crack not connected to the ID of the nozzle. The margins for error associated with positioning the EDM equipment through 70 feet of water resulted in a shallow cut in Penetration #46. The resulting undersized sample was either inadvertently discarded or completely consumed in the margins of the EDM cutting tool. The boat sample from Penetration #1 captured material and defects from the J-groove weld and J-groove/tube interface, as designed. A composite drawing showing the axial crack, weld flaw and weld crack is attached.

The boat sample from Penetration #1 contained a portion of the large through-wall axial crack in the tube, three "discontinuities" which were confirmed to be lack of fusion resulting from slag inclusions, and one crack at the helium bubble location which connects the surface of the J-groove weld to the largest area of lack of fusion.

The crack in the weld that connects the surface of the J-groove weld to the largest area of lack of fusion is singular and unique. The 0.2-inch long crack spans an 80 mil ligament separating the lack of fusion void from the surface of the J-groove weld in the ground fillet transition at the tube/J-groove weld interface. The length of the crack spans and is limited to the width of the lack of fusion void. The section of the boat sample containing this crack was broken in the laboratory to expose the crack face for examination. Tenacious deposits obscured the crack face, and gradually more aggressive attempts to remove the deposits also attacked and distressed the metal surface. The crack exhibits some intergranular characteristics. To some reviewers, the nature of the oxide deposits suggests hot cracking. Fatigue could also be a factor in the development of this crack. However, the precise mechanism responsible for initiating and propagating this crack could not be determined.
