South Texas Project
Unit 2
Docket No. STN 50-499
Licensee Event Report 2-03-004
Standby Diesel Generator 22 Failure

LICENSEE EVENT REPORT (LER)

Standby Diesel Generator 22 Failure

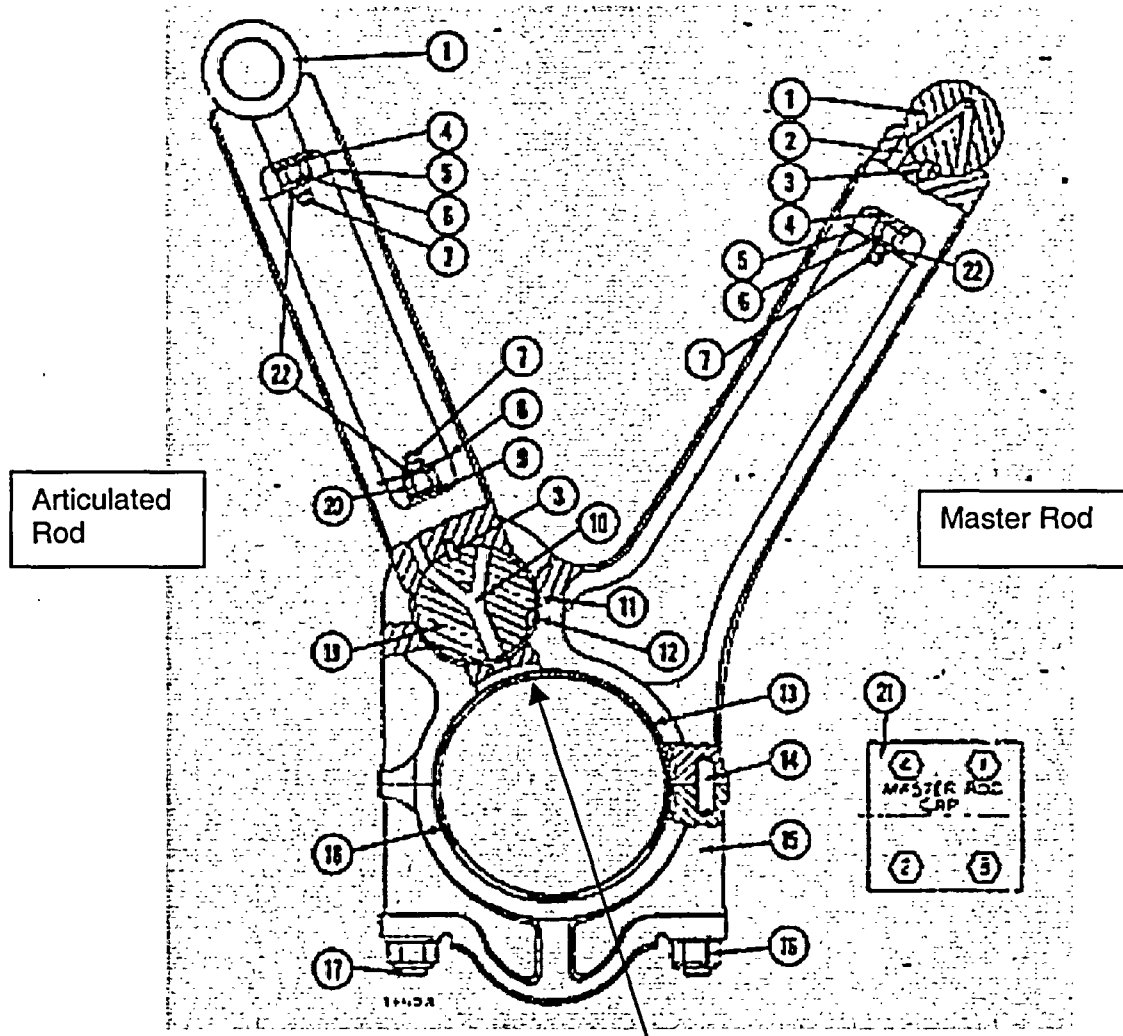
Attachment 1 Diagram of Connecting Rods

The crack initiated on the master connecting rod in the area (ligament) between the crankshaft

bearing bore and the articulating rod bushing bore. The crack propagated through the section thickness (approximately 1") and then propagated across the width of the bore. One side of the fracture essentially extended across the width of the fracture face with only a small corner section showing overload. The other side of the fracture extended approximately 3.5" angled toward the articulating rod bushing surface, followed by failure due to overload.

Visible "beach marks", which indicate that a crack was propagated by cyclic stresses, were found on a fracture surface on the position 9 master rod at the common ligament area between the master rod crankshaft bearing bore and the articulated rod pin bore. The articulated rod, a piece of the master rod, and several other damaged pieces were sent to a metallurgical lab for analysis. Lab results confirmed that there was a high cycle fatigue crack on the master connecting rod.

The root cause of the diesel engine failure was microcracks created on the position 9 master connecting rod during the manufacturing process. The microcracks propagated due to high cycle fatigue until the master connecting rod failed.

The crack began in a region of microcracks at the surface of the master rod bearing bore. The crack initiation area was at the bottom of a small indentation made after the master rod failure (the area was struck during the failure). The indentation was a smooth, high energy impact zone with directional lines, and partially overlapped the fracture surface. The surface features in the bottom of the indentation and next to the indentation at the fracture surface were examined and the indentation was found to not be the stress riser that initiated the crack. The surface features in both areas are comparable. Both areas exhibit surface microcracking. The microcracking orientation is parallel to the failure fracture surface.

Site of crack initiation (on the master rod under the bearing shell)
