**Pacific Gas and
Electric Company**

PG&E Letter DCL-01-099

Diablo Canyon Units 1 and 2
Licensee Event Report 1-2001-002-00
System Actuation: Unplanned Diesel Start Due to Loss of Startup Power

Unplanned Diesel Start Due to Loss of Startup Power

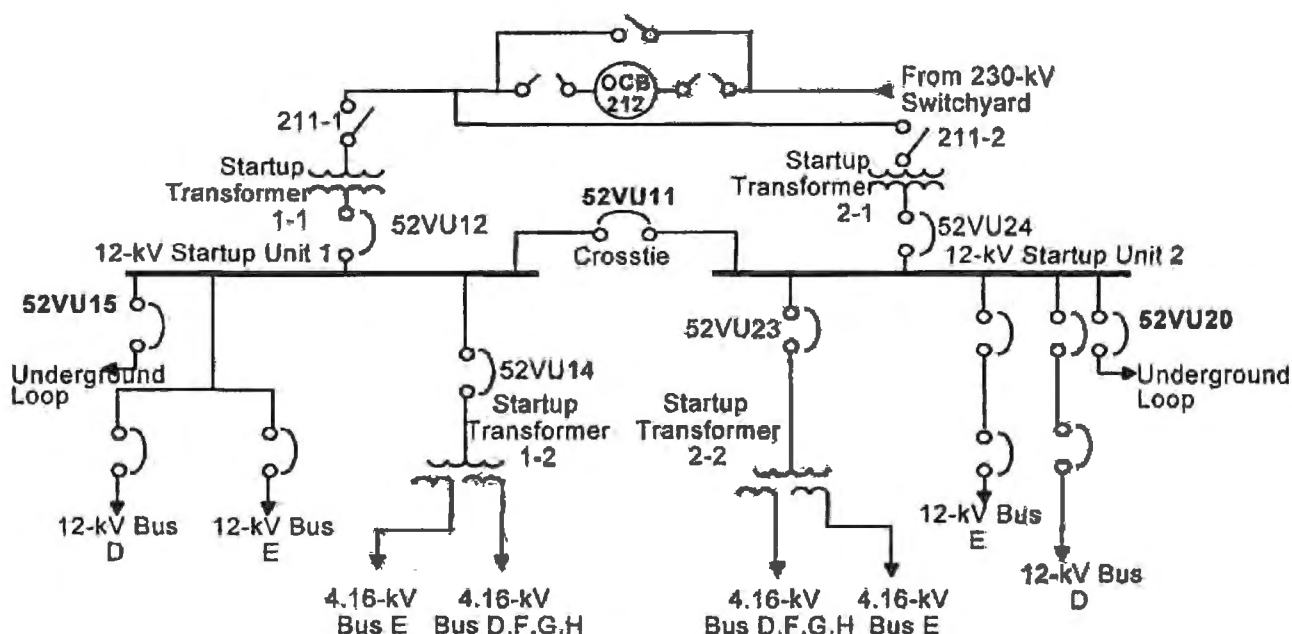
Figure 1: Startup Power Diagram

Oil Circuit Breakers (OCB) are used in the 230kV switchyard to connect and disconnect the 230kV system from the plant. The 230kV system provides power through OCB 212 to Startup Transformers (SUT) 1-1 and 2-1 (230kV to 12kV) [EA][XFMR]. SUTs 1-1 and 2-1 then distribute power to the Unit 1 and Unit 2 Startup Buses, respectively. The Unit 1 and Unit 2 Startup Buses then feed SUT 1-2 and SUT 2-2 (12kV to 4160 V) [EA][XFMR], respectively. SUTs 1-2 and 2-2 can then supply power to each unit's 4160 V vital and nonvital buses. Figure 1 provides additional detail of the startup power system.
