PG&E Letter DCL-09-061

Docket No. 50-275, OL-DPR-80
Diablo Canyon Unit 1
Licensee Event Report 1-2009-002-00
Two Trains of Auxiliary Feedwater Inoperable Due to Protection System Failure

Two Trains of Auxiliary Feedwater Inoperable Due to Protection System Failure

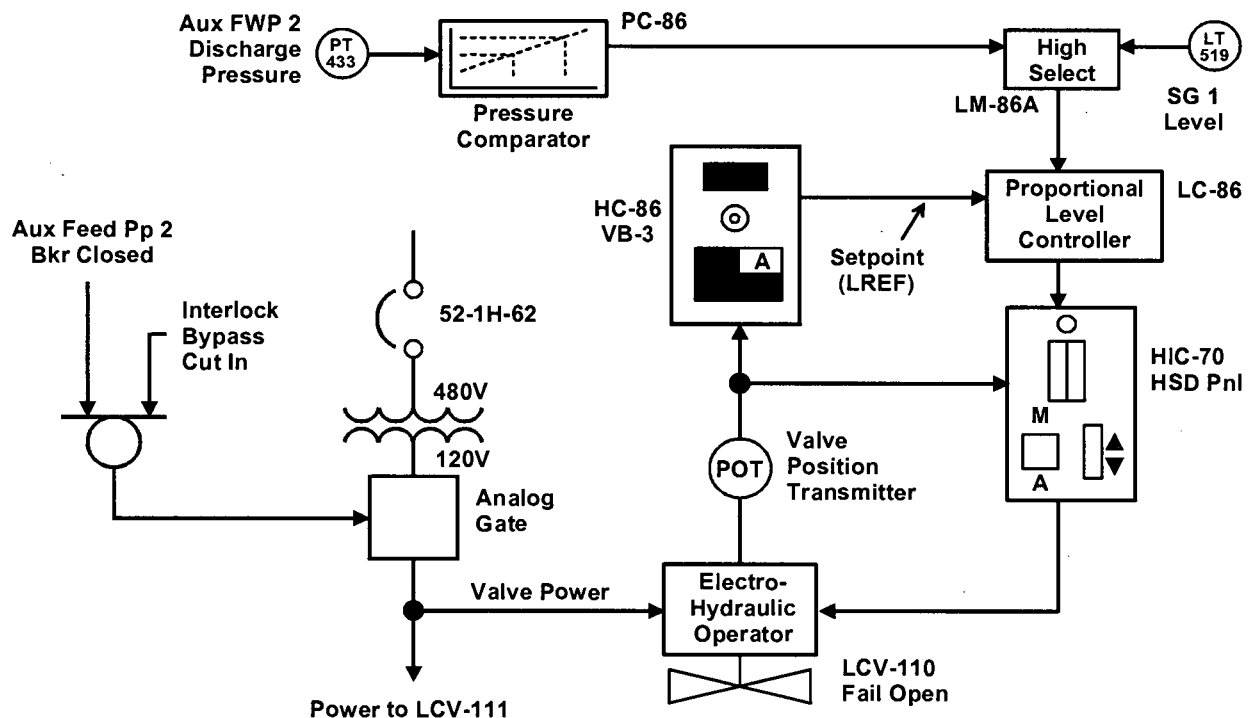
A simplified sketch of the AFW control system is shown below:

During this event, the Eagle 21 Protection Set II, Rack 8, experienced a "lockup" condition when the LCP failed. As designed, the safety-related outputs went to the "trip" condition and the non-safety outputs failed "as-is." This froze the outputs to the normal operating SG level at approximately 65 percent level. Based on the Scaling Calculations for the loop, this represents approximately 50 percent open on the valves. So if the hand controllers (HCs) on the control room Vertical Board were left in Auto during the time that Rack 8 was locked up and a SG lo-lo level trip occurred, the LCV-110 (SG Loop 1) valve would have been demanded to 50 percent open and the LCV-113 (Loop 4) would be demanded to 50 percent open when the motor driven AFW pumps were started. The other two valves (LCV-111 and LCV-115) would be at 100 percent open and then control on the actual active level control signal.
