**Pacific Gas and
Electric Company**

PG&E Letter DCL-03-125

**Docket No. 50-275, OL-DPR-80
Docket No. 50-323, OL-DPR-82
Diablo Canyon Units 1 and 2
Licensee Event Report 2-2003-007-01
Technical Specification 3.8.4 Violation Due To Common Mode Battery
Charger Failures**

Technical Specification 3.8.4 Violation Due To Common Mode Battery Charger Failures

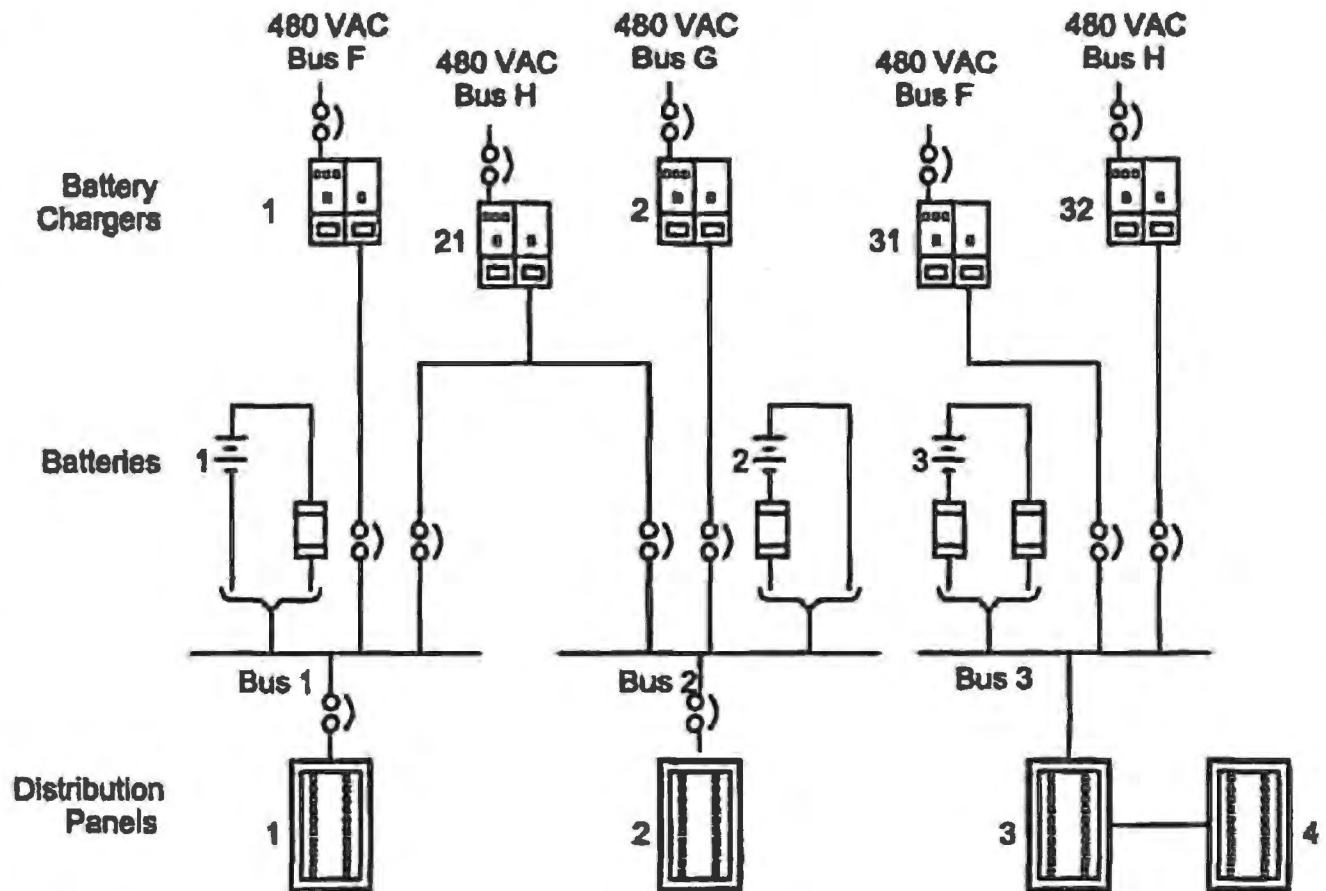
Figure 1 – Single Line Diagram of the 125 Volt DC Vital Power Supply System

Each Diablo Canyon Power Plant (DCPP) Unit has three 60-cell, 125 Volt DC (VDC) vital batteries and 5 full capacity battery chargers (BTCs)[BYC]. Each of the three vital 125 VDC busses has a dedicated battery and charger. The design of the vital 125 VDC system is such that a battery may be supplied by two full capacity chargers: one supplied from its associated 480 volt alternating current (480 VAC) vital bus, or an alternate charger supplied by another 480 VAC vital bus. The first additional charger can be switched to either of two of the batteries. The second charger is a dedicated backup charger for the third vital battery. See Figure 1 – "Single Line Diagram of the 125 Volt DC Vital Power Supply System."
