**Pacific Gas and  
Electric Company**

PG&E Letter DCL-00-147

Licensee Event Report 1-2000-009-00

Component Cooling Water Valves Would Not Close Properly due to Misadjusted Travel  
Stops – Personnel Error

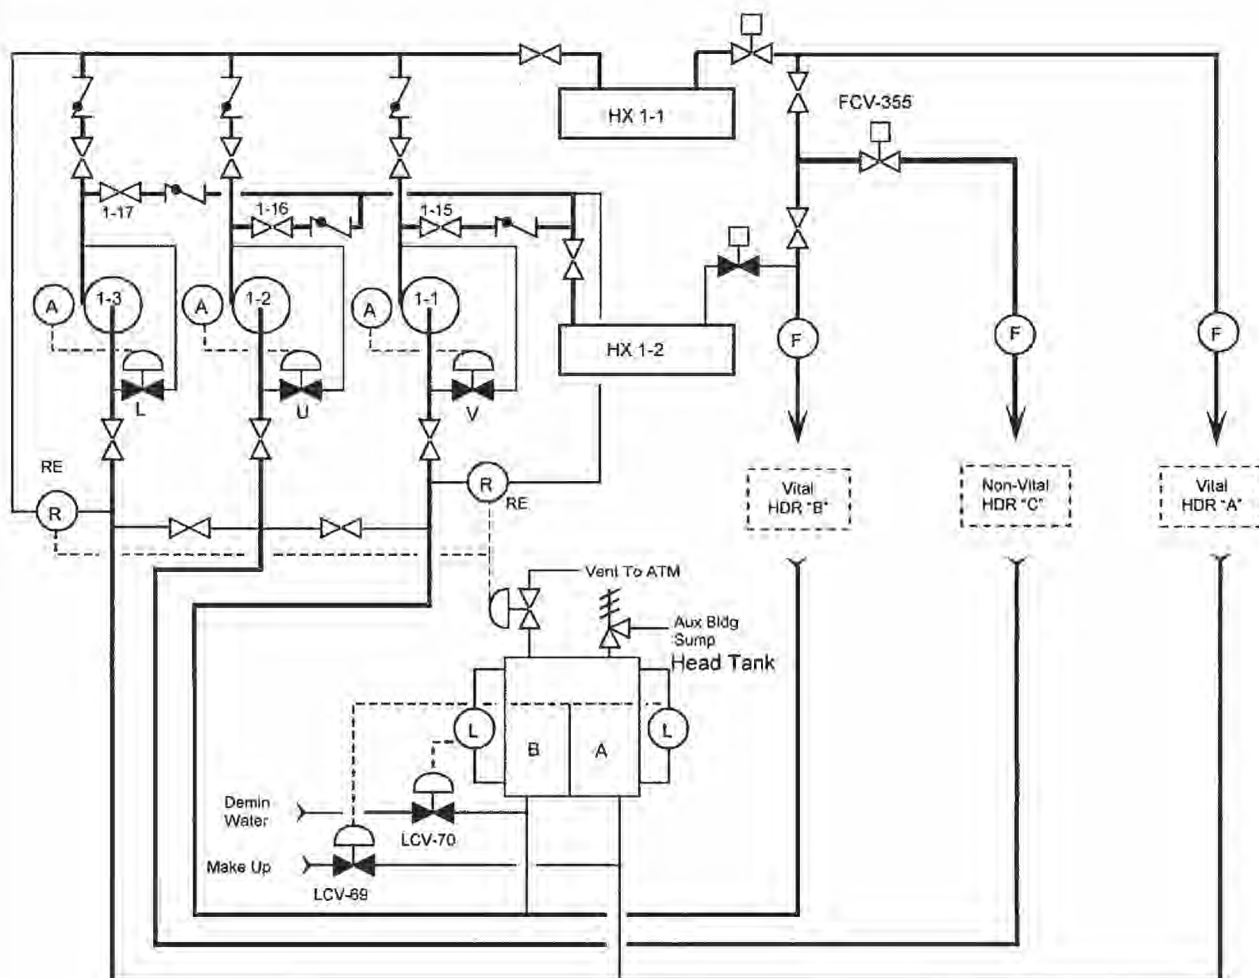
Figure 1

For a graphical representation of the CCW System, refer to Figure 1. Additional information on the design and operation of the system, along with a list of the components served, is presented in the Final Safety Analysis Report, Section 9.2.2.

## Component Cooling Water System
