**Pacific Gas and  
Electric Company**

PG&E Letter DCL-02-043

Docket No. 50-275, OL-DPR-80  
Docket No. 50-323, OL-DPR-82  
Diablo Canyon Units 1 and 2  
Licensee Event Report 1-2002-001-00

Technical Specification Violation Due to Nonconservative Steam Generator Narrow  
Range Water Level Instrumentation

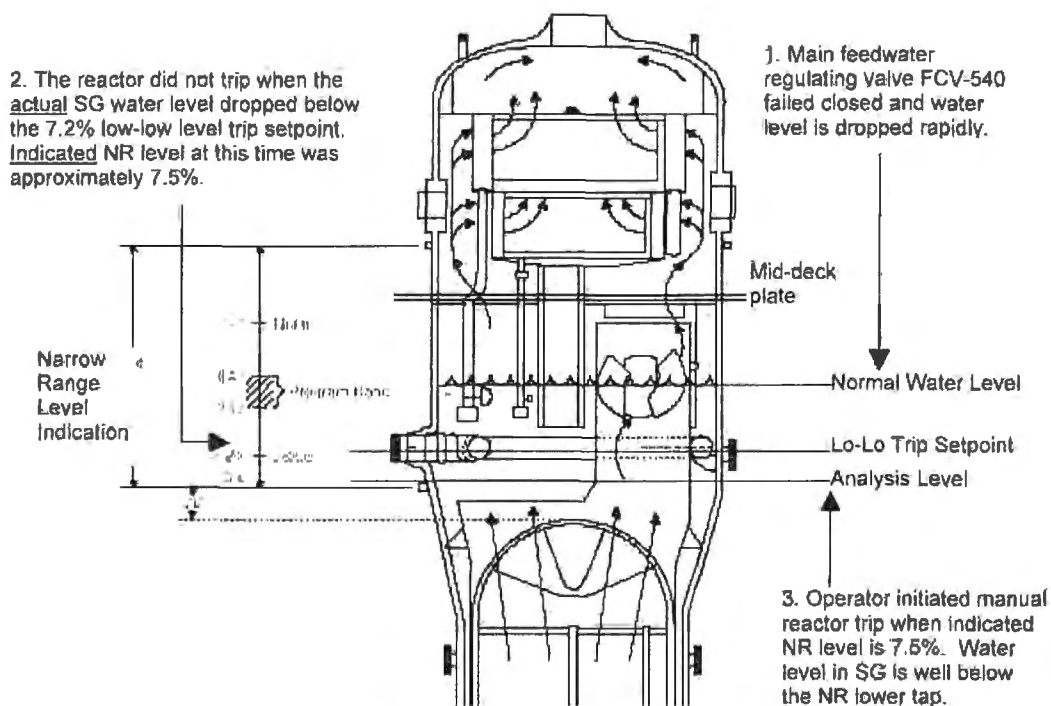
Figure 1 – Steam Generator Narrow Range Level Illustration

The Diablo Canyon Power Plant (DCPP) steam generators (SGs) incorporate a mid-deck plate at the top of the primary separator assembly. The mid-deck plate is located between the upper and lower instrumentation sensing taps used for SG narrow range (NR) water level measurements (see Figure 1). When some of the steam in the SG flows through the separator downcomer instead of the separator orifice, this steam with some entrained moisture flows upwards through the flow area in the mid-deck plate. This steam flow through the mid-deck plate results in a measurable pressure drop at higher steam flows. This pressure drop adversely affects SG level uncertainty calculations as a bias and was not included in the process measurement accuracy (PMA) term for reactor trip or engineered safeguards actuation system (ESFAS) setpoints.

The mid-deck plate dP adversely affects the SG NR instrumentation by biasing the output high at high steam flow conditions, effectively delaying the reactor trip and start of auxiliary feedwater pumps. The SG level input to the ATWS Mitigation System Actuation Circuitry (AMSAC) would also cause a delay in actuation of AMSAC.

The immediate cause of the nonconservative SG level instrumentation was the identification of a previously unaccounted PMA term for the dP across the SG mid-deck-plate.

The cause of this event was that Westinghouse failed to identify to PG&E the mid-deck plate differential pressure effect on reactor trip and ESFAS setpoints.

On February 15, 2002, following review of vendor data and incorporation of appropriate conservatisms, PG&E issued and implemented a design change increasing the SG NR low-low level setpoint from 7.2 to 15 percent.

1. Utility plant operators reduced reactor power to return the SG NR low-low level trip to an operable condition.
2. Utility plant engineers issued a plant design change to establish conservative SG low-low level setpoints.
