South Texas Project Electric Generating Station P.O. Box 289 Wadsworth, Texas 77483

South Texas Project  
Unit 1  
Docket No. STN 50-498  
Licensee Event Report 00-006  
Two Trains of Essential Chilled Water System Inoperable

Two Trains of Essential Chilled Water System Inoperable

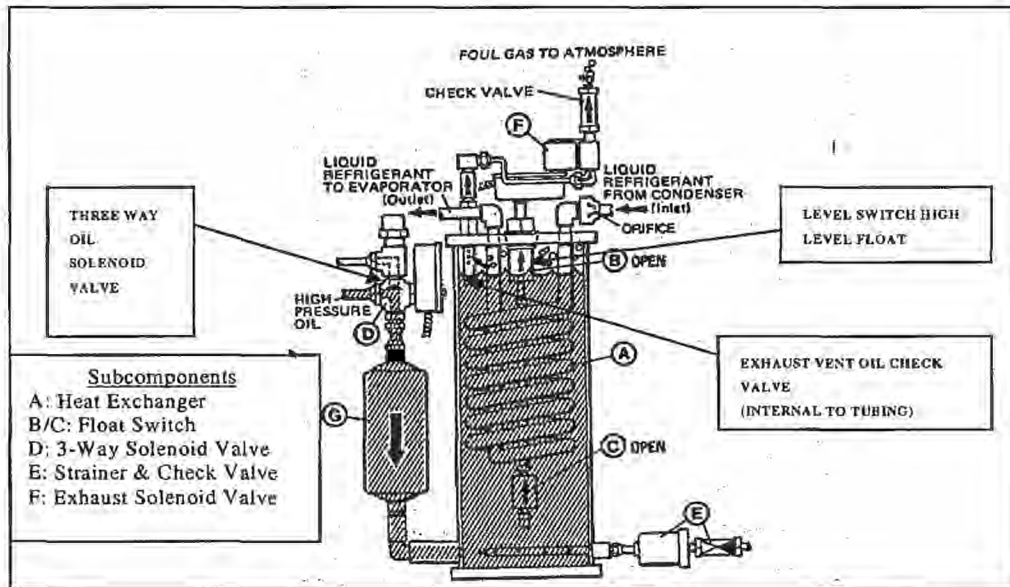
Figure 1: York Chiller Purge Unit – At High Level

A post-event walkdown identified oil on overhead piping which, based on the oil spray pattern, came from the purge exhaust line. No evidence of broken or loose connections existed. No other parts of the chiller revealed evidence of oil leakage. Oil loss was estimated at approximately seven gallons based on amount of oil later removed from the chiller. Based on these findings, it was determined that a failure of the level control system occurred. This failure caused the purge unit to fill with oil, which concurrent with a failure to seat the float check valve, resulted in oil being pumped out of the foul gas exhaust line. The failure of the level control system is attributed to mechanical binding of the upper float assembly caused by debris internal to the purge unit. The purge unit is a dirty point in the system. It takes all the air and moisture that leaks into the chiller, and vents it. Due to the presence of moisture, all of the following can be present: acid, rust, corrosion products, and debris. The current chiller Preventive Maintenance scope does not clean debris from inside the purge unit.

The float check valve also did not operate properly to prevent oil passing through the exhaust vent when the level control failure occurred. Inspection of the float check valve revealed age-related degradation (swelling, reducing operation clearances, etc.) of the plastic float that contributed to improper operation. For details of system operation, see Figure 1.

The cause of this event was concurrent failure of the level control system due to debris induced mechanical binding of the upper float assembly and failure of the float check valve. The float check valve failure was due to a previously unidentified failure mechanism of age related degradation.

1. Essential Chiller 12C was restored to an operable status at 0754 on August 21<sup>st</sup>, 2000.
2. The relief valve, shut-off safety float check valve, float switch and three-way oil supply solenoid valve were replaced on Essential Chiller 12A and the chiller was restored to an operable status on August 22<sup>nd</sup>, 2000.
3. Develop Preventive Maintenance Activities and instructions with appropriate frequency for each of the 300-ton chillers. The Preventive Maintenance scope will include an inspection and cleaning of the purge tank and float switch and replacement of the shut-off safety float check valve. This will be completed by October 31<sup>st</sup>, 2000.
4. Inspect and clean the purge tank and float switch, and replace the shut-off safety float check valves on the 300-ton essential chillers. These will be completed by November 30<sup>th</sup>, 2000.
