South Texas Project Electric Generating Station P.O. Box 289 Wadsworth, Texas 77483

May 10, 2001
NOC-AE-01001096
File No.: G26
10CFR50.73

South Texas Project
Unit 2
Docket No. STN 50-499
Licensee Event Report 2-01-003
Steam Generator 2C Classified as Category C-3

Steam Generator 2C Classified as Category C-3 in 2RE08

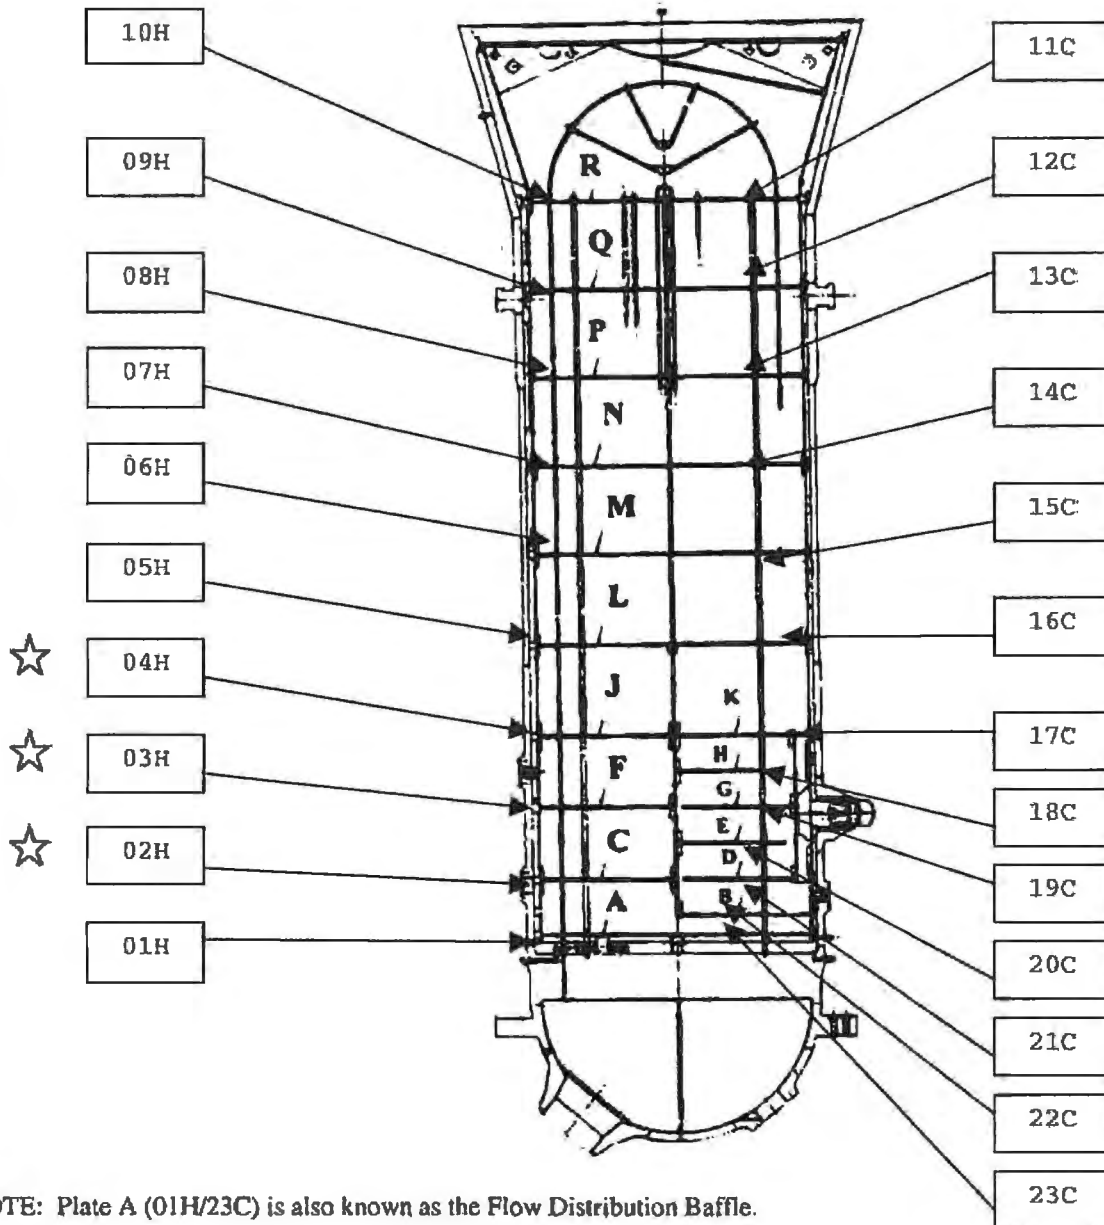
FIGURE 1
TUBE SUPPORT PLATE IDENTIFICATION IN MODEL E SGs

The inspection results are discussed below by degradation mechanism. A summary of how many defective tubes were attributed to each of these damage mechanisms is provided in Table 1. As discussed below, many tubes were also preventively plugged. A summary of all tube plugging is given in Table 2. Figure 1 provides identification of the tube support plates in the Model E steam generators.

☆ Three Volt ARC applies at these plates only.
