FirstEnergy Nuclear Operating Company

Davis-Besse Nuclear Power Station  
Docket Number 50-346, License Number NPF-3  
Licensee Event Report 2008-001, Pressure Boundary Leak Found During Decay Heat  
Removal Drop Line Weld Overlay

Enclosure: LER 2008-001 (NP-33-08-001-00)

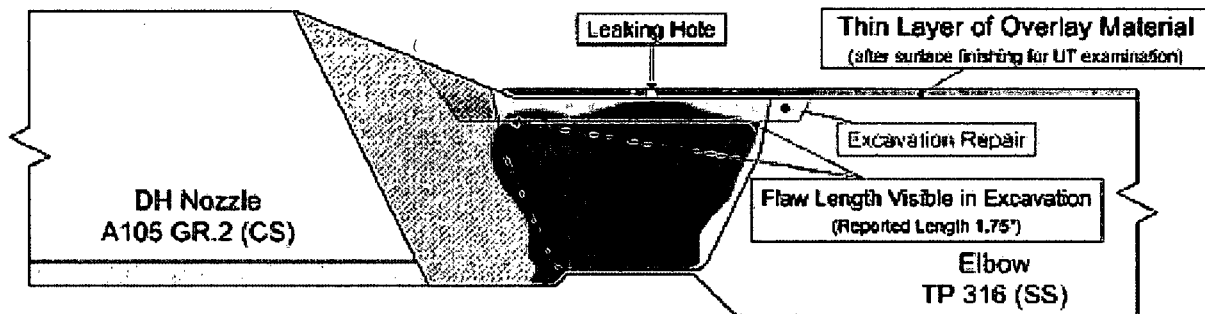
Figure 1: 12 Inch Decay Heat Drop Line Branch Connection Weld

Based upon an ODMI recommendation, the refueling canal was filled and the core was offloaded as originally scheduled. The leakage was measured as less than one drop per minute with at least 23 feet of borated water covering the top of the irradiated fuel assemblies seated within the reactor pressure vessel. Once the core was offloaded, work proceeded on repair of the weld. The first layer of the overlay was ground smooth to allow ultrasonic examination using the phased array technique. A recently developed manual phased array ultrasonic examination procedure was qualified such that it addressed the configuration of the hot leg to Decay Heat Removal Drop Line nozzle and dissimilar metal butt weld region in order to characterize the flaw. This qualification included detection and depth sizing of flaws in dissimilar metal butt welds and was demonstrated on samples containing implanted cracks. Utilizing an EPRI Performance Demonstration Initiative (PDI) mock-up, a detailed examination plan was developed to minimize the scan restrictions existing on the dissimilar metal weld region. The technique used a 32 x 32 element phased array search capable of generating angles from 0 to 84 degrees in one degree increments for circumferential flaws, and 0 to 69 degrees for axial flaws (limited by physical restraints of the wedge). The search output is raster scanned to the extent that the configuration of the dissimilar metal weld geometry allows. The phased array examination determined that the flaw was an axial flaw approximately 1.75 inches long, wholly contained in the dissimilar metal butt weld and had a profile consistent with other stress corrosion cracking axial flaws in alloy 82/182 weld material that have been confirmed in other plants. No other flaws were noted during this initial ultrasonic examination of the decay heat nozzle weld. Refer to Figure 1 for a diagram of the weld and flaw.

At the completion of the ultrasonic examination, a cavity two inches wide, 2.5 inches long and approximately 0.375 inches deep was ground into the weld and adjacent base material in order to prepare the area for evaluation and repair. The UT Examination of the area and the excavated cavity confirmed that the flaw was axially oriented and allowed the configuration of the dissimilar metal butt weld region to be more accurately depicted.

The axial flaw was located in the alloy 82/182 portion of the dissimilar metal weld. The thickness of the alloy 82/182 portion of the dissimilar metal weld is approximately 1.25 inches. The Decay Heat Removal Drop Line had been in service for 19.25 effective full power years (EFPY) at a temperature of 606.4 degrees Fahrenheit.

The probable cause of the axial flaw in the hot leg to decay heat removal nozzle dissimilar metal butt weld was determined to be the result of PWSCC that resulted in the axial flaw progressing through-wall, and resulted with water seeping during the application of the structural weld overlay. The stress corrosion failure mode is supported by ultrasonic examination results which confirm a similar profile and characteristics to stress corrosion cracking at other plants established by metallurgical examination.

Corrective actions taken to repair the leak included excavation of a cavity, peening the area of the flaw, seal welding, completion of the planned full structural weld overlay, and an acceptable ultrasonic examination. The implementation of the structural weld overlay provided a new RCS pressure boundary, an acceptable method of preventing future PWSCC, and an acceptable contour for ultrasonic examination.
