**Pacific Gas and
Electric Company**

PG&E Letter DCL-00-026

Docket No. 50-275, OL-DPR-80
Docket No. 50-323, OL-DPR-82
Diablo Canyon Units 1 and 2
Licensee Event Report 1-1999-007-01
Plant Outside Design Basis Due to Degraded Indicating Lamp Sockets

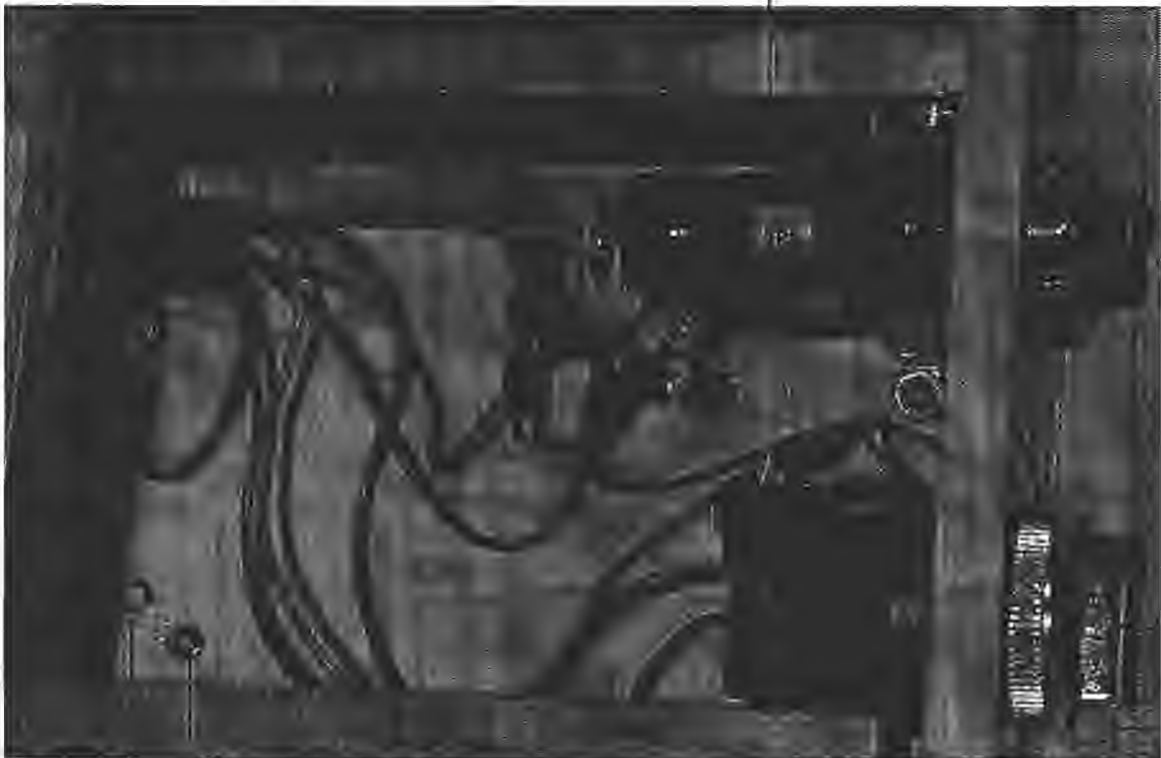
PG&E found two specific degraded conditions in the sockets. Some sockets were broken (separated). Others were cracked to various extents but the socket remained integral. PG&E has replaced broken sockets and cracked sockets that broke during a 3-lb force check. PG&E has also replaced many of the cracked sockets.

The root cause was determined to be lamp socket design. An easily achievable torque in the socket assembly retaining nut generates a stress in the plastic socket material exceeding its yield value. Plasticity occurs along with creep (time dependent deformation) at the socket operating temperature.

The creep eventually leads to cracking at the top edge of the socket's

thinnest section. The crack continues to grow as long as some stress remains. The failure mechanism proceeds until either the stress is relieved by the crack opening further, or the socket breaks.

Figure 1
Broken Minalite Socket Installed
