LER 2000-001

Davis-Besse Nuclear Power Station, Unit No. 1
Date of Occurrence - September 26, 1998

Failure To Perform Technical Specification Action With Switchyard Circuit Inoperable Due To Inadequate Procedure

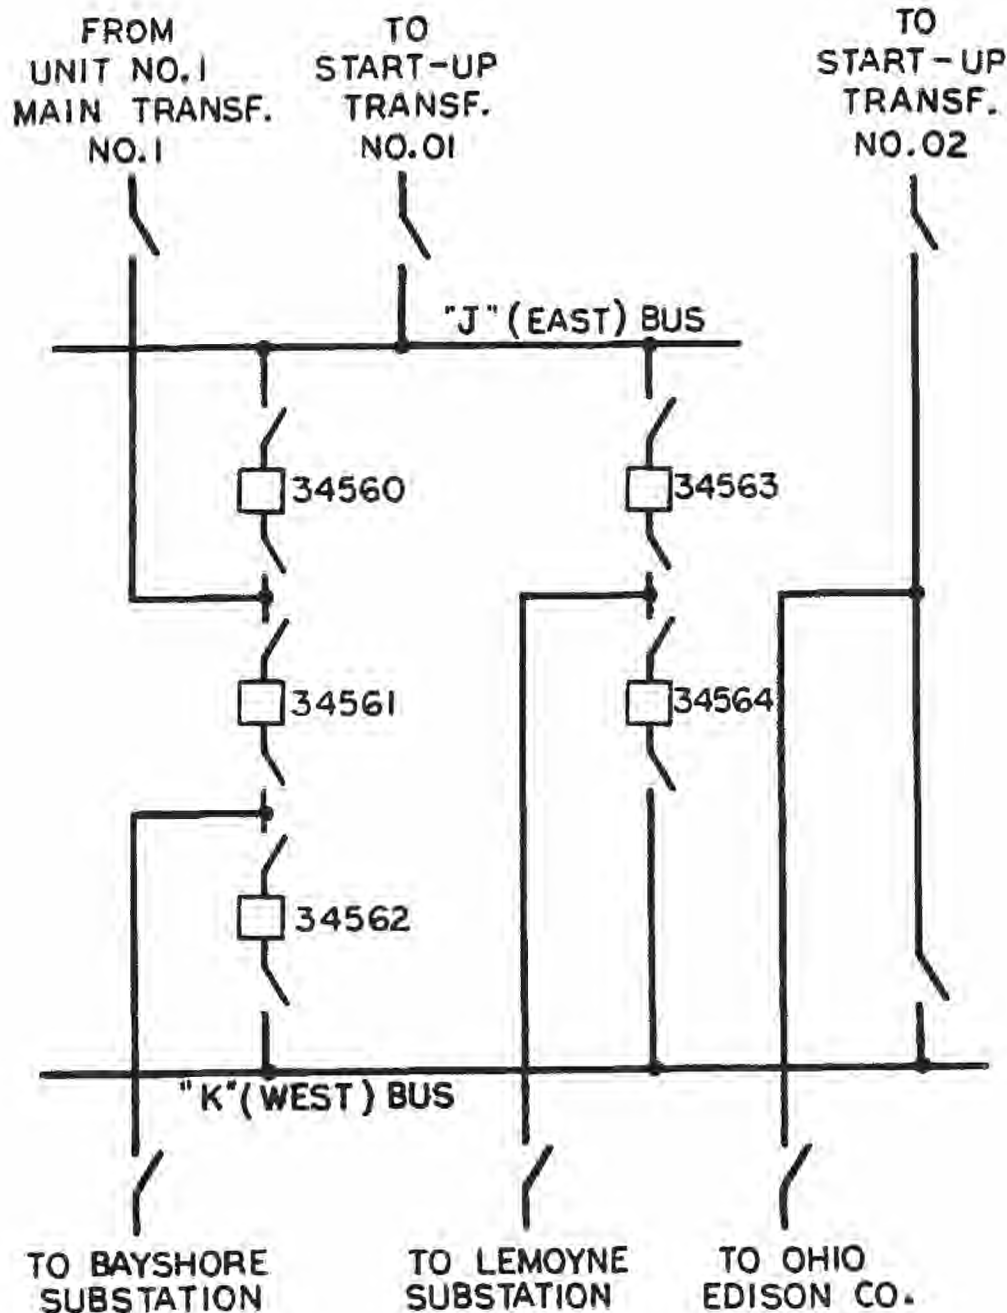
FIGURE 1

When a fault is detected on a switchyard breaker, protective relays open the breaker in an attempt to clear the fault. Protective relaying also exists for detecting when a breaker has failed to properly isolate a circuit. This relaying initiates a lockout of the circuits adjacent to the failed breaker, which opens all breakers associated with those circuits. Refer to Figure 1 for a diagram of the Davis-Besse Nuclear Power Station (DBNPS) Switchyard. If this lockout relaying fails and initiates a lockout of breaker 34562, breakers 34561 and 34564 would open, as well as the breakers on the Bayshore and Ohio Edison lines. A similar condition can occur if breaker 34564 experiences a lockout. The lockout of breakers 34562 and 34564 is discussed in the DBNPS Updated Safety Analysis Report (USAR) Section 8.2.1.1, Offsite Power System Reliability Considerations, but the configuration of the switchyard during maintenance is not discussed. With breaker 34563 open because of the low air pressure condition, a lockout of breaker 34562 would result in a loss of offsite power. Station operating procedures identified that Technical Specification LCO 3.8.1.1 should be entered when either the Bayshore or Lemoyne 345 kV transmission lines were removed from service as a result of the potential for this lockout fault, but did not identify entry into the LCO when opening other switchyard breakers.

Davis-Besse Nuclear Power Station 345 kV Switchyard One-Line Diagram
