FIELD SUPERVISION REPORT

P1-P2 walls. This pour consist of 25MPa concrete adhering to the NSPW's division 5 section 7 of the standard specifications. The concrete was supplied by Quality Concrete and the contractor was Duron construction.

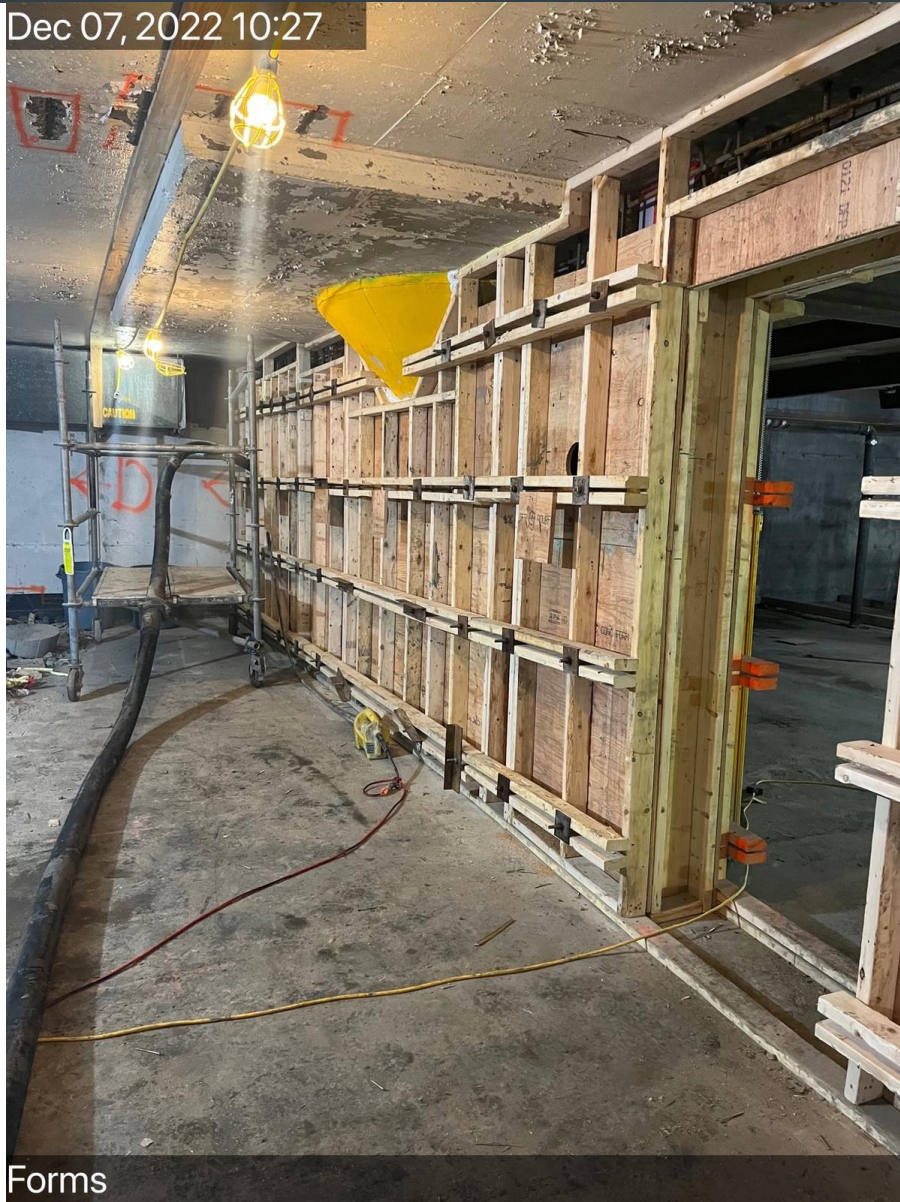
Forms

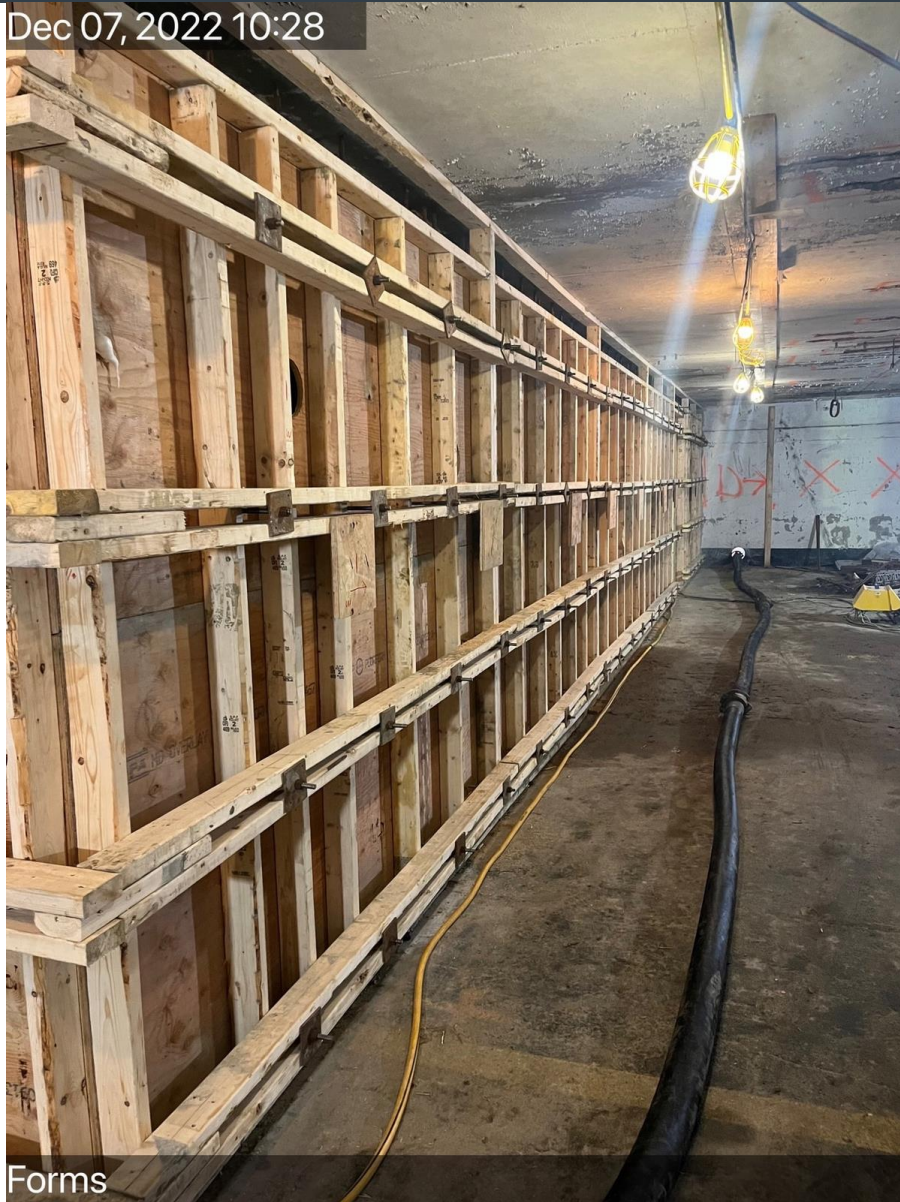
Forms

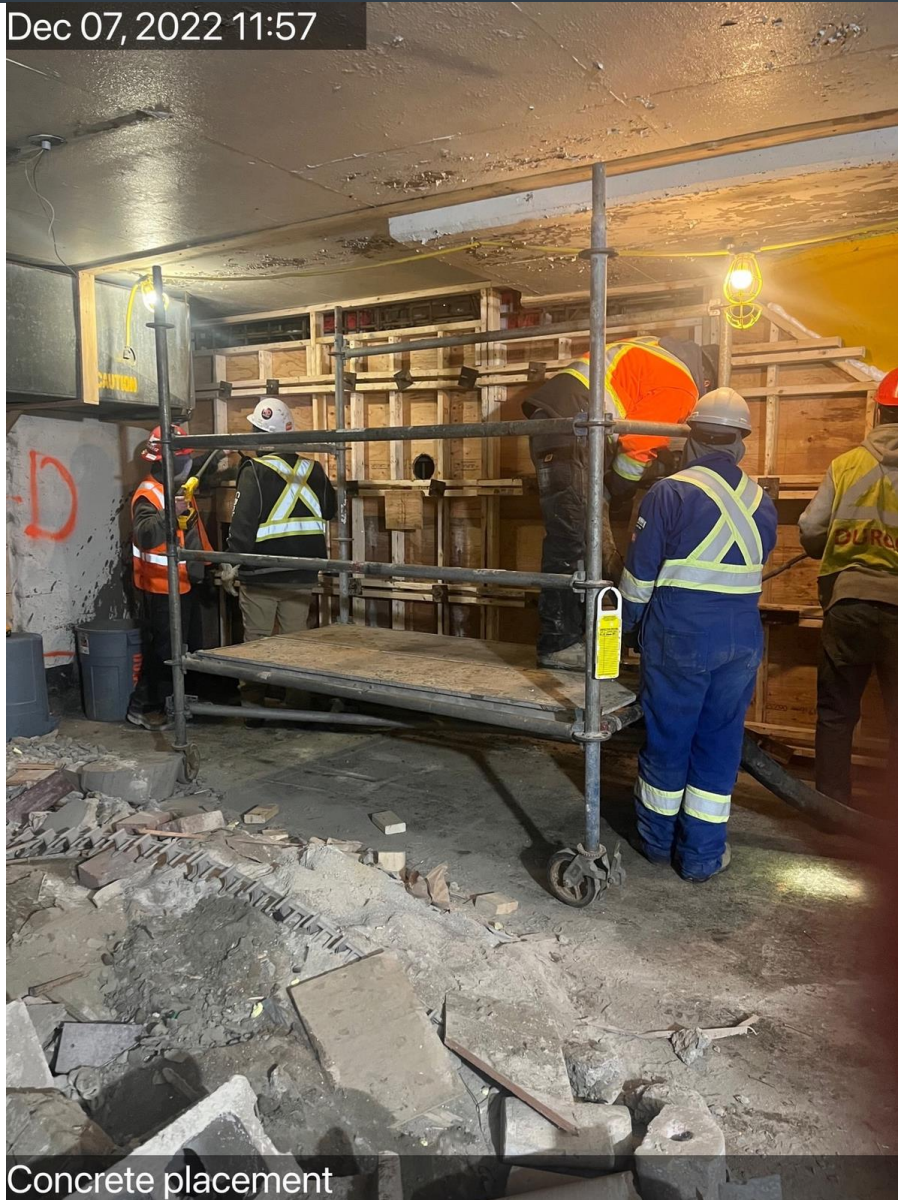
Concrete placement
