Legionella Risk Assessment

Birtley House, Birtley House Group Ltd

**Birtley House
Nursing Home
Bramley
Surrey
GU5 OLB**

Report reference No: WHRA12695/0020/290318/6

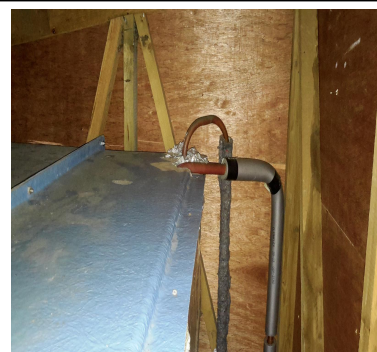
Plant Item	No	Hazard Location
CWST02	17	Roof, Main Building

HWS vent pipe enters the cold water storage cistern.

Potential for hot water to discharge from the HWS open vent pipe into the cistern.

This is likely to increase the temperature of the stored water to above recommended level.

Employ a competent contractor to reroute the hot water vent pipe so that it discharges into a tundish and to drain.

Ensure the discharge is in a safe and conspicuous location to prevent a scalding hazard. Provide a label adjacent to the point of discharge advising the source of the discharge.

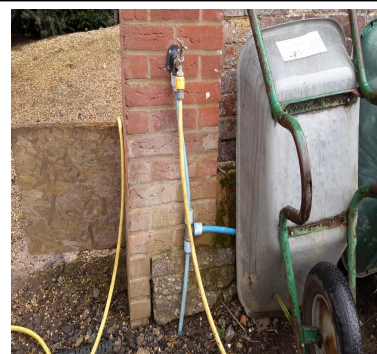
Plant Item	No	Hazard Location
Bib Tap	5678	Ground, Garden

Bib tap connected up with Blue Polyethylene pipes which is exposed to the elements. Blue polyethylene pipes may be used above ground in situations where it is not exposed to direct sunlight.

Potential health hazard.

Employ a competent contractor to cut back pipes and cap off or replace pipes with wras approved pipes.

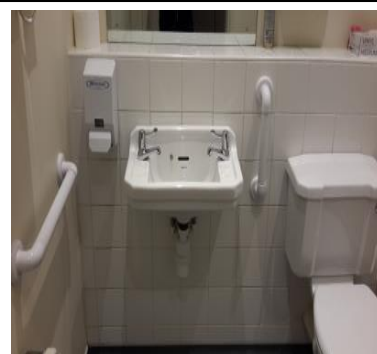
Plant Item	No	Hazard Location
TMV (possible no access)	118	Ground, Main Building, WC2 by Office

Mixer valve faulty, due to hot is flowing into cold.

The mixer valve controls were found to be inaccurate and therefore in need of adjustment or replacement.

The faulty mixer valve requires maintenance to ensure that water at the pre-selected temperatures are discharged within acceptable limits. Record actions in Water Hygiene Log Book.
