Airsafe Surveys Ltd

Demolition / Refurbishment Asbestos Survey Report

Kitchen, Wash Room & Prep Room

Birtley House

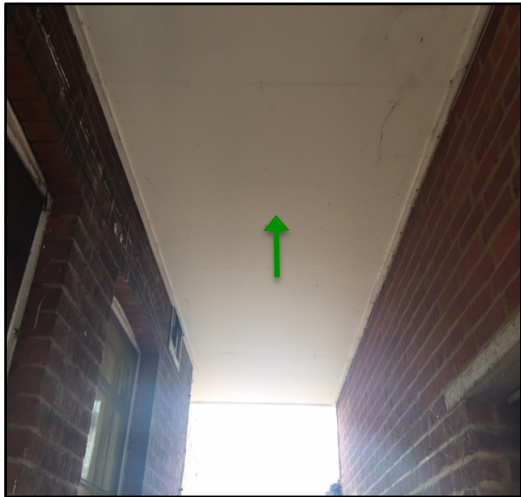
Material Sampled: Boarding to canopy

Analysis Result: **No Asbestos Detected**
Approximate Quantity:
Product Type:
Condition:
Surface Treatment:

Material Assessment Score: **0**

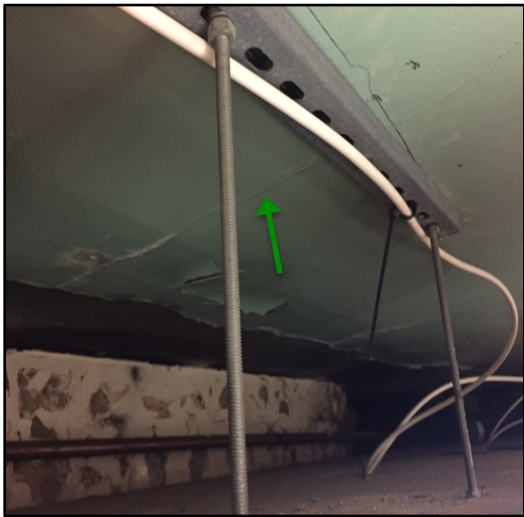
Material Sampled: Plaster ceiling above grid ceilings

Analysis Result: **No Asbestos Detected**
Approximate Quantity:
Product Type:
Condition:
Surface Treatment:

Material Assessment Score: **0**

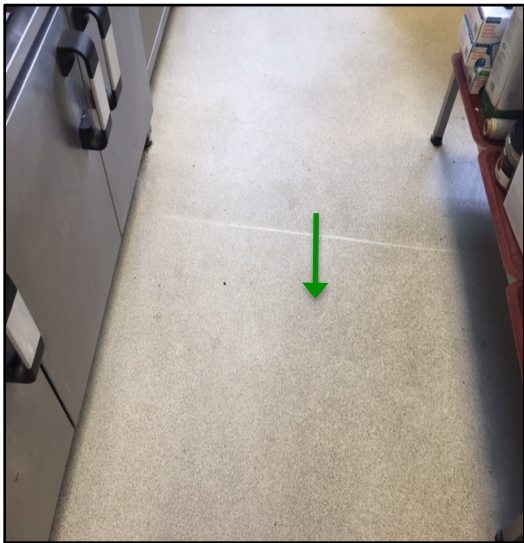
Material Sampled: Flooring beneath vinyl layer

Analysis Result: **No Asbestos Detected**
Approximate Quantity:
Product Type:
Condition:
Surface Treatment:

Material Assessment Score: **0**

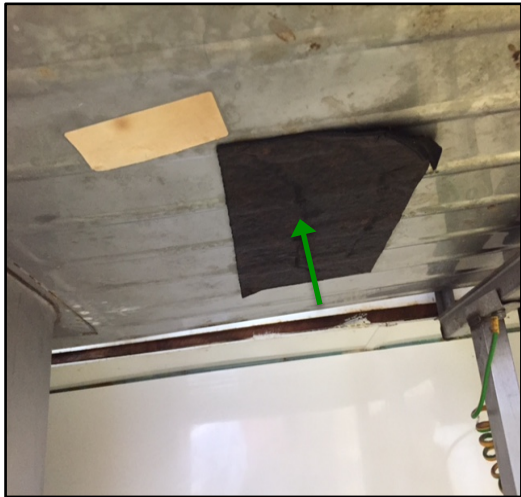
Material Sampled: Sink pad

Analysis Result: No Asbestos Detected

Material Assessment Score: 0

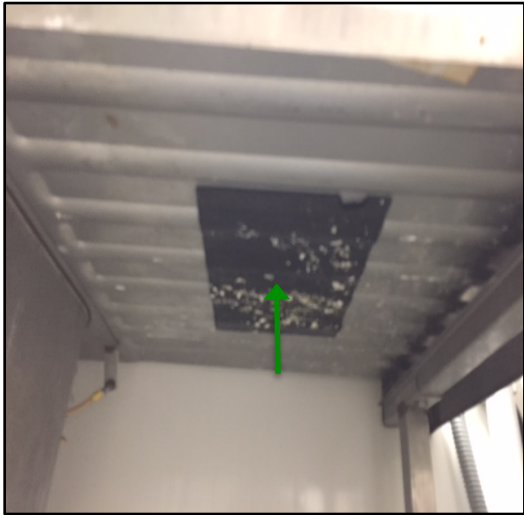
Material Sampled: Sink pad

Analysis Result: No Asbestos Detected

Material Assessment Score: 0

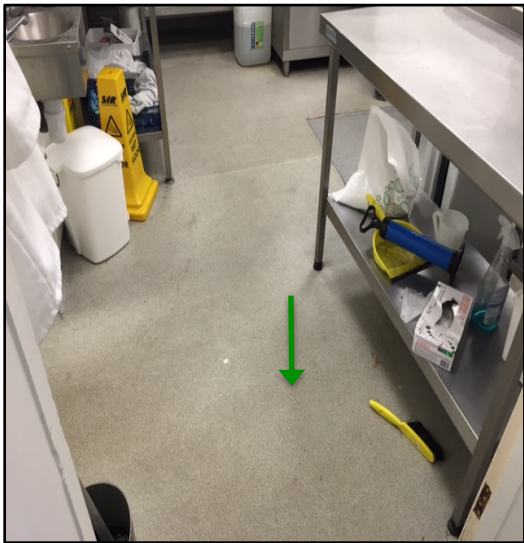
Material Sampled: Flooring beneath vinyl layer

Analysis Result: No Asbestos Detected

Material Assessment Score: 0

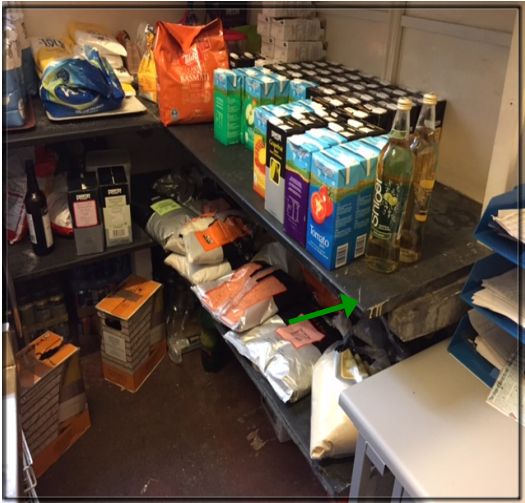
Material Sampled: Slate shelving

Analysis Result: **No Asbestos Detected**

Material Assessment Score: **0**
