# Demolition / Refurbishment Asbestos Survey Report

Birtley House Group Ltd

Birtley House

11<sup>th</sup> April 2015

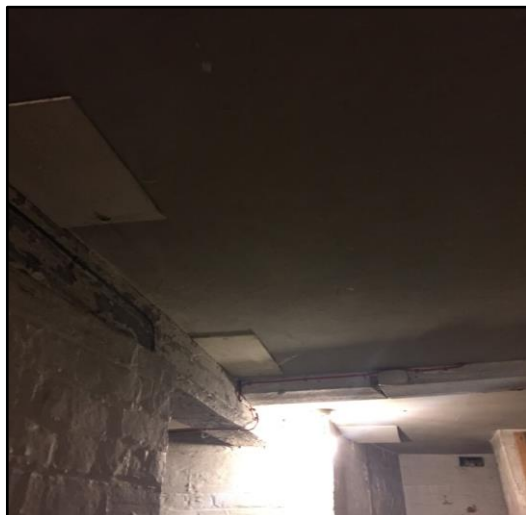
Sample Ref:	B01	Location:	Basement Panels to Ceiling
-------------	-----	-----------	----------------------------

Material Sampled: Supalux (New Fibre) Insulation Board

Analysis Result: **No Asbestos Detected**

Material Assessment Score: **0**

Remarks / Recommendations: N/A

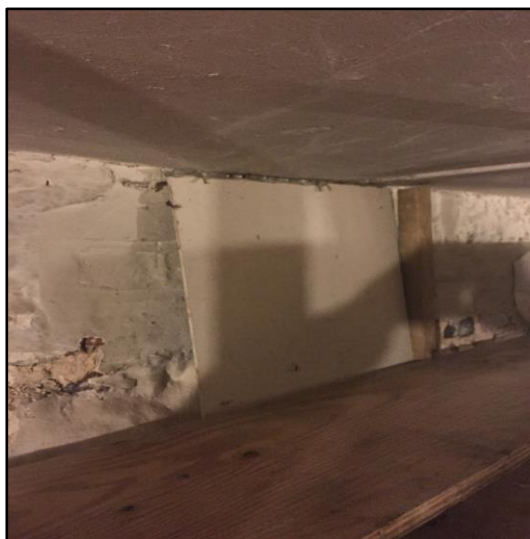
Sample Ref:	B02	Location:	Basement Panels to Walls
-------------	-----	-----------	--------------------------

Material Sampled: Supalux (New Fibre) Insulation Board

Analysis Result: **No Asbestos Detected**

Material Assessment Score: **0**

Remarks / Recommendations: N/A

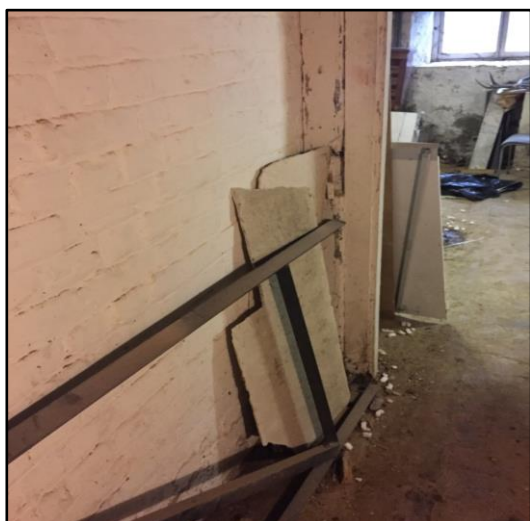
Sample Ref:	B03	Location:	Basement Loose Panels
-------------	-----	-----------	-----------------------

Material Sampled: Supalux (New Fibre) Insulation Board

Analysis Result: **No Asbestos Detected**

Material Assessment Score: **0**

Remarks / Recommendations: N/A

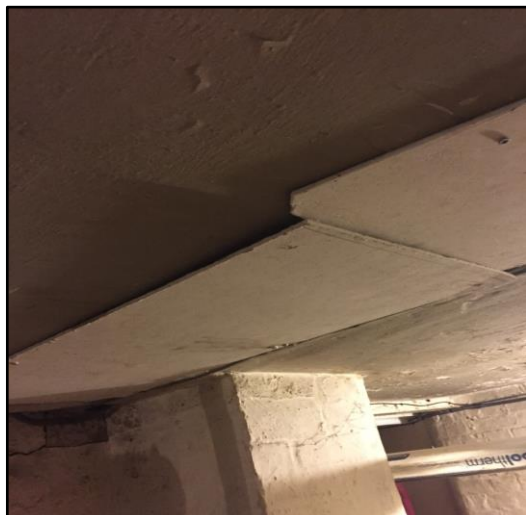
Sample Ref:	B04	Location:	Basement Panels to Ceiling
-------------	-----	-----------	----------------------------

Material Sampled: Supalux (New Fibre) Insulation Board

Analysis Result: **No Asbestos Detected**

Material Assessment Score: **0**

Remarks / Recommendations: N/A

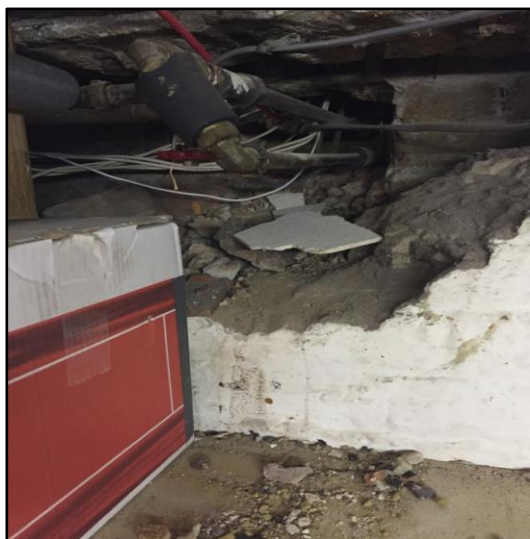
Sample Ref:	B05	Location:	Basement Debris
-------------	-----	-----------	-----------------

Material Sampled: Supalux (New Fibre) Insulation Board

Analysis Result: **No Asbestos Detected**

Material Assessment Score: **0**

Remarks / Recommendations: N/A

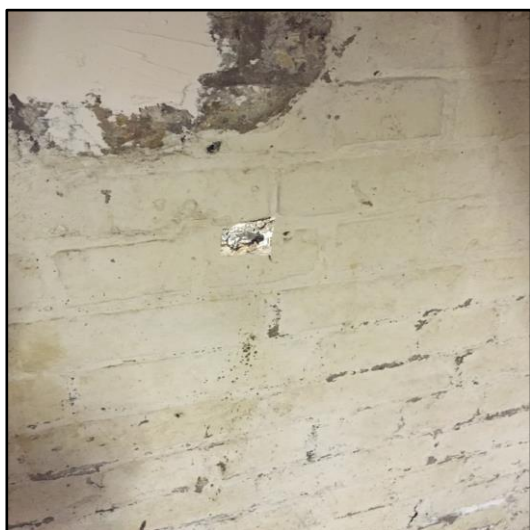
Sample Ref:	B06	Location:	Boiler Room Area Debris to Walls
-------------	-----	-----------	----------------------------------

- B06 – Boiler Room Area Walls – Lagging Debris to Wall Area – Amosite (Brown) Asbestos + Chrysotile (White) Asbestos.

Material Sampled: Lagging

**Amosite (brown) Asbestos**

Analysis Result: **Chrysotile (white) Asbestos**

Approximate Quantity: Throughout

Product Type: **Thermal Insulations (lagging / sprayed)**

Condition: **Medium Damage**

Surface Treatment: **Unsealed Lagging**

Material Assessment Score: **9**

Remarks / Recommendations: **REMOVE**

An environmental clean of the walls is recommended by a licensed contractor.

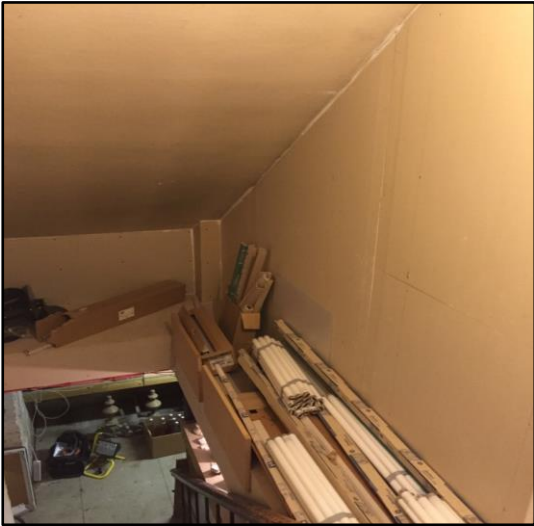
- B07 – Basement Stairwell Panels – Insulation Board – Amosite (Brown) Asbestos.

Material Sampled: Insulation Board

Analysis Result: **Amosite (brown) Asbestos**

Approximate Quantity: 20 m²

Product Type: **AIB / Millboards / Textiles**

Condition: **Low Damage**

Surface Treatment: **Unsealed AIB / Encapsulated Lagging**

Material Assessment Score: **7**

Remarks / Recommendations: **REMOVE**

Removal prior to refurbishment works by a licensed Contractor. The Insulation Board is located behind the plasterboard.
