# Asbestos Management Survey Report

**Birtley House Group Ltd**

**Birtley House**

**7<sup>th</sup> June 2016**

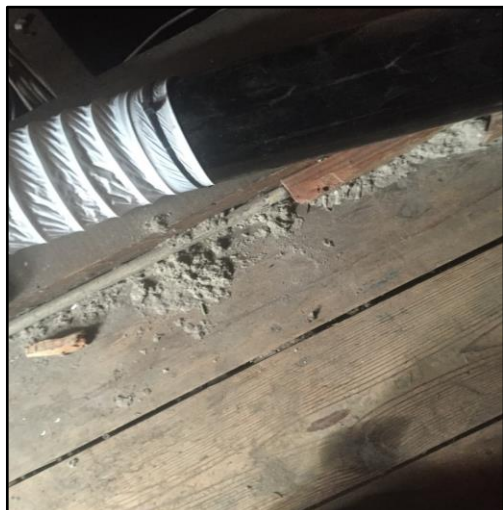
Sample Ref: B01 Location: 2nd Floor Walk In Loft Area

Material Sampled: Debris

Analysis Result: **No Asbestos Detected**

Material Assessment Score: **0** **No Remedial Action Required**

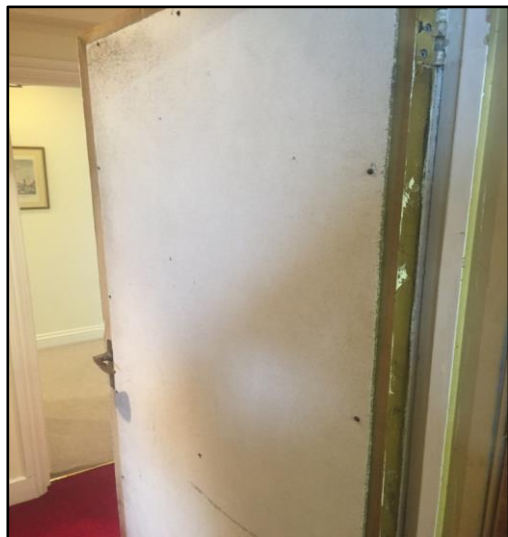
Sample Ref: B02 Location: 2nd Floor Walk in Loft Area Door Panel + Fillet

Material Sampled: Supalux (New Fibre) Insulation Board

Analysis Result: **No Asbestos Detected**

Material Assessment Score: **0** **No Remedial Action Required**

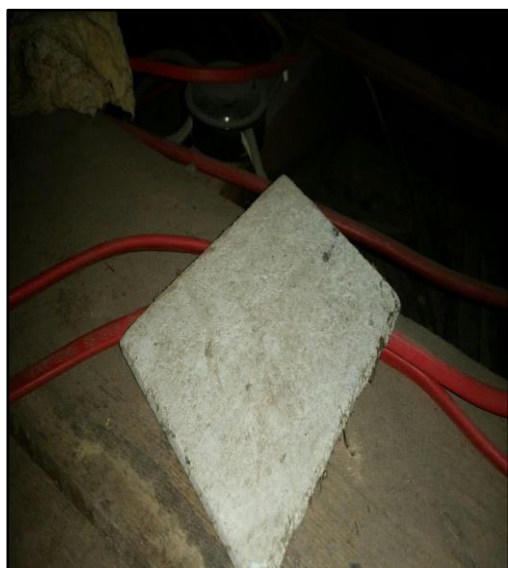
Sample Ref: B03 Location: Lakeview Apartment Loft Loose Panel

Material Sampled: Insulation Board

Analysis Result: **Amosite (brown) Asbestos**

Approximate Quantity: < 1m<sup>2</sup>

Condition: **Good Condition**

Surface Treatment: **Unsealed AIB / Encapsulated Lagging**

Material Assessment Score: **6** **No Remedial Action Required**

Priority Assessment Score: **2**

The panel is located within a small loft area.

Normally not accessed.

Remarks / Recommendations: Manage in Situ

Monitor for any damage or deterioration.

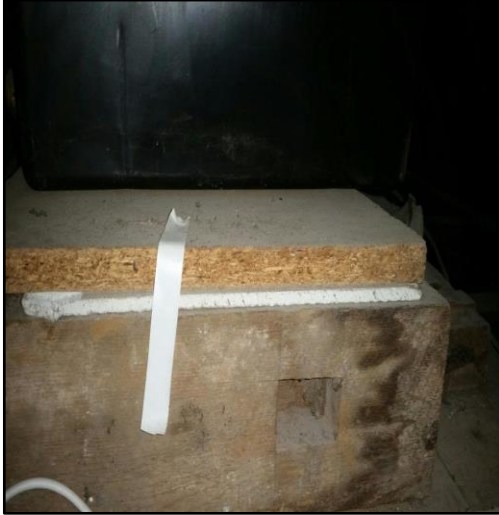
**Sample Ref:** B04**Location:** Lakeview Apartment Loft Panel Under Water Tank

Material Sampled: Insulation Board

Analysis Result: **Amosite (brown) Asbestos**Approximate Quantity: 1 m<sup>2</sup>Product Type: **AIB / Millboards / Textiles**Condition: **Good Condition**Surface Treatment: **Unsealed AIB / Encapsulated Lagging**Material Assessment Score: **6** **No Remedial Action Required**Priority Assessment Score: **2**

The panel is located within a small loft area.

Normally not accessed.

Remarks / Recommendations: Manage in Situ

Monitor for any damage or deterioration.

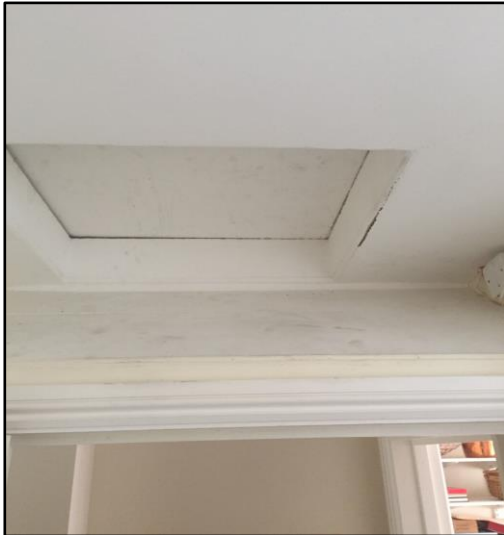
**Sample Ref:** B05**Location:** Lakeview Apartment Loft Hatch Panel

Material Sampled: Insulation Board

Analysis Result: **Amosite (brown) Asbestos**Approximate Quantity: 1 m<sup>2</sup>Product Type: **AIB / Millboards / Textiles**Condition: **Good Condition**Surface Treatment: **Unsealed AIB / Encapsulated Lagging**Material Assessment Score: **6** **No Remedial Action Required**Priority Assessment Score: **2**

The panel is located to the back of the loft hatch

Remarks / Recommendations: Manage in Situ

Monitor for any damage or deterioration.

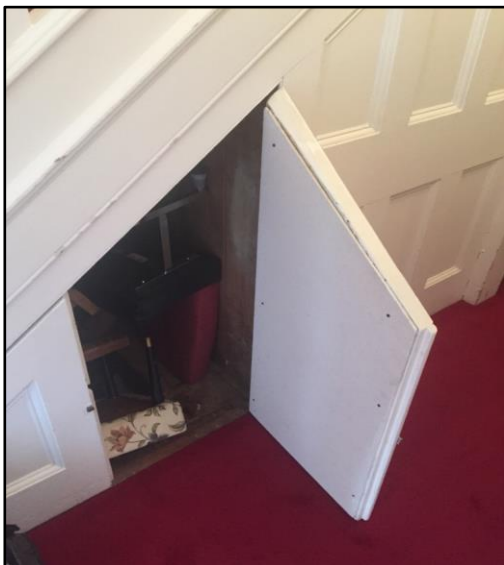
**Sample Ref:** B06**Location:** 1st Floor Under Stairs Cupboard Door Panel

Material Sampled: Supalux (New Fibre) Insulation Board

Analysis Result: **No Asbestos Detected**

Material Assessment Score: **0** **No Remedial Action Required**Priority Assessment Score: **0**

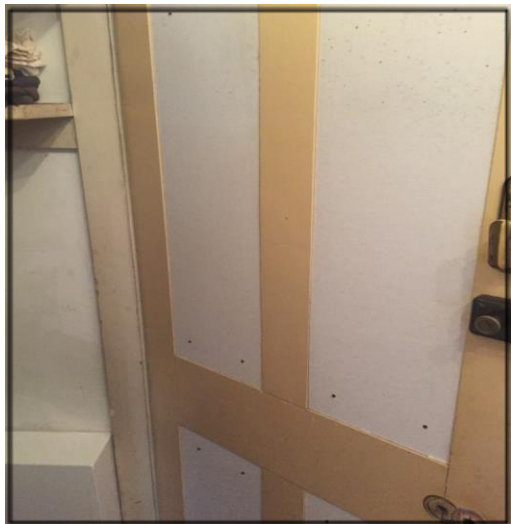
Location: 1st Floor Under Stairs Door + Wall Panel

Material Sampled: Supalux (New Fibre) Insulation Board

**No Asbestos Detected**

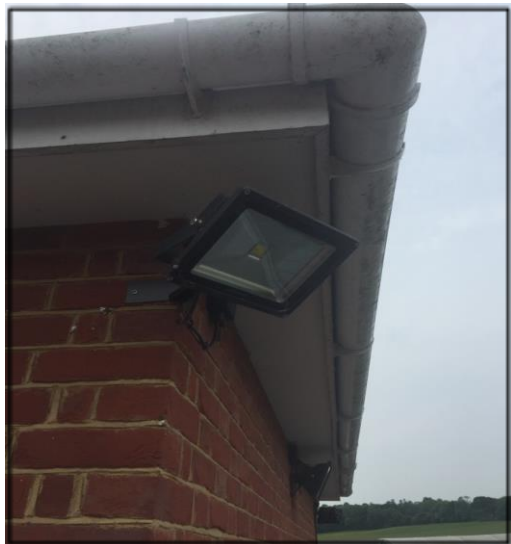
Location: 1st Floor Soffits

Material Sampled: Supalux (New Fibre) Insulation Board

**No Asbestos Detected**

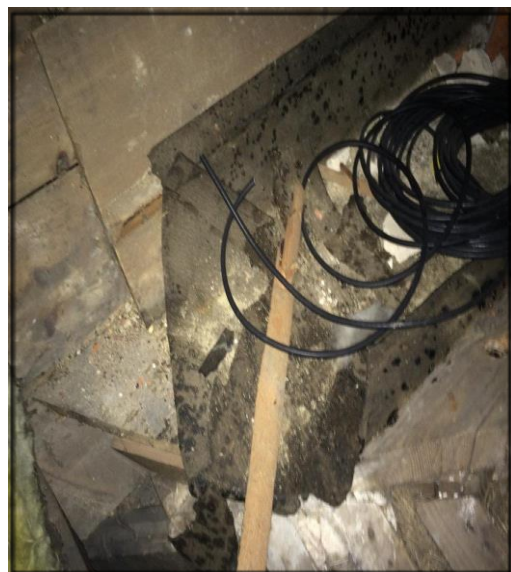
Location: Roof Area

Material Sampled: Bitumen Roofing Felt

**No Asbestos Detected**

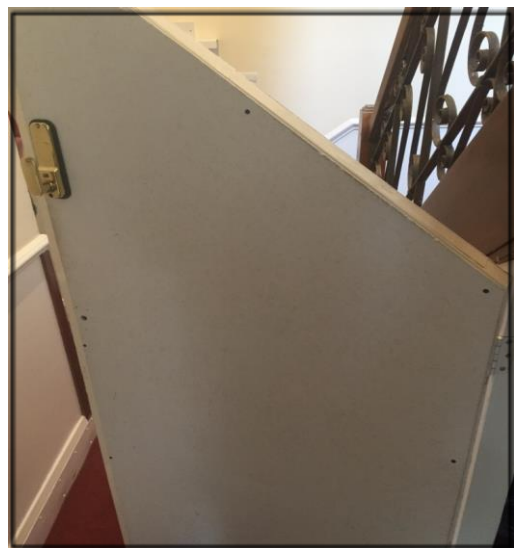
Location: Ground Floor Cleaners Cupboard Door + Wall Panel

Material Sampled: Supalux (New Fibre) Insulation Board

No Asbestos Detected

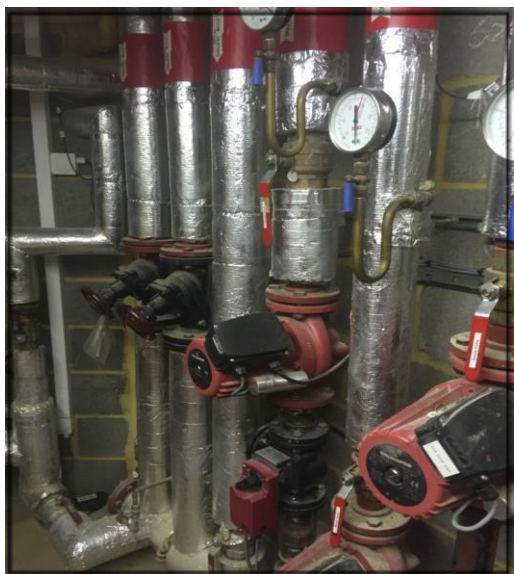
Location: Boiler Room Pipe Work

Material Sampled: Gaskets

No Asbestos Detected

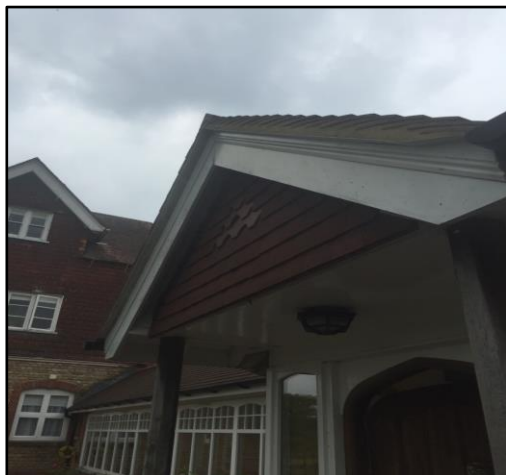
Location: Main Entrance External Under Cloak

Material Sampled: Board

Analysis Result: **No Asbestos Detected**

Also located within the courtyard.

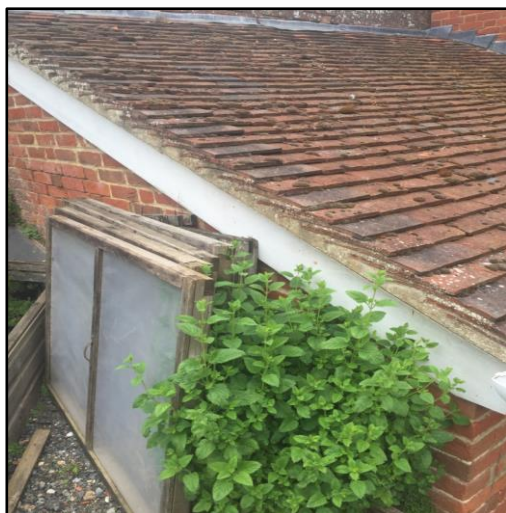
Location: External Kitchen Stores Under Cloak

Material Sampled: Board

Analysis Result: **No Asbestos Detected**

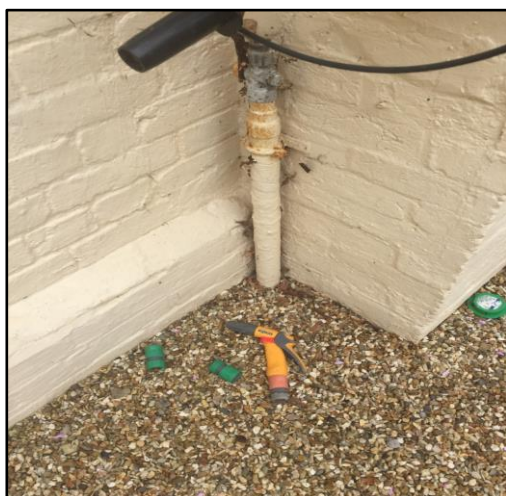
Location: External Main Building Wrap to Pipe

Material Sampled: Bitumen

Analysis Result: **No Asbestos Detected**

Also located within the courtyard.

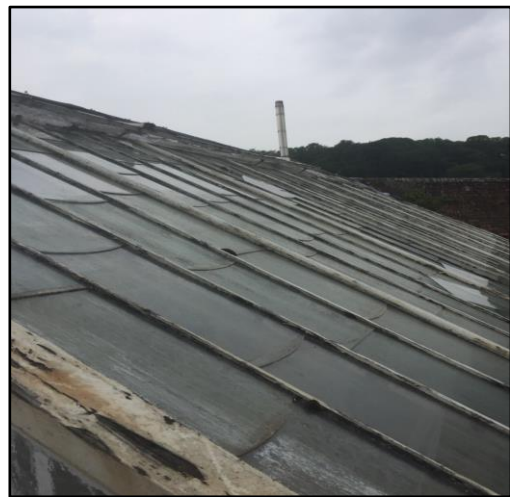
Material Sampled: Putty

Analysis Result: No Asbestos Detected

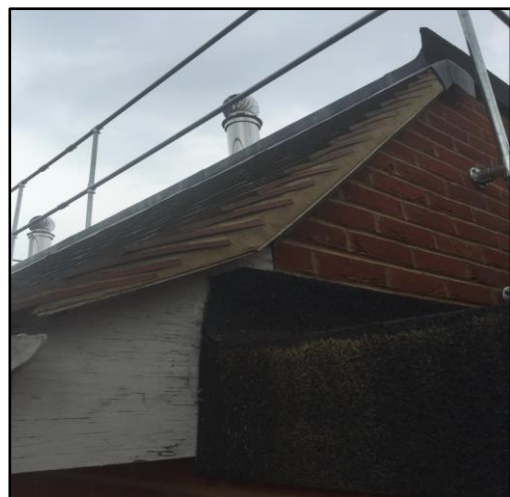
Material Sampled: Board

Analysis Result: No Asbestos Detected
