**Asbestos Survey
Update/Re-Inspection
Report**

**Birtley House
Nursing Home
Bramley
Surrey
GU5 0LB
Care of
Hunter FM**

Report reference No: ASBRI12695/0020/070318

Site Visit Date: 07/03/2018

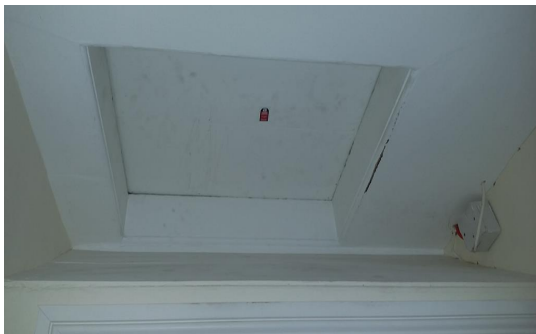
Sample/Ref No.: B03

Sample/Ref No.	Sampled	Floor	Room/ area No	Description of Product	Product type	Condition at survey	Comments	Picture
B03	Yes	2nd Floor	2.01	Insulation board loose panel in Lakeview Apartment loft area	Insulating board	Good	Programme for planned removal

Recommendations from Original Report							Condition at reinspection	
Implement management and inspection programme:							Unable to gain access due to contamination risk from hatch

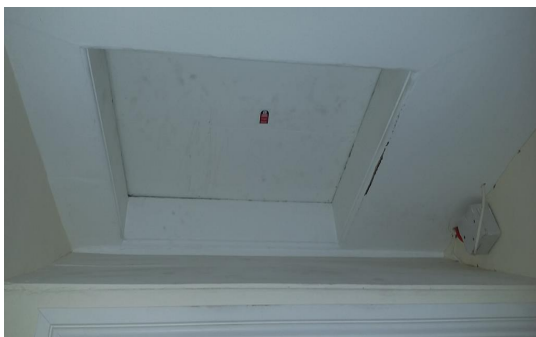
Sample/Ref No.: B04

Sample/Ref No.	Sampled	Floor	Room/ area No	Description of Product	Product type	Condition at survey	Comments	Picture
B04	Yes	2nd Floor	2.02	Insulation board panel under water tank in Lakeview Apartment loft area	Insulating board	Good	Programme for planned removal

Recommendations from Original Report							Condition at reinspection	
Implement management and inspection programme:							Unable to gain access due to contamination risk from hatch

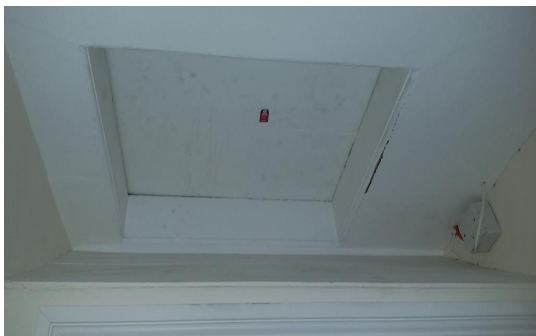
Sample/Ref No.: B05

Sample/Ref No.	Sampled	Floor	Room/ area No	Description of Product	Product type	Condition at survey	Comments	Picture
B05	Yes	2nd Floor	2.03	Insulation board loft hatch panel to Lakeview Apartment loft	Insulating board	Good	Programme for planned removal

Recommendations from Original Report							Condition at reinspection	
Implement management and inspection programme:							The panel is to the front of the loft hatch. Unable to lift hatch due to disturbing asbestos

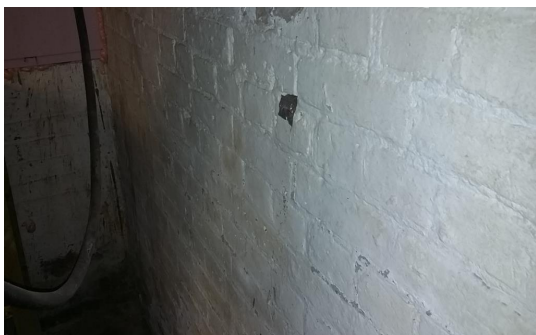
Sample/Ref No.: B06

Sample/Ref No.	Sampled	Floor	Room/ area No	Description of Product	Product type	Condition at survey	Comments	Picture
B06	Yes	Basement	B.01	Lagging debris to boiler room walls	Insulation	Medium Damage	Encapsulate damaged or exposed areas. Label as asbestos. Manage and re-inspect

Recommendations from Original Report							Condition at reinspection	
Programme for planned removal:							Medium Damage

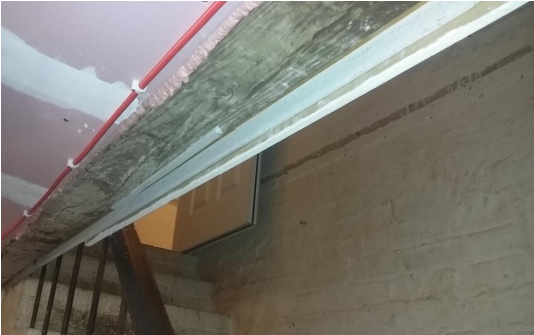
Sample/Ref No.: B07

Sample/Ref No.	Sampled	Floor	Room/ area No	Description of Product	Product type	Condition at survey	Comments	Picture
B07	Yes	Basement	B.02	Insulation board panels to basement stairwell (behind plasterboard)	Insulating board	Low Damage	Encapsulate damaged or exposed areas. Label as asbestos. Manage and re-inspect

Recommendations from Original Report							Condition at reinspection	
Programme for planned removal:							Low Damage
