STM32F446xC/xE device errata

Applicability

This document applies to the part numbers of STM32F446xC/xE devices and the device variants as stated in this page. It gives a summary and a description of the device errata, with respect to the device datasheet and reference manual RM00390. Deviation of the real device behavior from the intended device behavior is considered to be a device limitation. Deviation of the description in the reference manual or the datasheet from the intended device behavior is considered to be a documentation erratum. The term “*errata*” applies both to limitations and documentation errata.

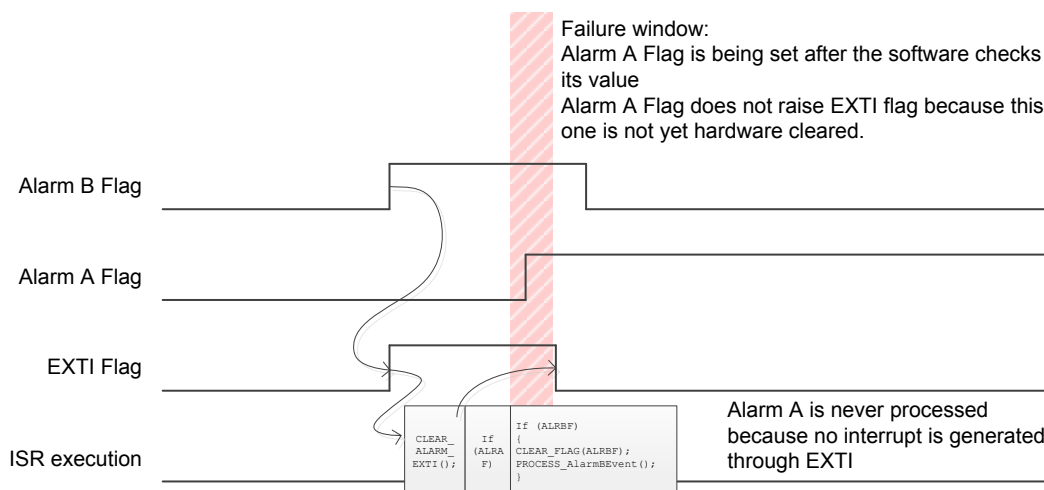
Figure 1. Masked RTC interrupt

The following code example and figure illustrate the failure mechanism: The Alarm A event is lost (fails to generate interrupt) as it occurs in the failure window, that is, after checking the Alarm A event flag but before the effective clear of the EXTI interrupt flag by hardware. The effective clear of the EXTI interrupt flag is delayed with respect to the software instruction to clear it.

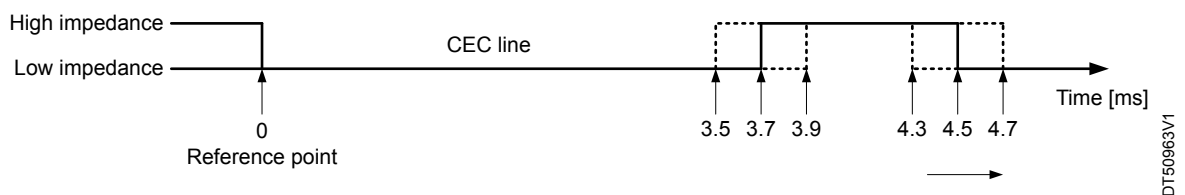
Figure 2. CEC start bit format with tolerances

The start bit timing standard tolerances are shown in [Figure 2](#). The start bit is initiated by the device by driving the CEC line low (reference point). After 3.7 ms, the device releases the CEC line and starts checking its level. The following conditions must be met for the start bit to be valid:

If one of these conditions is not met, the transmission is aborted and never automatically retried. No error flag is set and the TXSOM (Tx Start Of Message) bit is not cleared.

The only way to detect this error is for the application software to start a timeout when setting the TXSOM bit, restart it upon ARBLST or any RX event (as the transmission can be delayed by interleaved reception), and stop it upon TXBR (proof that the start bit was transmitted successfully) or TXEND event, or upon any TX error (which clears TXSOM). If the timeout expires (because none of those events occurred), the application software must restart the CEC peripheral and retransmit the message.
