REPORT ON MAINTENANCE CONDUCTED AT BUGESERA AND NGOMA DISTRICTS.

This report provides a summary of maintenance activities conducted on weather stations located in Bugesera and Ngoma Districts from September, 30th to October, 3rd, 2025. This involves conducting preventive maintenance and corrective maintenance of the automatic weather stations, automatic rain gauges, and manual stations located in mentioned districts.

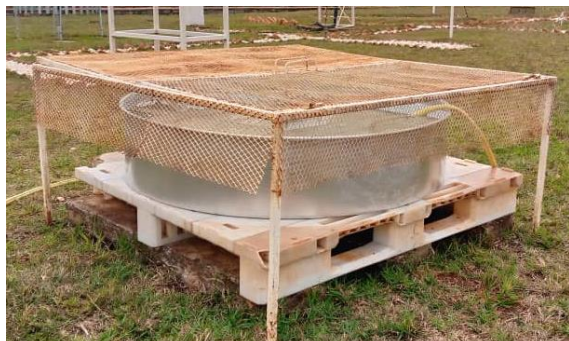
STATION		FINDINGS	PERMODED ACTIVITIES	RECOMMENDATIONS
1	KAZO	No evaporation pan available.	Installation of evaporation pan.	Regular preventive maintenance.

Figure 1:Evaporation Pan at KAZO site.
