**MINISTRY IN CHARGE OF EMERGENCY  
MANAGEMENT (MINEMA)**

**DRAFT FINAL REPORT FOR FEASIBILITY  
STUDY; VOLUME 4- (DRAINAGE DESIGN  
SECTION) FOR KARONGI DISTRICT**

**BEZA CONSULTING ENGINEERS PLC**

September, 2021G.C

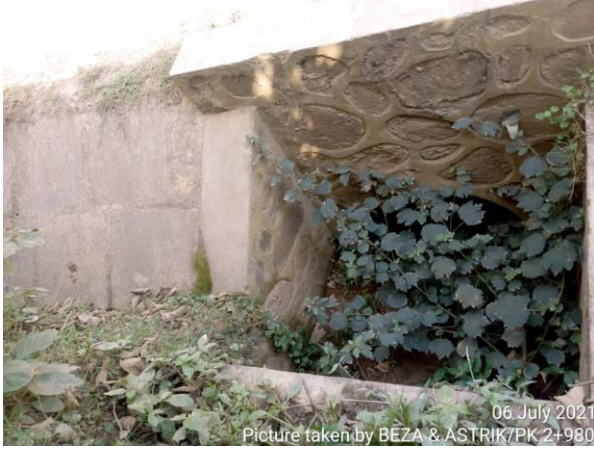
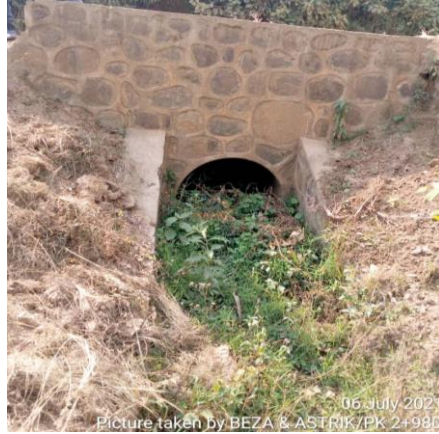
No.	Station	Type	No. opening	Opening Size(cm)	Flow Direction	Problem	Inlet Photo	Outlet Photo	Remark
9	2+980	PC	1	100	Right	<ul style="list-style-type: none"> <li>70 % of the pipe clogged with sediment.</li> <li>Channelization and protection work at the outlet required.</li> <li>Silt removal.</li> </ul>

<p>06 July 2021 Picture taken by BEZA &amp; ASTRIK/PK 2+980</p>	<ul style="list-style-type: none"> <li>To be replaced</li> </ul>
10	3+370	PC	1	80	Right	<ul style="list-style-type: none"> <li>Jointing problem.</li> <li>Outlet protection required.</li> <li>Silt removal.</li> </ul>

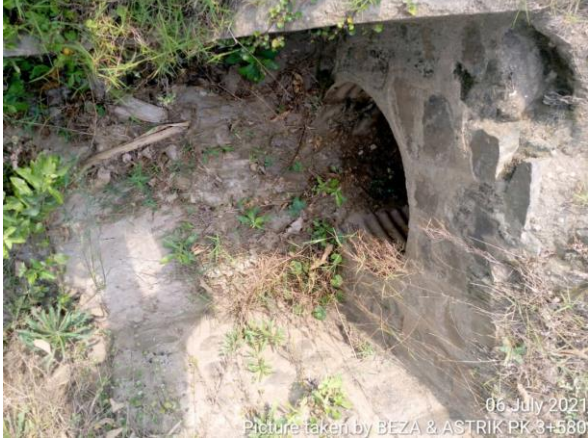
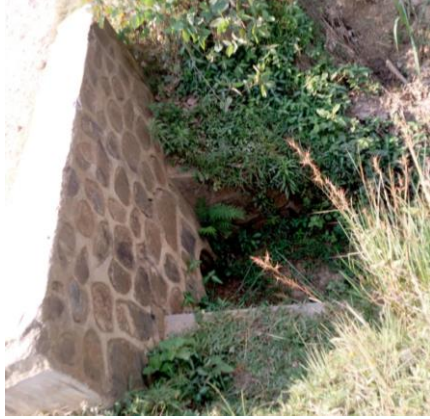
No.	Station	Type	No. opening	Opening Size(cm)	Flow Direction	Problem	Inlet Photo	Outlet Photo	Remark
11	3+680	PC	1	80	Right	<ul style="list-style-type: none"> <li>Vegetation removal.</li> <li>Jointing problem.</li> <li>Paved water way clearing.</li> <li>Pipe bed silt cleaning.</li> <li>Headwall failure.</li> </ul>

<ul style="list-style-type: none"> <li>To be replaced</li> </ul>
12	4+390	PC	1	80	Left	<ul style="list-style-type: none"> <li>The pipe is clogged with vegetation.</li> <li>Paved water way clearing.</li> <li>Pipe bed silt cleaning.</li> </ul>

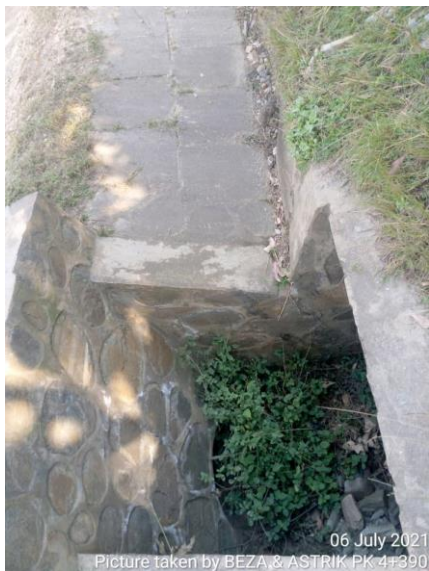
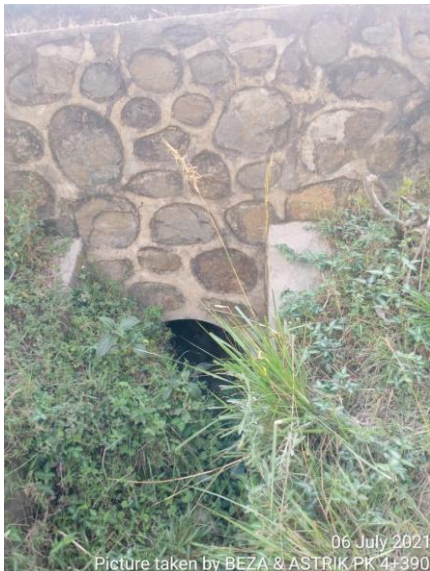
No.	Station	Type	No. opening	Opening Size(cm)	Flow Direction	Problem	Inlet Photo	Outlet Photo	Remark
13	4+390	PC	1	100	Left	<ul style="list-style-type: none"> <li>Vegetation removal.</li> <li>Paved water way clearing.</li> </ul>

<p>06 July 2021 Picture taken by BEZA &amp; ASTRIK PK 4+390</p>	<ul style="list-style-type: none"> <li>To be replaced</li> </ul>
14	4+710	PC	1	80	Left	<ul style="list-style-type: none"> <li>Vegetation removal.</li> <li>Paved water way clearing.</li> <li>Headwall failure.</li> </ul>

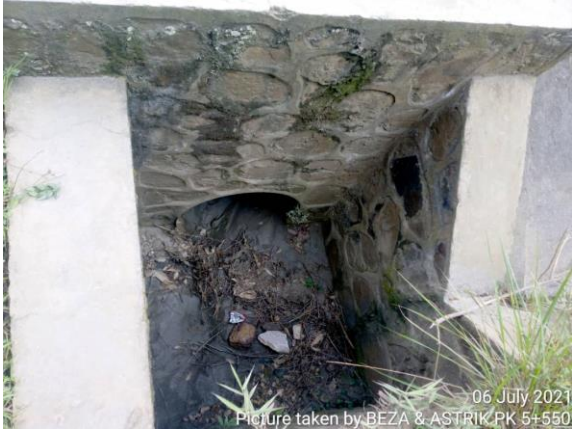
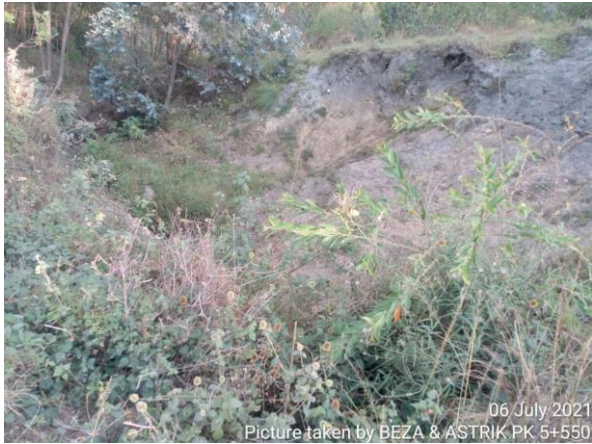
No.	Station	Type	No. opening	Opening Size(cm)	Flow Direction	Problem	Inlet Photo	Outlet Photo	Remark
16	5+550	PC	1	80	Left	<ul style="list-style-type: none"> <li>outlet wall failure.</li> <li>Clogged up to 70% at the outlet.</li> <li>Silt removal.</li> <li>Outlet protection works required.</li> </ul>

<p>06 July 2021 Picture taken by BEZA &amp; ASTRIK PK 5+550</p>	<ul style="list-style-type: none"> <li>To be replaced</li> </ul>
17	5+110	PC	1	80	Left	<ul style="list-style-type: none"> <li>Jointing problem.</li> <li>Paved water way clearing.</li> <li>Pipe bed silt cleaning.</li> <li>Headwall failure.</li> </ul>

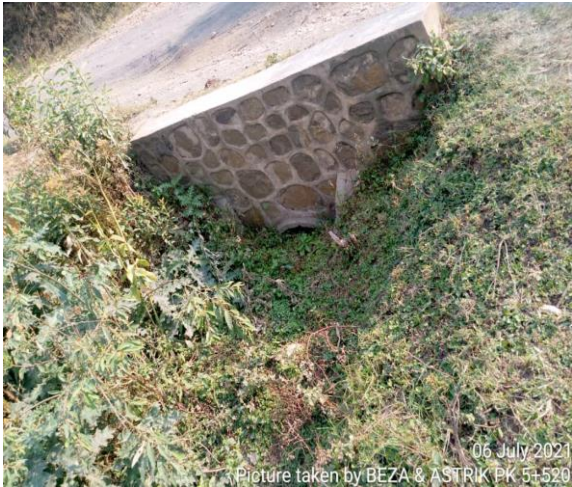
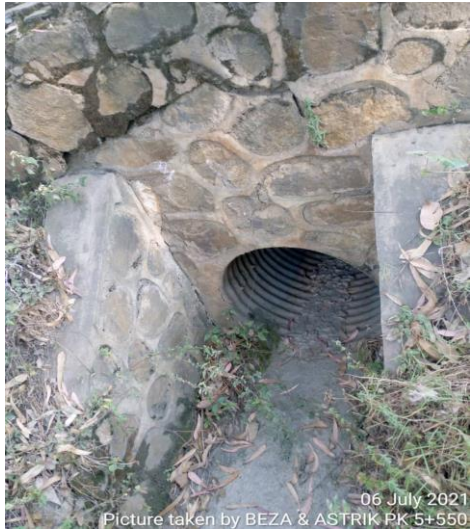
No.	Station	Type	No. opening	Opening Size(cm)	Flow Direction	Problem	Inlet Photo	Outlet Photo	Remark
20	5+550	PC	1	80	Left	<ul style="list-style-type: none"> <li>Vegetation removal.</li> <li>Jointing problem.</li> <li>Paved water way clearing.</li> </ul>

<p>06 July 2021 Picture taken by BEZA &amp; ASTRIK PK 5+550</p>	<ul style="list-style-type: none"> <li>To be replaced</li> </ul>
21	5+950	PC	1	80	Left	<ul style="list-style-type: none"> <li>Jointing problem.</li> <li>Paved water way clearing.</li> <li>Headwall failure.</li> <li>Outlet apron and cascade failure</li> </ul>

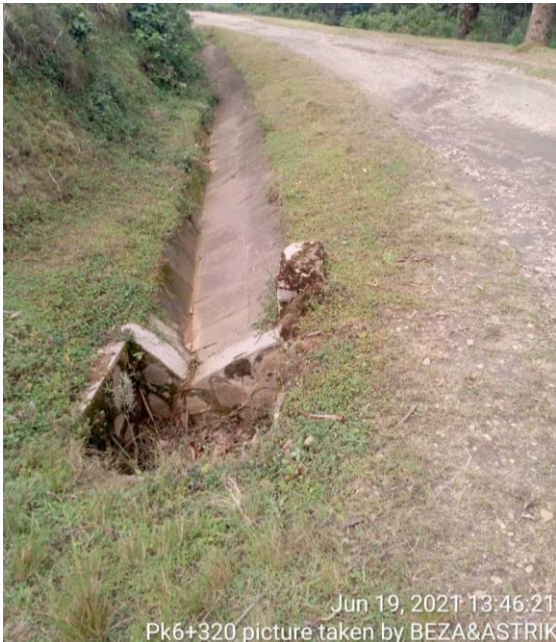
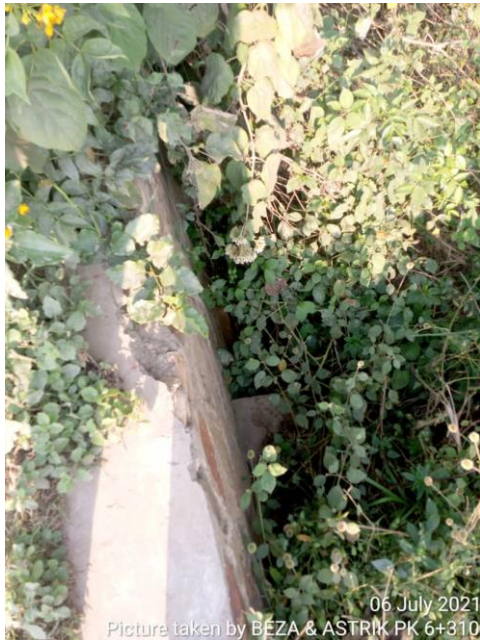
No.	Station	Type	No. opening	Opening Size(cm)	Flow Direction	Problem	Inlet Photo	Outlet Photo	Remark
22	6+310	PC	1	80	Left	<ul style="list-style-type: none"> <li>The pipe is fully clogged.</li> <li>Outlet protection works required.</li> </ul>

<p>06 July 2021 Picture taken by BEZA &amp; ASTRIK PK 6+310</p>	<ul style="list-style-type: none"> <li>To be replaced</li> </ul>
23	6+750	PC	1	80	Left	<ul style="list-style-type: none"> <li>The pipe is fully clogged.</li> <li>Outlet protection works required.</li> <li>Vegetation removal.</li> <li>Not functional</li> <li>Pipe bed silt cleaning.</li> <li>Headwall failure.</li> </ul>

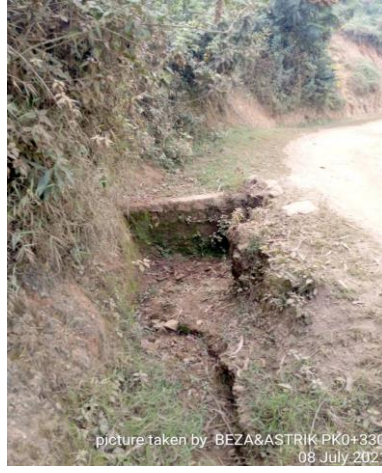
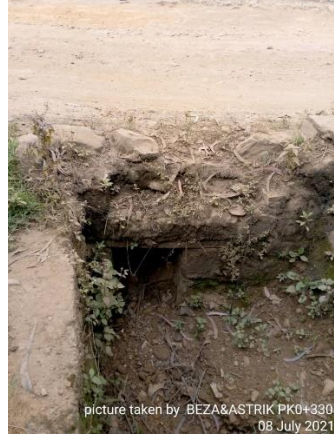
o.	Station	Type	No. opening	Opening Size(cm)	Flow Direction	Remark	Inlet Photo	Outlet Photo	Remark
1	0+330	TS	1	50*40	Right	<ul style="list-style-type: none"> <li>The drainage is fully clogged with sediments</li> <li>It is small in size</li> <li>Inlet construction required</li> <li>Outlet protection works required</li> </ul>

<p>picture taken by BEZA&amp;ASTRIK PK0+330 08 July 2021</p>	<ul style="list-style-type: none"> <li>To be replaced</li> </ul>
2	0+375	PC	1	RCPC Dia 60	Right	<ul style="list-style-type: none"> <li>The pipe is clogged with debris at inlet.</li> <li>Outlet protection works required</li> </ul>

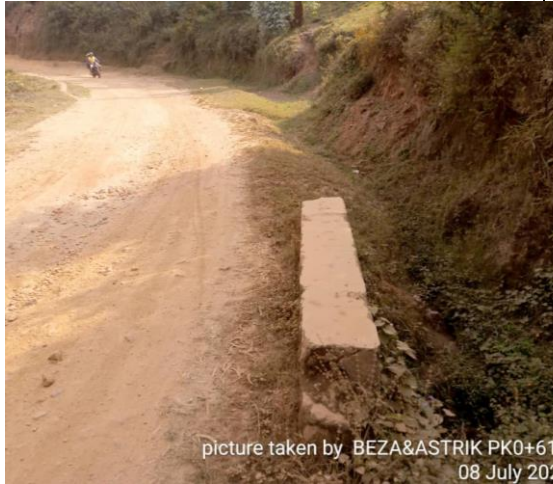
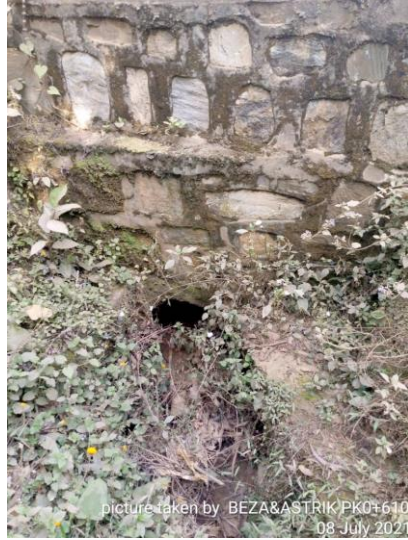
o.	Station	Type	No. opening	Opening Size(cm)	Flow Direction	Remark	Inlet Photo	Outlet Photo	Remark
3	0+610	PC	1	RCPCDia 60	Right	<ul style="list-style-type: none"> <li>The pipe is clogged with sediments and vegetation both at inlet and outlet.</li> <li>Vegetation removal at both ends.</li> <li>Pipe bed silt cleaning.</li> </ul>

<p>picture taken by BEZA&amp;ASTRIK PK0+610 08 July 2021</p>	<ul style="list-style-type: none"> <li>To be replaced</li> </ul>
4	0+690	CS	1	100*40	Right	<ul style="list-style-type: none"> <li>The crossing ditch is clogged.</li> <li>Outlet protection works required.</li> <li>Vegetation removal at both ends.</li> <li>Paved water way clearing.</li> </ul>

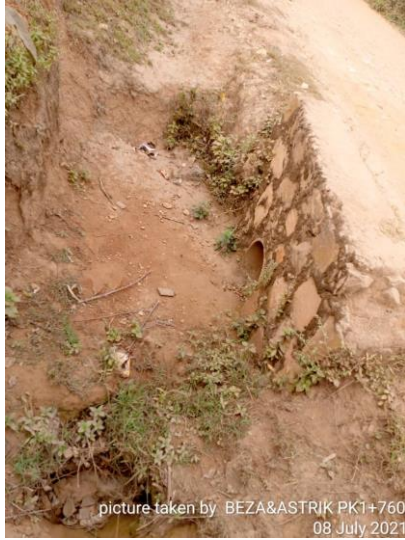
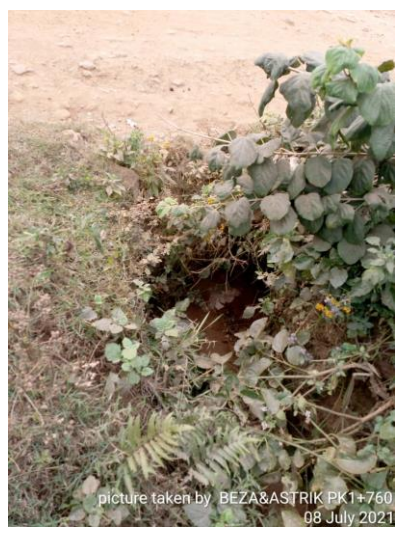
o.	Station	Type	No. opening	Opening Size(cm)	Flow Direction	Remark	Inlet Photo	Outlet Photo	Remark
6	1+760	PC	1	60	Right	<ul style="list-style-type: none"> <li>The pipe is clogged at outlet</li> <li>Inlet and outlet protection works required</li> </ul>

<p>picture taken by BEZA&amp;ASTRIK PK1+760 08 July 2021</p>	<ul style="list-style-type: none"> <li>To be replaced</li> </ul>
7	1+880	PC	1	60	Right	<ul style="list-style-type: none"> <li>The pipe is clogged at outlet</li> <li>Inlet and outlet protection works required</li> <li>Wing walls &amp; headwalls failure and improper construction.</li> <li>Silt deposited at outlet bed</li> </ul>

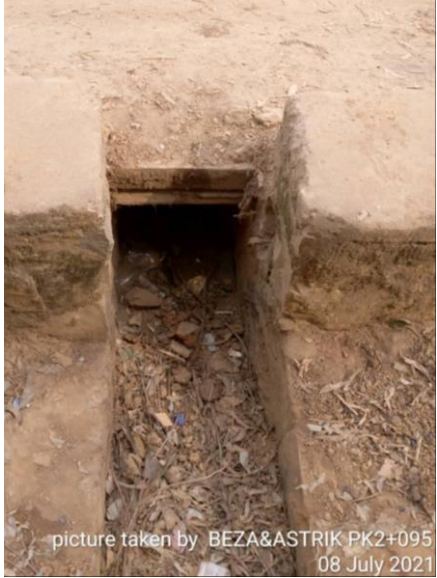
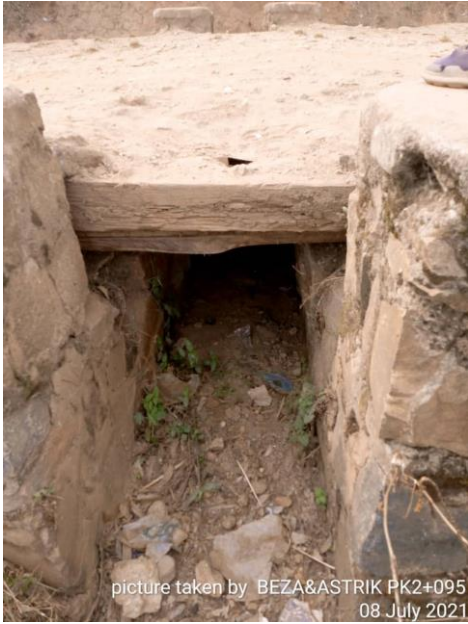
o.	Station	Type	No. opening	Opening Size(cm)	Flow Direction	Remark	Inlet Photo	Outlet Photo	Remark
8	2+095	TS	1	50*40	Right	<ul style="list-style-type: none"> <li>Small in size</li> <li>Timber slabs failure</li> <li>The crossing ditch is clogged with debris and silt.</li> <li>Outlet protection works required.</li> </ul>

<p>picture taken by BEZA&amp;ASTRIK PK2+095 08 July 2021</p>	<ul style="list-style-type: none"> <li>To be replaced</li> </ul>
9	2+140	PC	1	60	Right	<ul style="list-style-type: none"> <li>The pipe is clogged with silt and vegetation</li> <li>Outlet protection works required</li> <li>Water way clearing required</li> </ul>

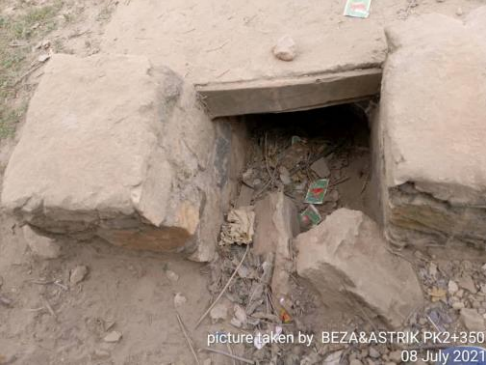
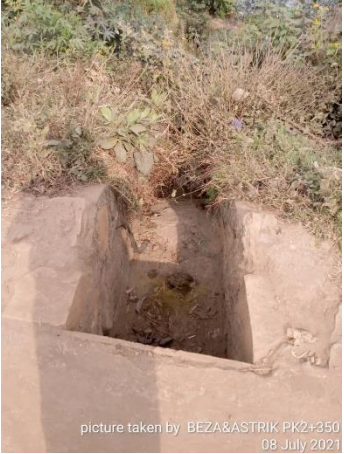
o.	Station	Type	No. opening	Opening Size(cm)	Flow Direction	Remark	Inlet Photo	Outlet Photo	Remark
10	2+350	TS	1	50*40	Right	<ul style="list-style-type: none"> <li>• Small in size</li> <li>• Timber slabs failure</li> <li>• The crossing ditch is clogged with debris and silt.</li> <li>• Outlet protection works required.</li> </ul>

<ul style="list-style-type: none"> <li>• To be replaced</li> </ul>

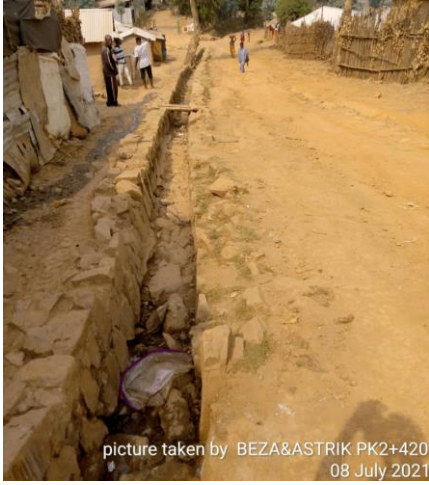
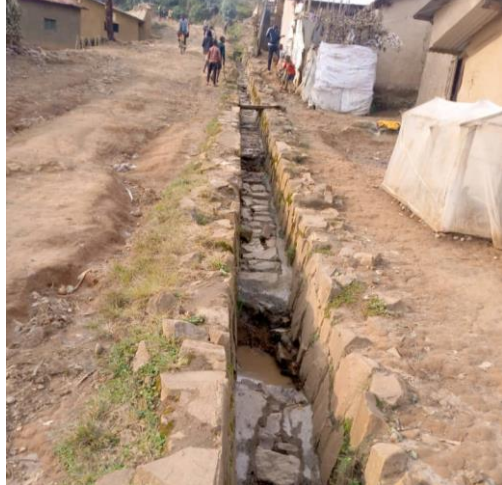
No.	Station	Type	No. opening	Opening Size(cm)	Flow Direction	Problem	Inlet Photo	Outlet Photo	Remark
11	2+420	MD	1	40*30		<ul style="list-style-type: none"> <li>Pavement failure</li> <li>Not covered</li> <li>Small in size which leads to overflow towards carriageway</li> </ul>

<ul style="list-style-type: none"> <li>To be replaced</li> </ul>
12	2+450	CS	1	Not det.		<ul style="list-style-type: none"> <li>Small in size</li> <li>The crossing ditch is fully clogged with sediments</li> <li>Silt removal.</li> </ul>

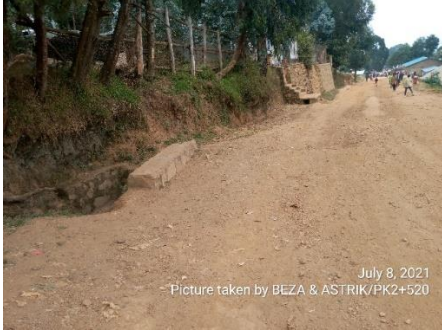
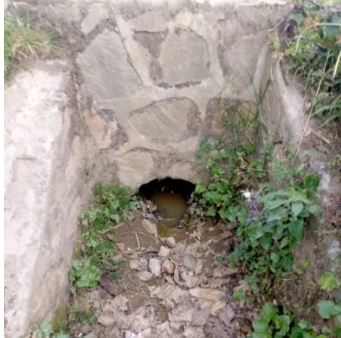
<p>Jun 19, 2021 16:09:11 Karongi Pk2+450picture taken by BEZA &amp; ASTRIK</p>		<ul style="list-style-type: none"> <li>To be replaced</li> </ul>
13	2+520	PC	1	60	Right	<ul style="list-style-type: none"> <li>Clogged up to 60% at the outlet.</li> <li>Silt removal.</li> <li>Outlet protection works required.</li> </ul>

<ul style="list-style-type: none"> <li>To be replaced</li> </ul>
