Maintenance Engineering & Technical Assurance (Civil Maintenance Engineering Discipline)

STRUCTURAL INTEGRITY ASSESSMENT OF PIPE SUPPORTS & CONDENSATE TANK FOUNDATION AT SOKU GAS PLANT

8TH FEBRUARY, 2022

SPDC-2022-02-00000004

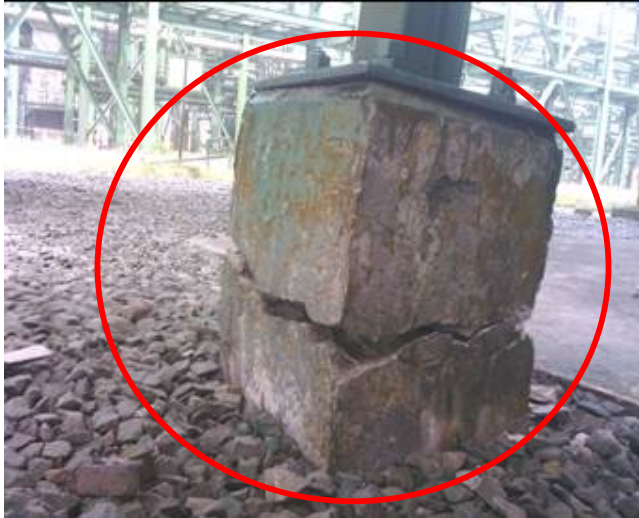
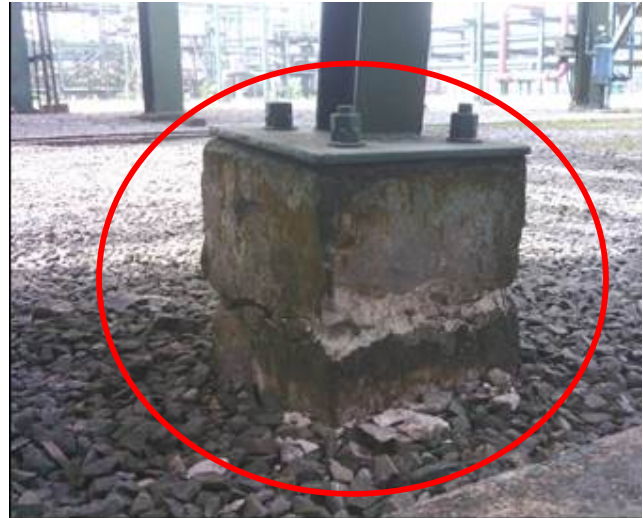
- Failed pipe support foundation and tilted stanchion
- Excessive spacing between pipe supports (7.8m & 5.1m). Required distance is **2.5m max**
- Failed/insufficient length of angle iron piping seats, and loose/missing U-clamps.

These defects are escalated by excessive vibrations (up to 90 bar) released by the glycol contactor valve into the 2" Rich glycol lines.

FAILED CONCRETE SUPPORTS

ASSET	FAILED CONCRETE SUPPORT AT GRU TRAIN 1		
COMPONENTS INSPECTED	DEFECTS OBSERVED	MEASURE/SIZE OF DEFECTS/REMEDIAL ACTION	PRIORITY
2" RICH GLYCOL RETURN LINE FROM CONTACTOR - REGENERATION UNIT AT GRU TRAIN 1	Failed concrete foundation and tilted stanchion <ul style="list-style-type: none"> Stanchion: 100 x 80mm IPE, 5m length Foundation stubs: 300x300x 405mm. Anchor bolts: 18.7mm dia. 	Demolish and reconstruct failed concrete foundation and straighten titled stanchion.	1
	Excessive spacing between pipe supports.	Fabricate and install additional pipe supports midway between the existing supports to reduce the spans to a maximum of 2.5m.	1
	Loose/missing U-clamps	Replace missing clamps and fix loose clamps.	
	Failed and insufficient length of piping seats 30 x 30mm E.A, 0.6m length, 6 Nos.	Provide equal angle section, cut to L-shape to provide sufficient seats for the 2" Rich glycol pipes 50 x 50mm E.A, 0.9m	1

Excessive vibrations (up to 90 bar) released by the glycol contactor valve into the 2" Rich glycol lines	Use Neoprene Packing placed between the Pipeline and Supports to dampen the effects of vibrations from the Pipe.	1
		Carry out further review of the excessive vibration issues with Process, Mechanical and Pipeline Engineering disciplines	2

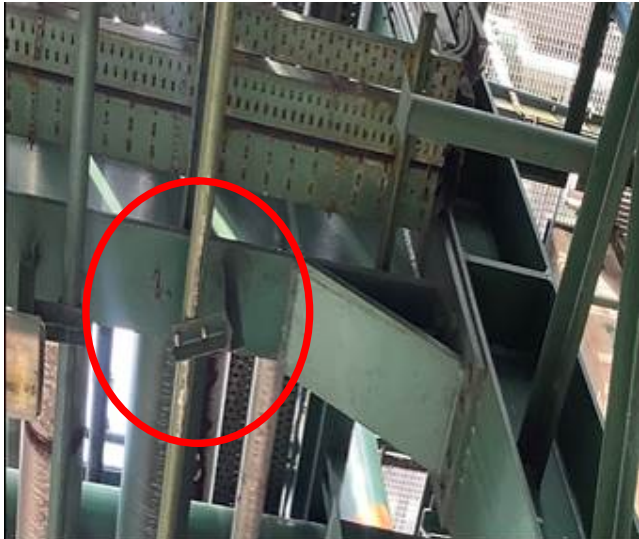
INSUFFICIENT LENGTH OF ANGLE IRON SEATS

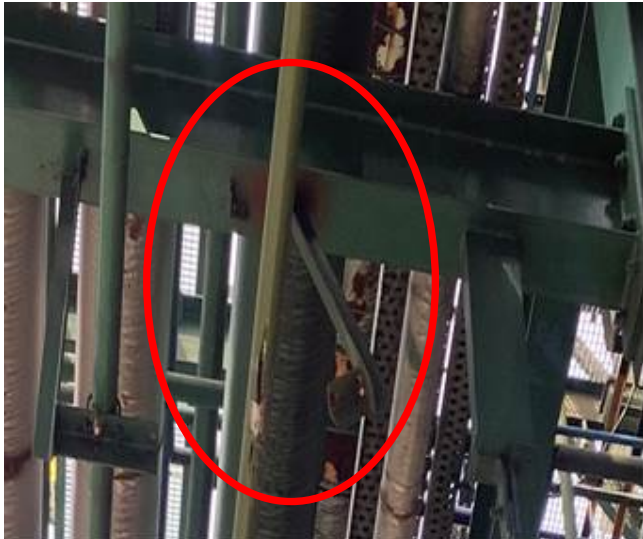
FAILED L-SHAPED EQUAL ANGLE SUPPORT FOR THE 2" LINE.

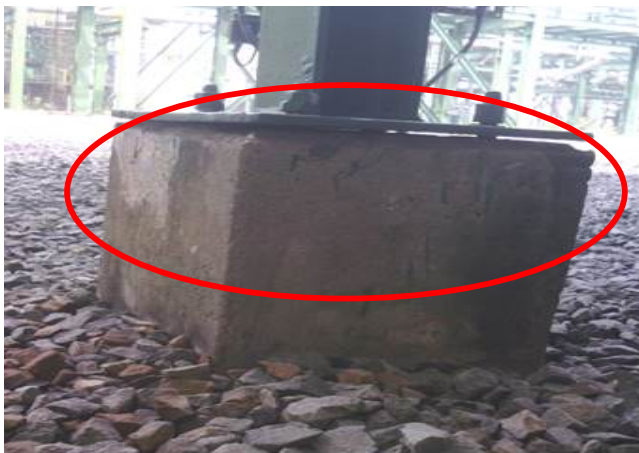
5MM CLEARANCE BETWEEN BASE PLATE & CONCRETE SUPPORT.

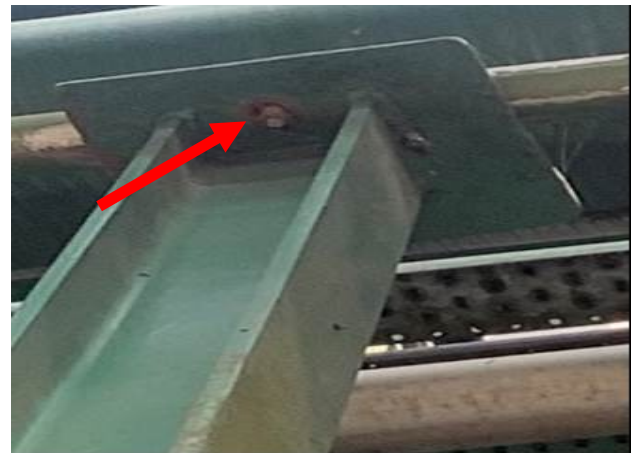
LOOSED PIPE CLAMP.

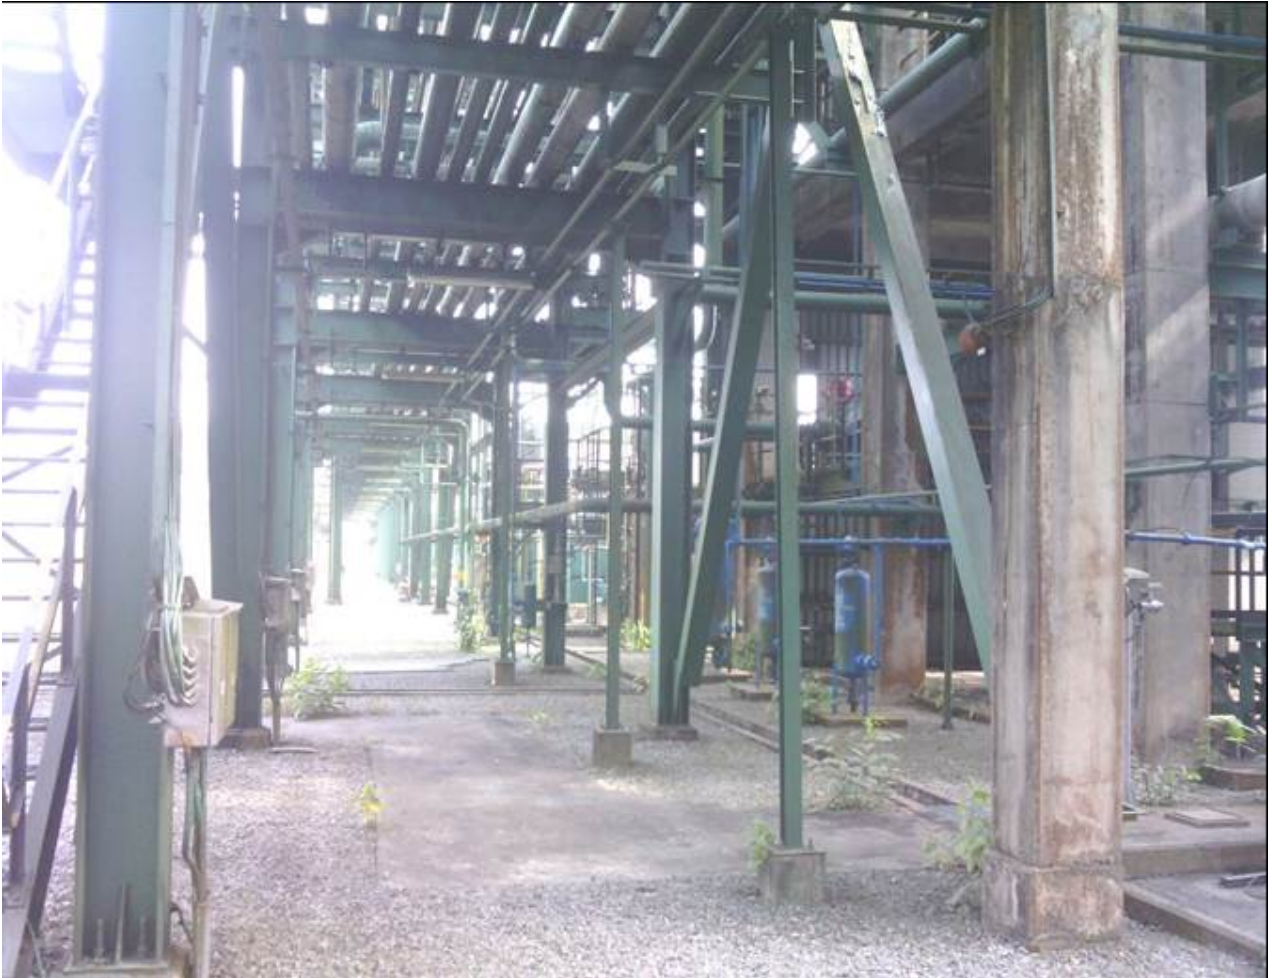
CONCRETE SUPPORT AND STEEL STANCHIONS: NO SIGN OF FAILURE AS AT THE TIME OF INSPECTION.

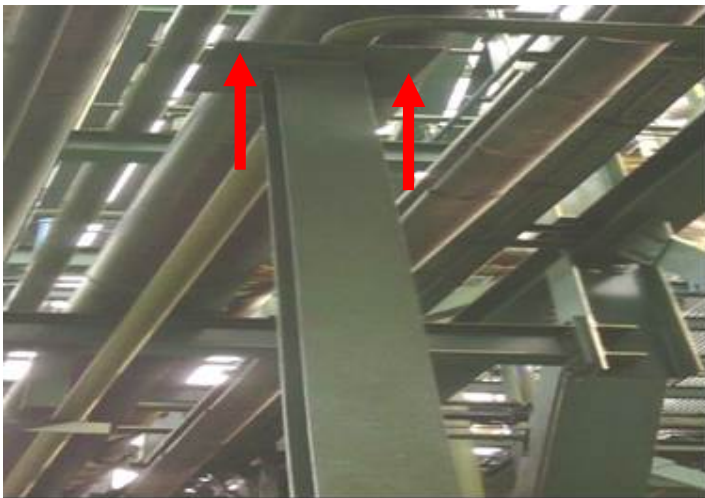
MISSING PIPE CLAMPS U-CLAMPS.

ASSET	CONCRETE SUPPORT AT GRU TRAIN 2		
COMPONENTS INSPECTED	DEFECTS OBSERVED	MEASURE/SIZE OF DEFECTS/REMEDIAL ACTIONS	PRIORITY
CONCRETE FOUNDATION AND STEEL PIPE SUPPORTS	No sign of failure as at time of inspection	No action Required	4
	Excessive spacing between pipe supports.	Fabricate and install additional pipe supports midway between the existing supports to reduce the spans to a maximum of 2.5m.	1
	Insufficient Length of L-shaped equal angle piping seats 30x30mm E.A, 0.6m, 6Nos.	Provide equal angle section, cut to L-shape to provide sufficient seats for the 2" Rich glycol pipes 50 x 50mm E.A, 0.9m x 10Nos.	2
	Missing U-clamps	Replace missing clamps	1
	Excessive vibrations (up to 90 bar) released by the glycol contactor valve into the 2" Rich glycol lines	Use Neoprene Packing placed between the Pipeline and Supports to dampen the effects of vibrations from the Pipe.	1
		Carry out further review of the excessive vibration issues with Process, Mechanical and Pipeline Engineering disciplines	2

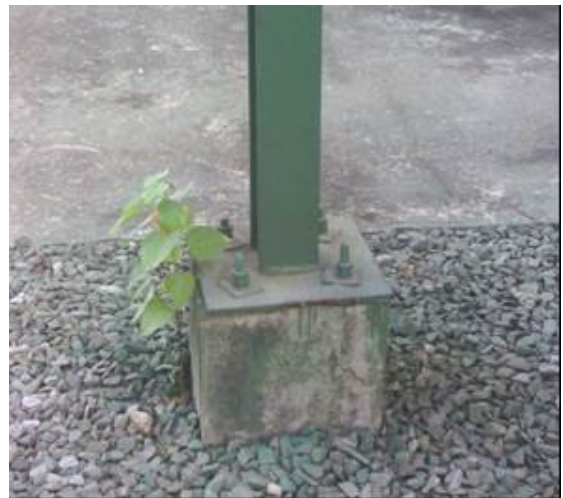
CONCRETE FOUNDATION IN GOOD CONDITION

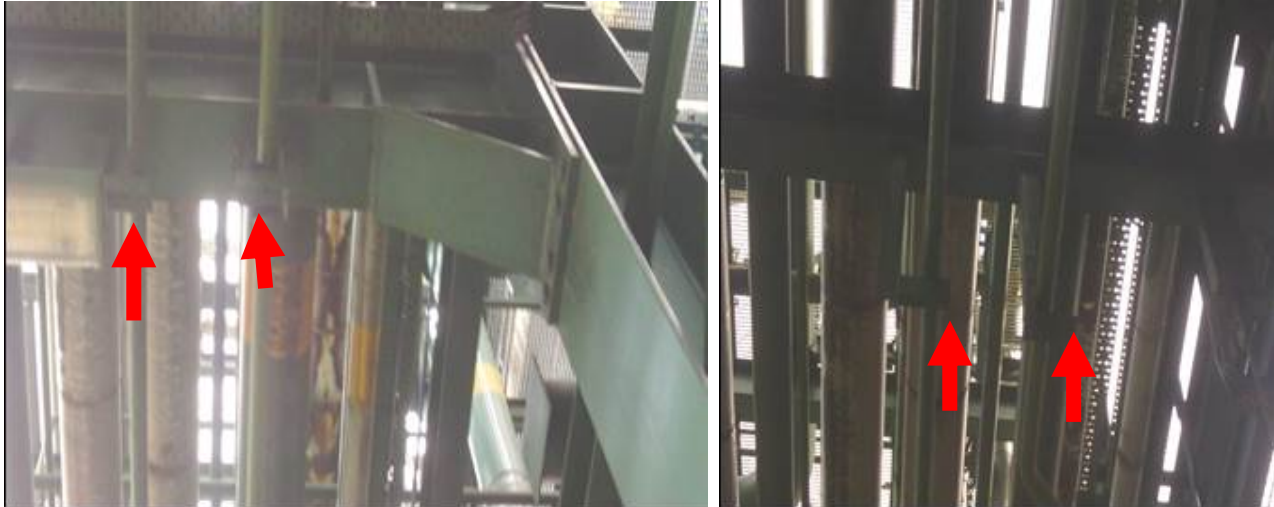
INSUFFICIENT L-SHAPED EQUAL ANGLE PIPING SEATS.

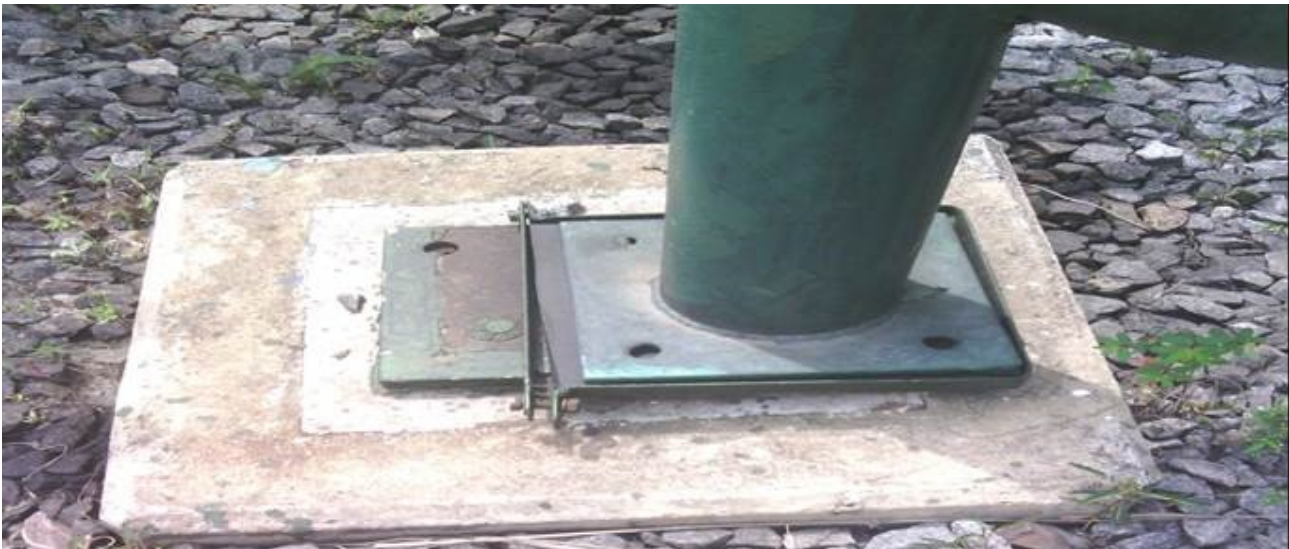
MISSING ANCHOR BOLTS & DISPLACEMENT OF PIPE SUPPORT FROM ORIGINAL POSITION

ASSET	CONCRETE AND STEEL SUPPORT AT SPIKING PUMP AREA		
COMPONENTS INSPECTED	DEFECTS OBSERVED	MEASURE/SIZE OF DEFECTS/REMEDIAL ACTION	PRIORITY
SPIKING PUM A AND B	Missing anchor bolts	Provide and install galvanized fischer anchor bolts.	1
	Displacement of pipe supports from original positions due to excessive vibrations from the spiking pump		
	Moderate to severe subsidence of concrete foundations leading to detachment of pipings from supports.	Demolish and reconstruct affected pipe supports.	1
	Excessive spacing between pipe supports.	Fabricate and install additional pipe supports midway between the existing supports to reduce the spans to a maximum of 2.5m.	1
	Excessive vibrations from spiking pumps	Use Neoprene Packing placed between the Pipeline and Supports to dampen the effects of vibrations from the Pipe.	1

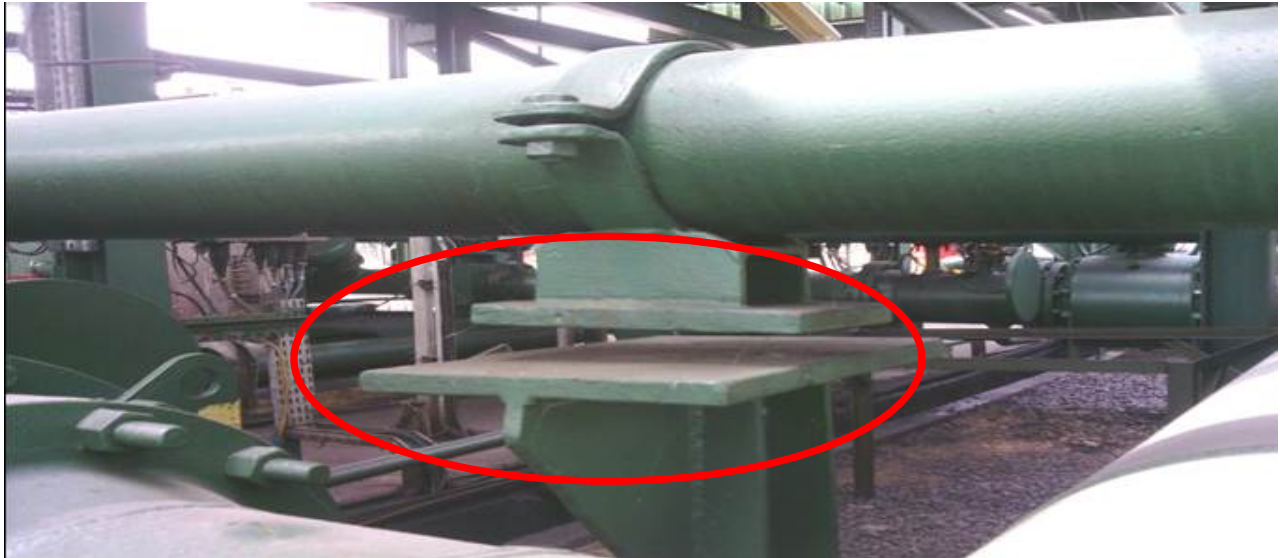
- Moderate to severe subsidence of pipe supports
- Detachment of pipes from supports,
- Excessive distance between pipe supports circa 6m
- Displacement of pipe supports from original positions, and missing anchor bolts.

SEVERE SUBSIDENCE OF PIPE SUPPORTS FOUNDATION & DETACHMENT OF PIPING FROM PIPE SUPPORT

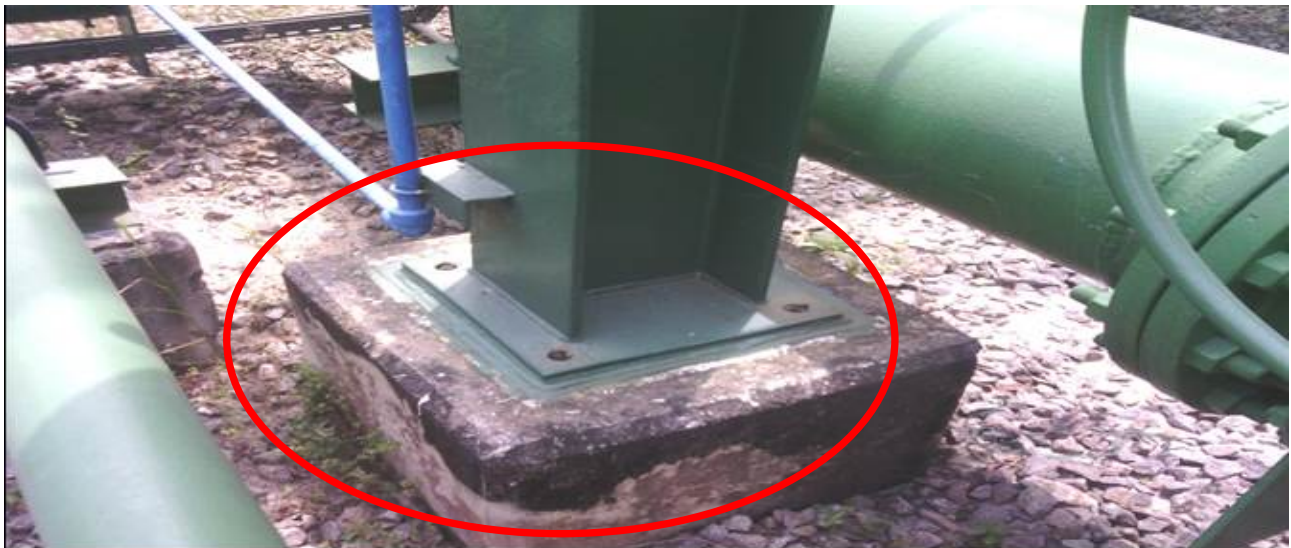
MISSING ANCHOR BOLTS.

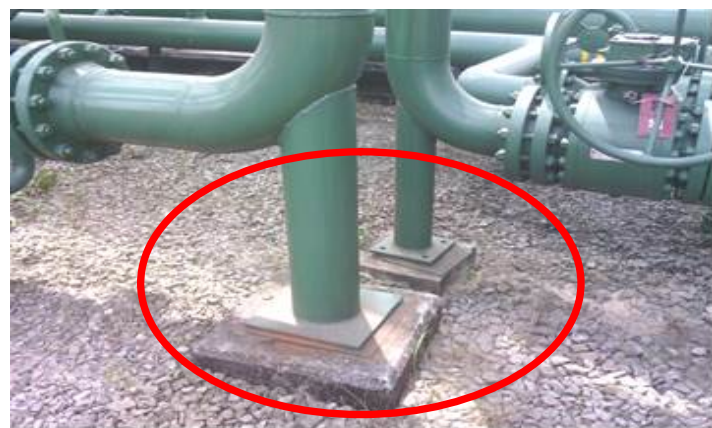
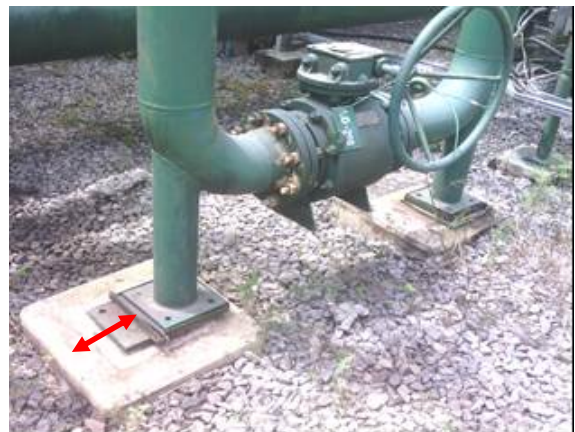
These defects are escalated by excessive vibrations from the spiking pumps which are propagated to the flow lines.

DISPLACEMENT OF PIPE SUPPORTS FROM ORIGINAL POSITIONS DUE TO EXCESSIVE VIBRATIONS FROM THE SPIKING PUMP.

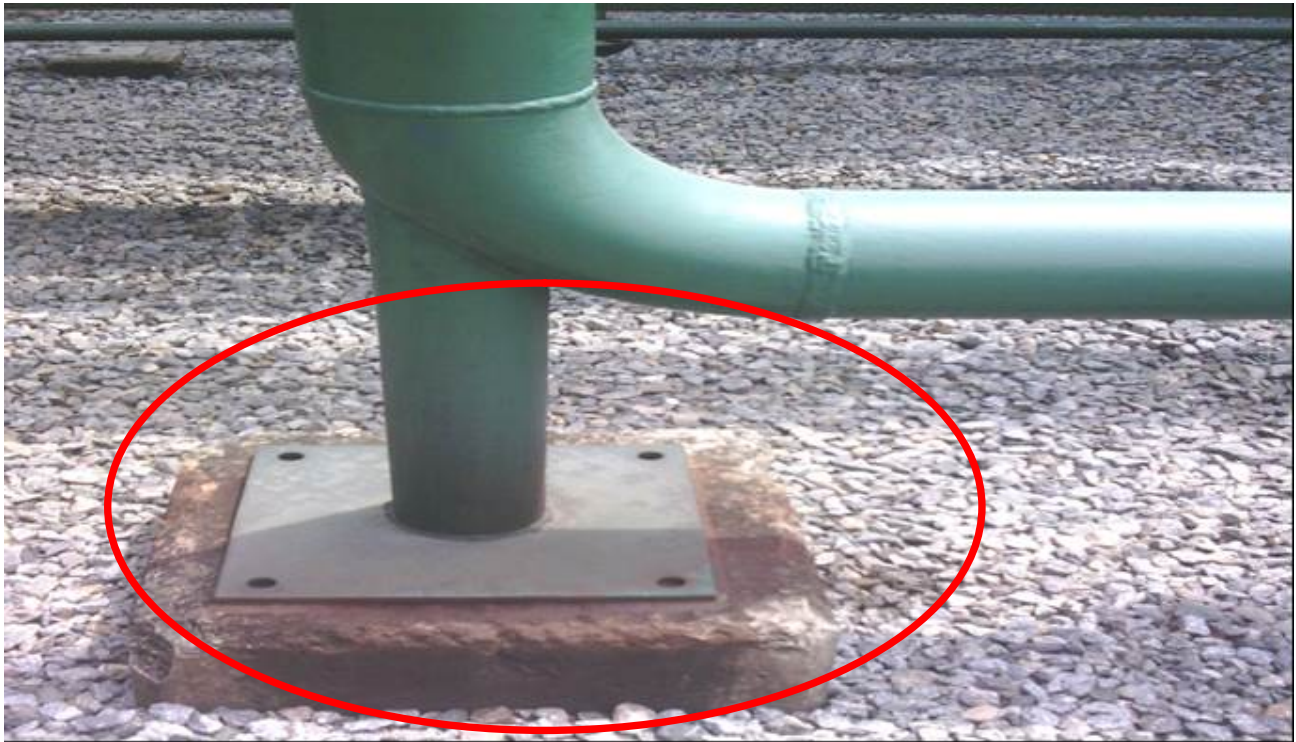
MISSING ANCHOR BOLTS.

Carry out further review of the excessive vibration issues with Process, Mechanical and Pipeline Engineering disciplines	2
SPIKING PUMP C AND D	Missing anchor bolts	Provide and install galvanized fischer anchor bolts.	1
	Displacement of pipe supports from original positions due to excessive vibrations from the spiking pump		
	Excessive spacing between pipe supports.	Fabricate and install additional pipe supports midway between the existing supports to reduce the spans to a maximum of 3.m.	1
	Excessive vibrations from spiking pumps	Use Neoprene Packing placed between the Pipeline and Supports to dampen the effects of vibrations from the Pipe.	1
		Carry out further review of the excessive vibration issues with Process, Mechanical and Pipeline Engineering disciplines	2

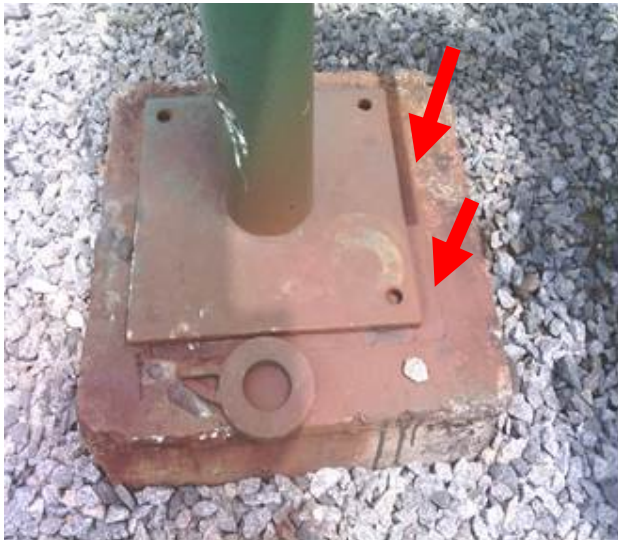
**DISPLACEMENT OF PIPE SUPPORTS FROM ORIGINAL POSITIONS
DUE TO EXCESSIVE VIBRATIONS FROM SPIKING PUMP.**

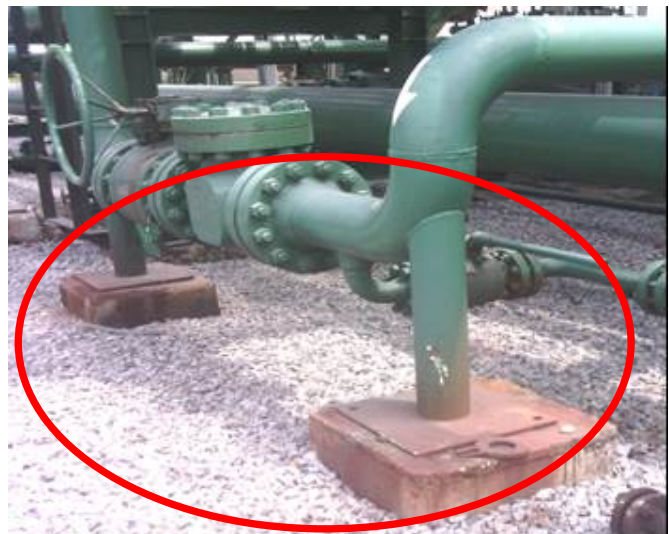
PIPE SUPPORTS INSTALLED WITHOUT ANCHOR BOLTS

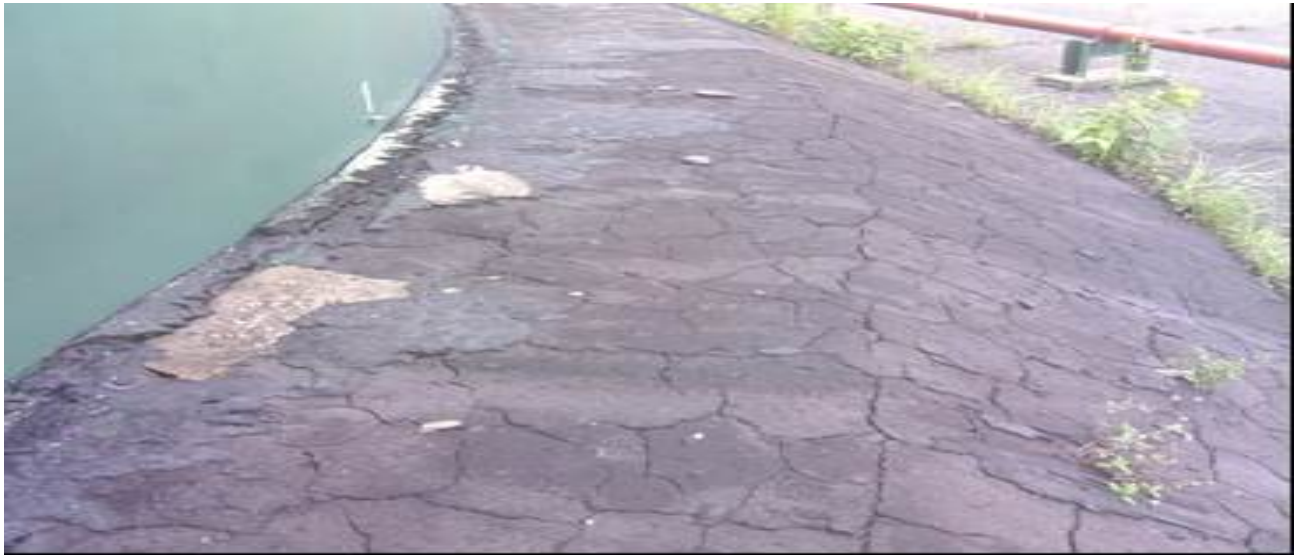
- Severe cracks on bituminous Tank pad
- Degraded expansion joint fillers and vegetation growth on expansion joints.

MULTIPLE CRACKS ON BITUMINOUS TANK PAD.

ASSET	CONDENSATE TANK T5501 AND CONDENSATE SURGE DRUM		
COMPONENTS INSPECTED	DEFECTS OBSERVED	MEASURE/SIZE OF DEFECTS/REMEDIAL ACTION	PRIORITY
CONDENSATE TANK T5501	Multiple cracks on bituminous tank pad	Remove and cart away degraded bituminous layer. Provide, mix and place BRC reinforced concrete grade 20 and make good 276m x 3.5 x 0.15m	1
	Pipe supports, personal access ladder/platform and Concrete bondwall – In good condition	No action is required	4
	Degraded expansion joint on concrete floor and vegetation growth along expansion joints	Remove vegetations with hand tools. Keep surface free and clean from debris. Provide and inject expansion joints with epoxy joint fillers and make good 256m x 0.1m x 10mm	2
CONDENSATE SURGE DRUM	Moderate cracks on concrete floor	Open up crack, prepare surface and treat with cement sand mortar or Epoxy Resin 21m x 0.1m x 5mm	2
	Personal access platform and elevated concrete foundation – In good condition	No action is required	4

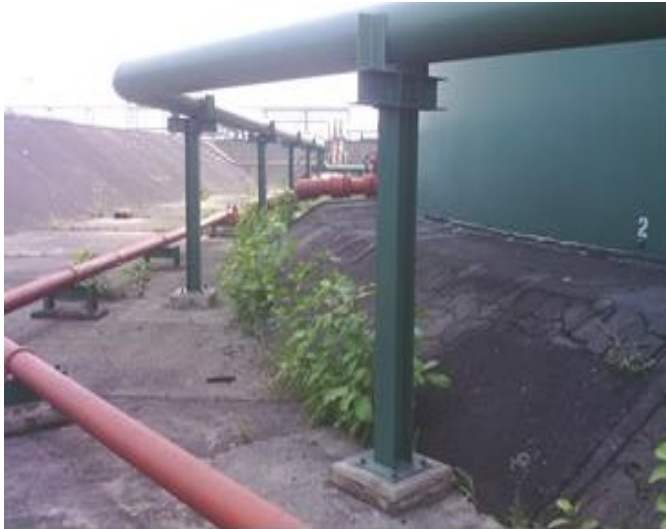
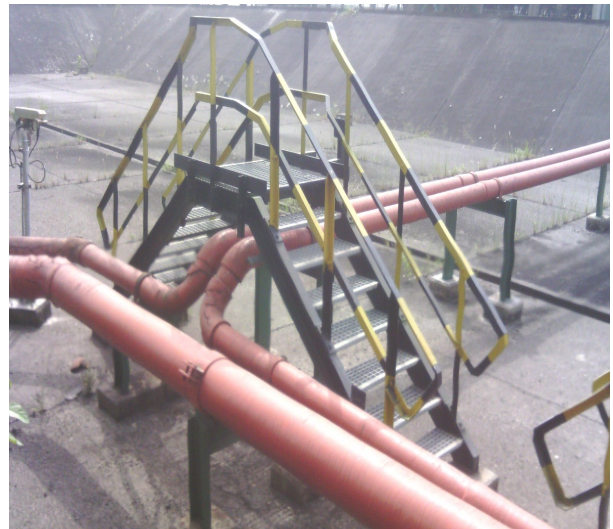
PIPE SUPPORTS, PERSONAL ACCESS LADDER/PLATFORM AND CONCRETE BONDWALL – IN GOOD CONDITION.

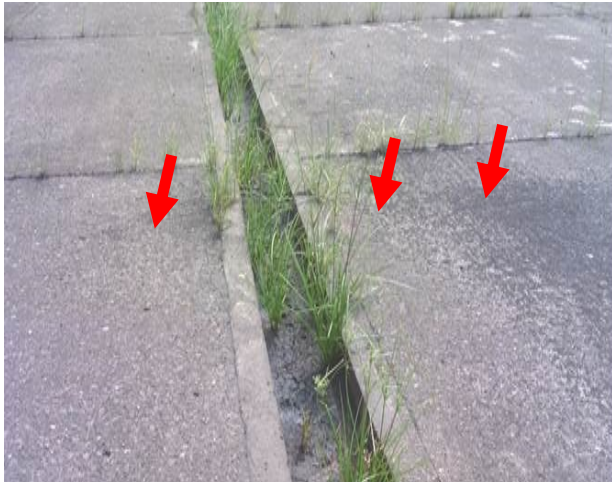
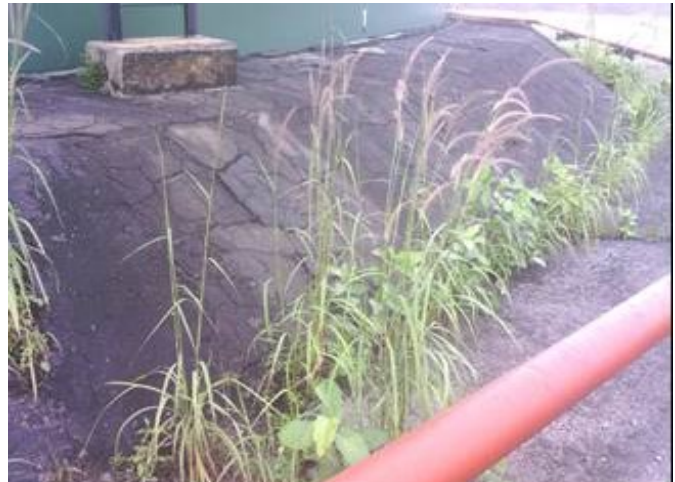
GRASSY PUP OUT ON DEGRADED EXPANSION JOINT FILLER ON CONCRETE FLOOR.

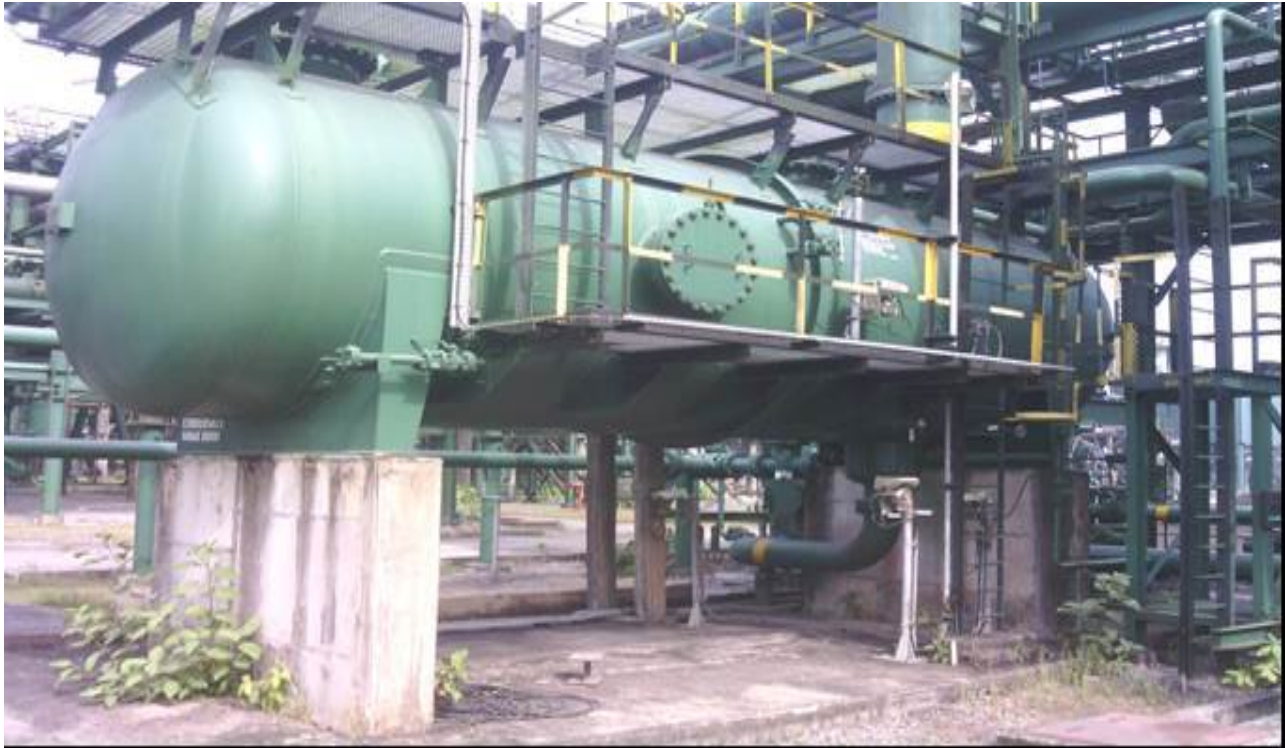
PERSONAL ACCESS PLATFORM AND ELEVATED CONCRETE FOUNDATION – IN GOOD CONDITION.

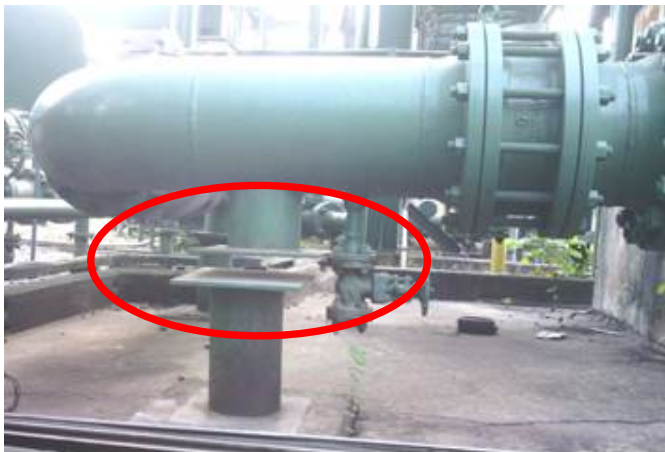
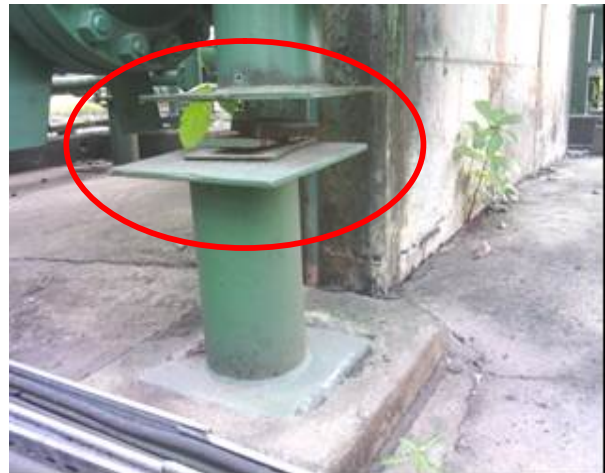
- Severe subsidence on pipe supports, tilted pipe supports and moderate cracks on concrete floor. These defects are escalated by excessive vibrations from nearby spiking pumps.

SEVERE SUBSIDENCE ON PIPE SUPPORTS

Severe subsidence on pipe supports.	Demolish and reconstruct affected pipe supports	1
	Tilted pipe supports	Straighen tilted pipe supports and connect them with crossed bracings	1
	Excessive vibrations from spiking pump	Use Neoprene Packing placed between the Pipeline and Supports to dampen the effects of vibrations from the Pipe.	1
		Carry out further review of the excessive vibration issues with Process, Mechanical and Pipeline Engineering disciplines	2

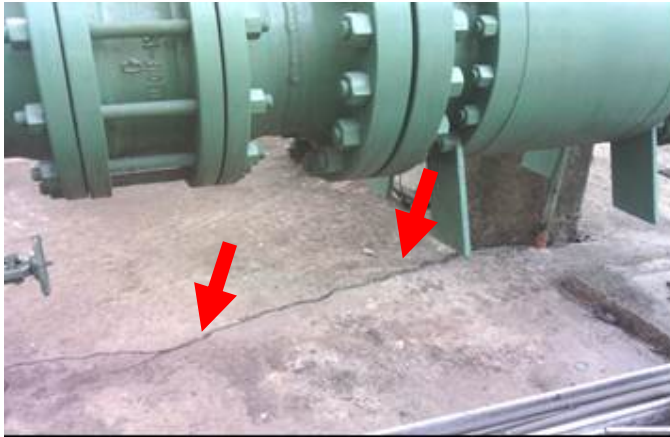
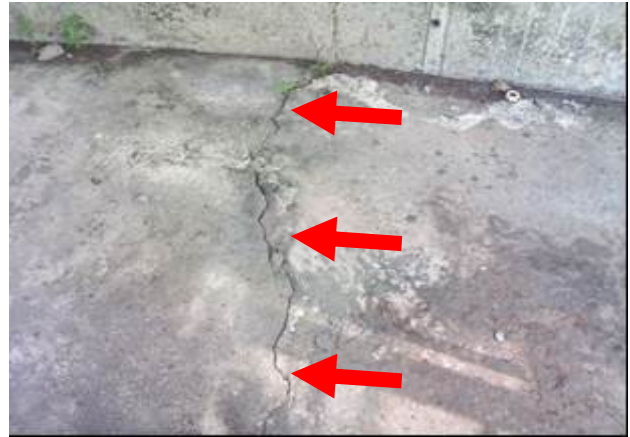
MODERATE CRACKS ON CONCRETE FLOOR.

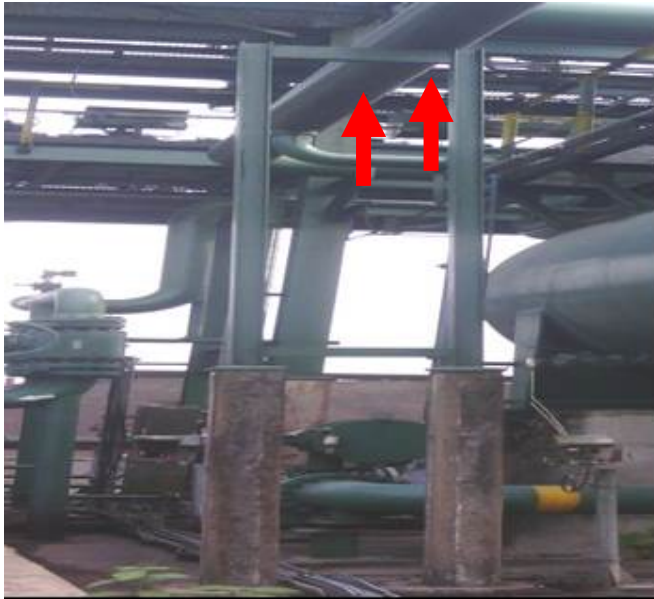
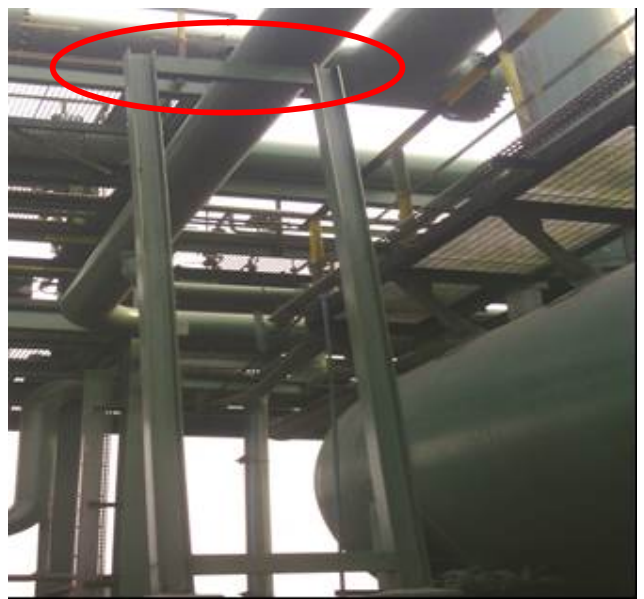
TILTED PIPE SUPPORTS.
