**Onshore Maintenance, Corrosion
and Inspection Organisation
(Civil/Struct Asset Integrity Insp.&
Mtce)**

**STRUCTURAL INTEGRITY
ASSESSMENT OF SOKU
FLOWSTATION – ANALYSIS OF
INCREASED VIBRATION LEVELS**

11th December, 2017

SPDC-2017-12-00000008

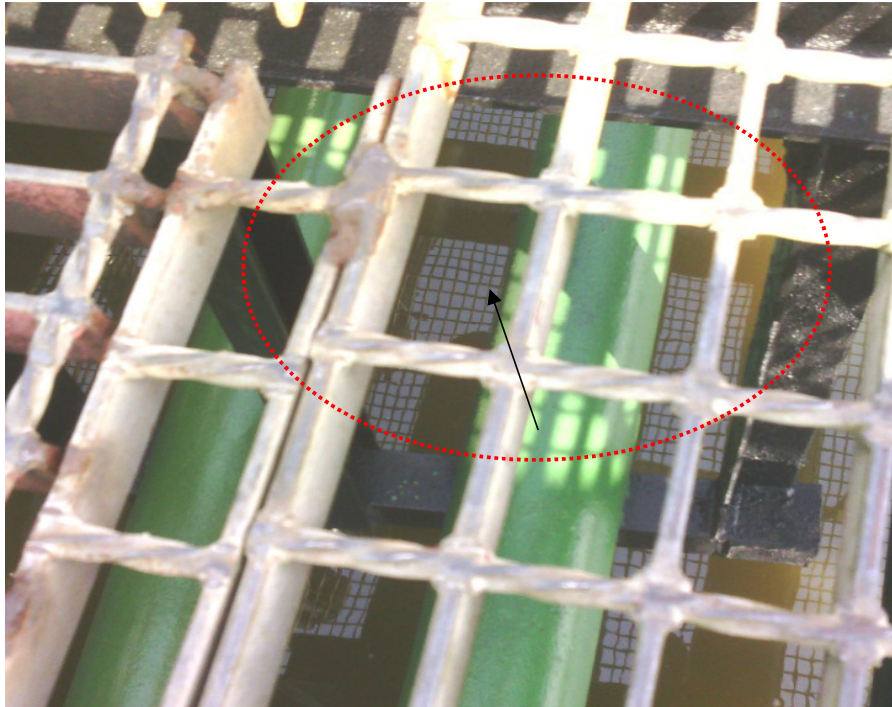
No lateral restraints (U bolts) on goal post type piping supports

1. Introduce U-bolts to restrain the 6" pipelines that are currently located below the grating to prevent lateral movements.
2. Tighten all bolts and screws on clamps fastened on pipelines.
3. Service the valves (suction and discharge) to help reduce fluctuation in flow.
4. Ensure that current operation of Pumps and Generators are within their integrity operating window as specified in the equipment design manual.
5. Continuously monitor vibration levels of the vibrating machinery on the Soku Flowstation.

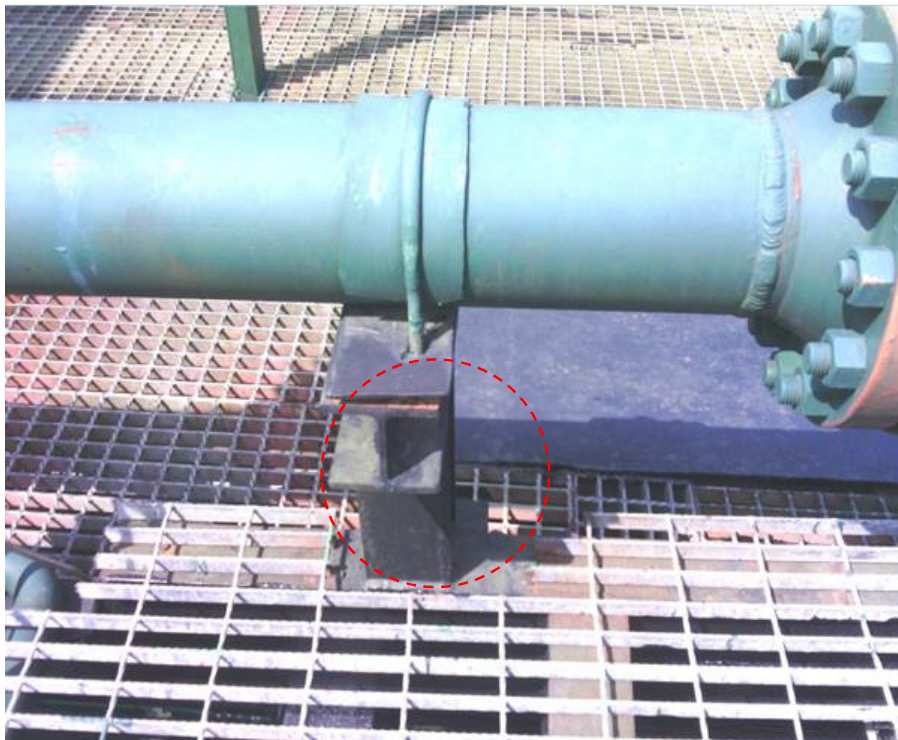
Loosely connected U bolts and piping supports structure
