**REPORT OF STRUCTURAL  
INTEGRITY ASSESSMENT OF  
GBARAN JETTY TOPSIDES &  
UNDERWATER STRUCTURES**

18<sup>th</sup> May 2022

SPDC-2022-04-00000161

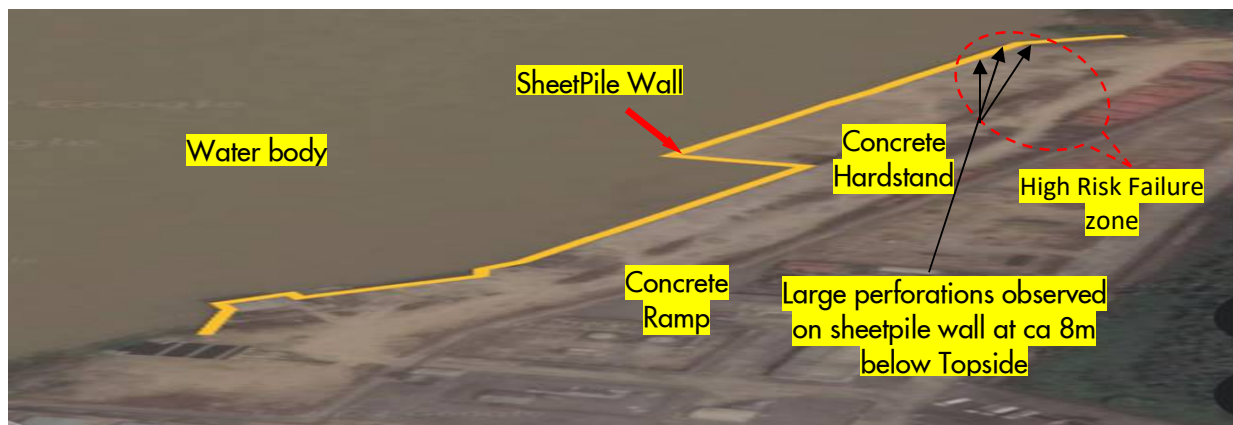
- Large perforations on section of the jetty sheetpile wall close to the military hut leading to severe loss of earth material and collapse of 1 No. lighting pole
- Severe scouring underneath section of concrete hardstand
- Severe corrosion and deformation of anchor tie rods

Figure 1 - Area View Of Gbaran Jetty showing high risk failure zone

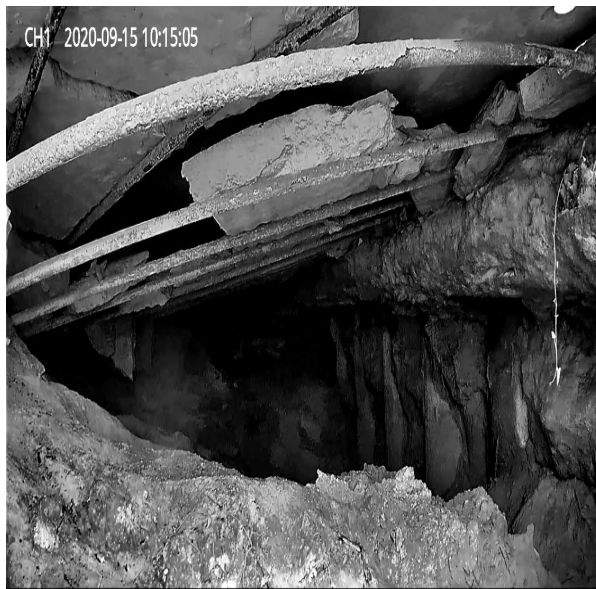
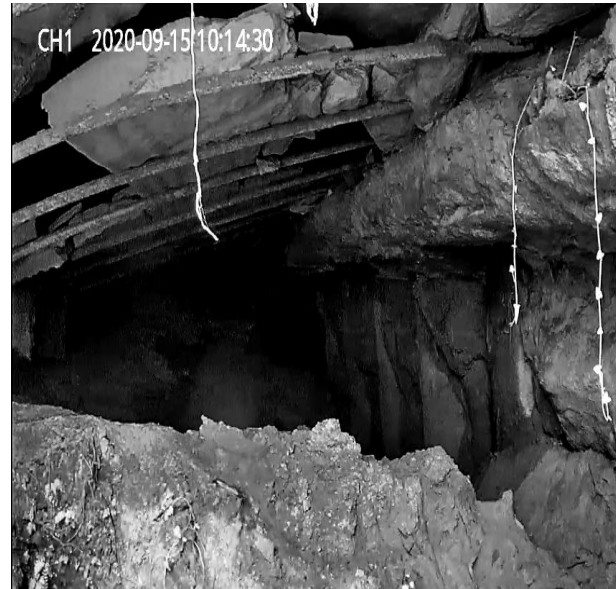
**COLLAPSED SECTION OF JETTY DUE TO SEVERE LOOSE OF EARTH MATERIAL BEHIND SECTION OF THE JETTY SHEET PILE CLOSE TO THE MILITARY POST.**

ASSET	GBARAN JETTY		
COMPONENTS INSPECTED	DEFECTS OBSERVED	MEASURE/SIZE OF DEFECTS/REMEDIAL ACTION	PRIORITY
SHEETPILE WALL CLOSE TO MILITARY CHECK POINT	3 No. large cavities on section of the jetty sheetpile wall at ca 8m below the topside close to the military check point	<b>Option 1</b> <ul style="list-style-type: none"> <li>Remove the 400mm concrete slab panel close to the - 400mmx6mx8m</li> <li>Cut off anchor tie rods across failed section to allow for excavation/access to the openings.</li> <li>Provide, mix and seal up openings with concrete grade 40</li> <li>Back fill around the openings using sand bags (1:3 cement/sand mix)</li> <li>Replace the cut sections of tie rod</li> <li>Provide, spread and fill and compact area with sharp sand - 18m x 9m x 2.5m</li> <li>Reconstruct hardstand and re-erect lighting pole</li> </ul>	1
	Severe loss of earth material and collapse of 1 No. lighting pole		1

Severe scouring underneath section of concrete hardstand		1
	Severe corrosion and deformation of anchor tie rods		1
		<b>Option 2</b> <ul style="list-style-type: none"> <li>Remove the 400mm concrete slab panel close to the - 400mmx6mx8m</li> <li>Cut off anchor failed tie rods across</li> <li>Weld plates to cover the openings - 0.85m x 3m long x 4Nos.</li> <li>Provide, spread and fill and compact area with sharp sand - 18m x 9m x 2.5m</li> </ul>	1
FENDERS	Moderately corroded	Prepare surface and apply self-priming Epoxy primer, Epoxy	2

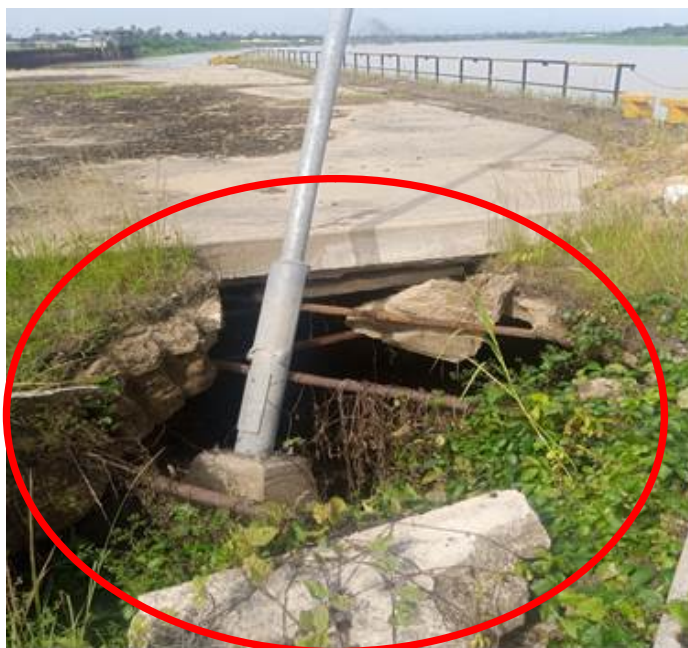
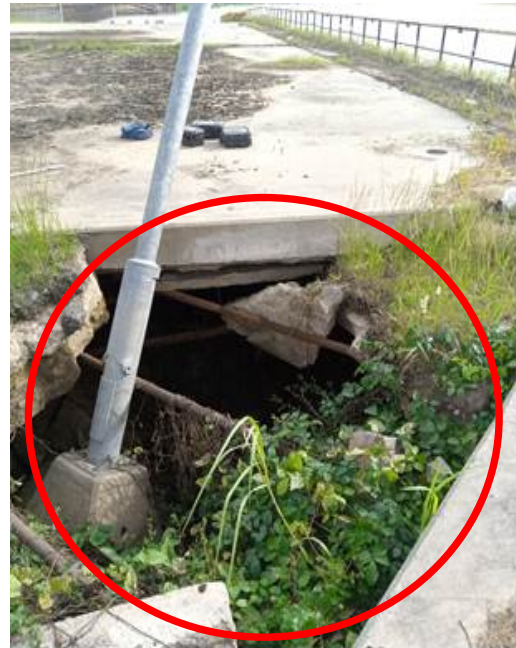
**COLLAPSED SECTION OF JETTY.**

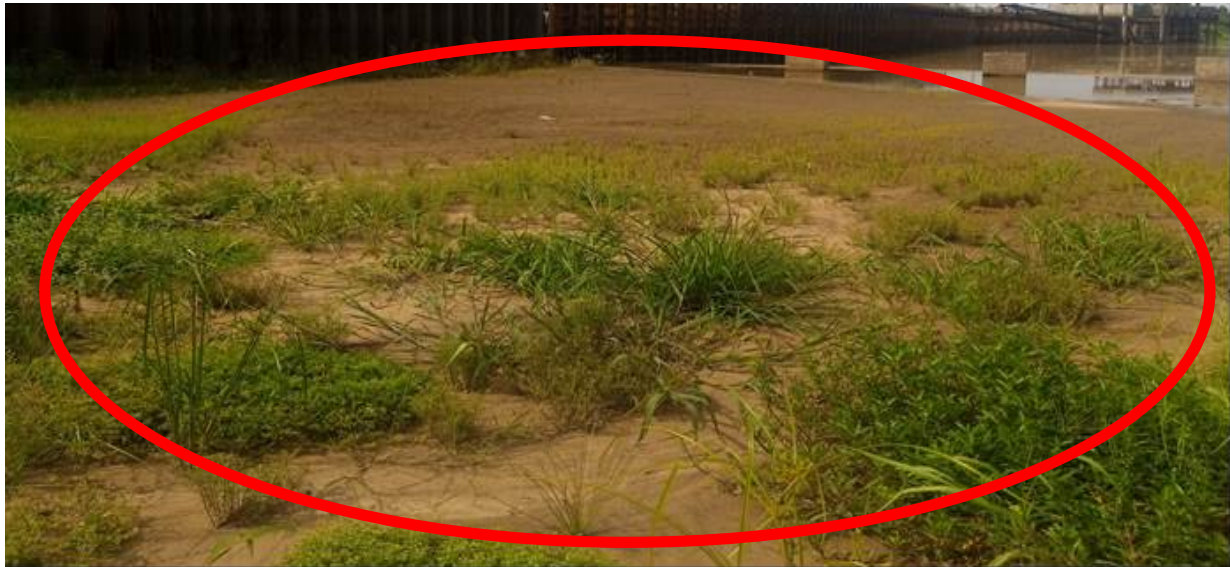
**VEGETATIVE GROWTH AND SILTED SECTION OF JETTY RAMP.**

fender supports	mid coat and Polyurethane topcoat, or other approved coating materials to the prepared surface 0.5 X 0.5m steel plate x 20Nos. x 40Nos.	
<b>CONCRETE JETTY RAMP</b>	Vegetative growth and silted section of jetty ramp	Remove vegetative growth with hand tool. Desilt ramp and make good	2
	Concrete spalling/broken sections with exposed reinforcements on edges of the concrete ramp	Prepare surface of exposed rebars. Provide, mix and treat spalled section with cement grout 0.85 x 2.5 x 0.3m x 2Nos.	2
	Broken section of Handrail	Provide, fix and weld Handrail Prepare surface and apply self-priming Epoxy primer, Epoxy mid coat and Polyurethane topcoat, or other approved coating materials to the prepared surface 0.045mm dia. CHS, 1.8m long	2
	Water seepages from wall of concrete ramp and moderate corrosion on sheet piles	Seal up opening with mortar mixed with water repellant cement additive. 0.8m x 0.4m x 2Nos.  Prepare surface and apply self-priming Epoxy primer, Epoxy mid coat and Polyurethane topcoat, or other approved coating materials to the prepared surface 5.5m x 250m wide	2

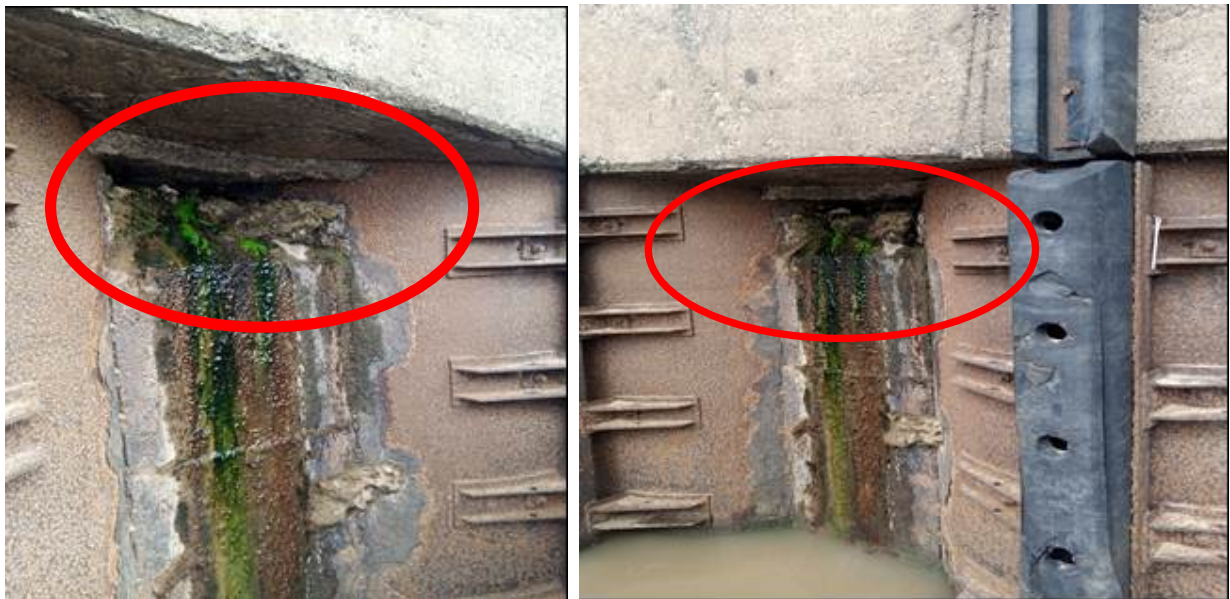
**WATER SEEPAGES FROM WALL OF CONCRETE RAMP AND MODERATE CORROSION ON SHEET PILES.**

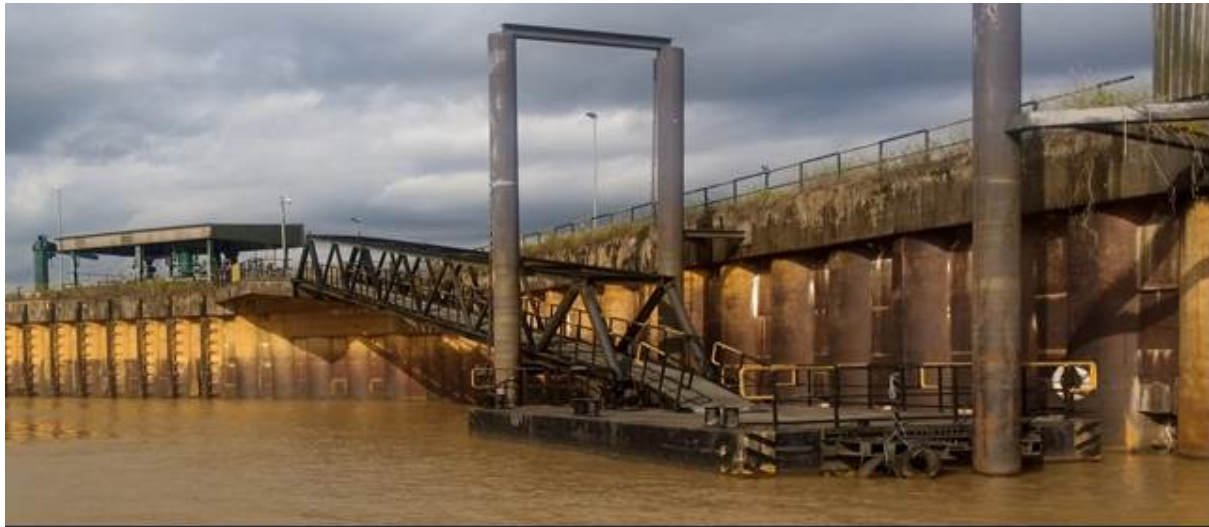
RAMP STEEL WALK WAY CLOSE TO FIRE WATER SHED: GRATINGS, GRATING SUPPORTS, STEEL STRUCTURAL FRAME, HANDRAIL AND STEEL LANDING.

Bollards – In good condition	No action is required	4
<b>RAMP STEEL WALK WAY CLOSE TO FIRE WATER SHED</b>	Gratings, Grating supports, steel structural frame, Handrail and steel landing	No action is required	4

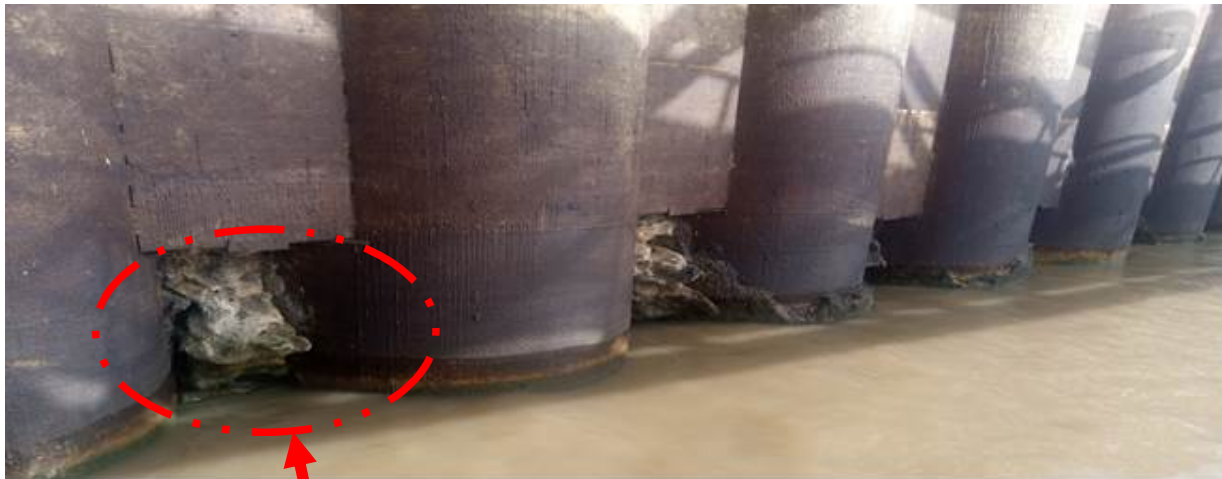
**PICTURE SHOWING AREA OF OPENING** (the labeled picture gives an example of what is happening under water)

Affected area with openings  
(0.8m x0.8m x 4Nos.)
