VIBRATION ASSESSMENT OF UNIT 55 PIPEWORK

LOCATION: SOKU GAS PLANT

REPORT NO: STATIC VIB/2022/EA/SGP-001

SURVEY PERIOD: 29th October – 3rd November 2022

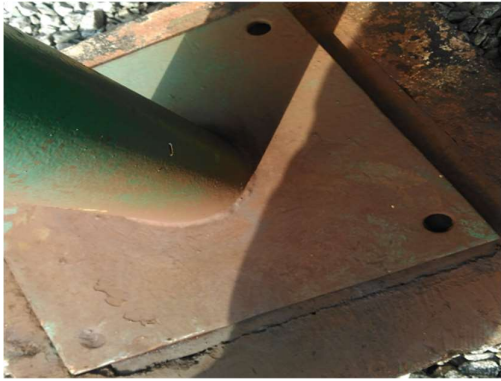
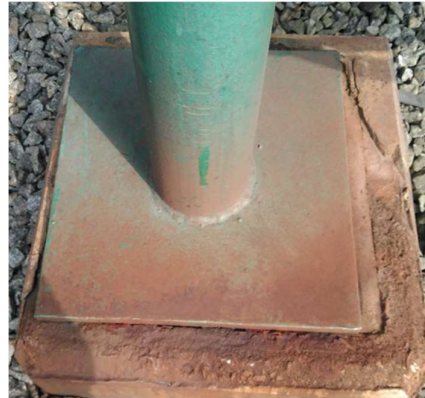
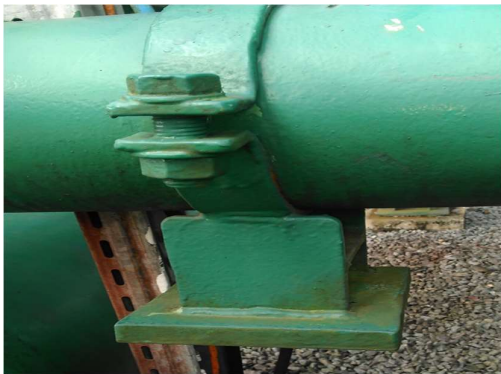
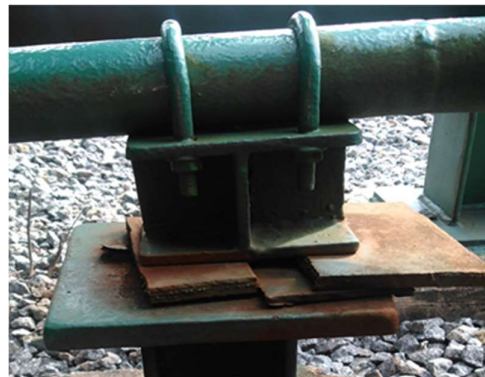
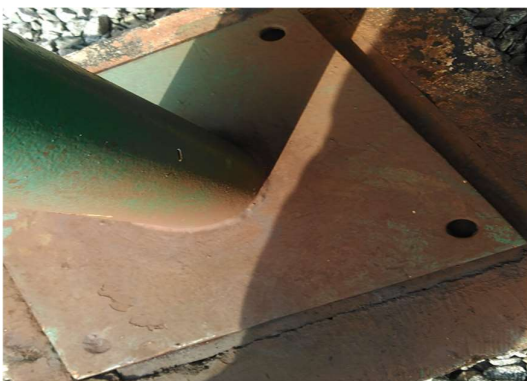
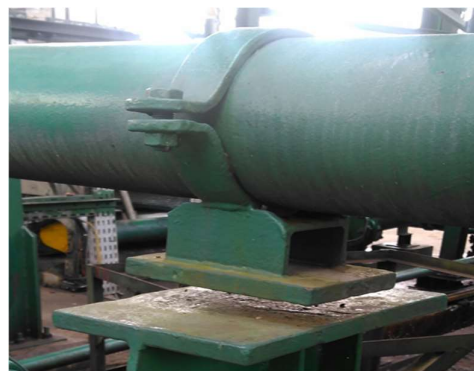
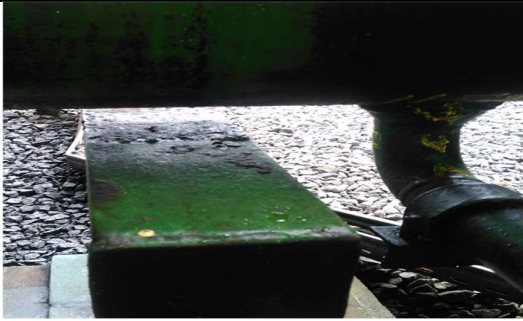
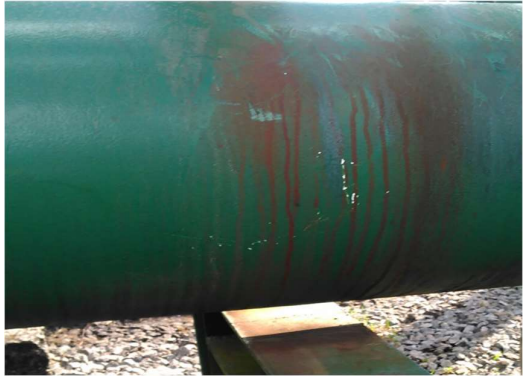
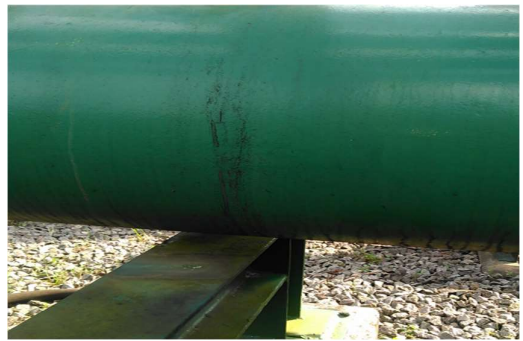
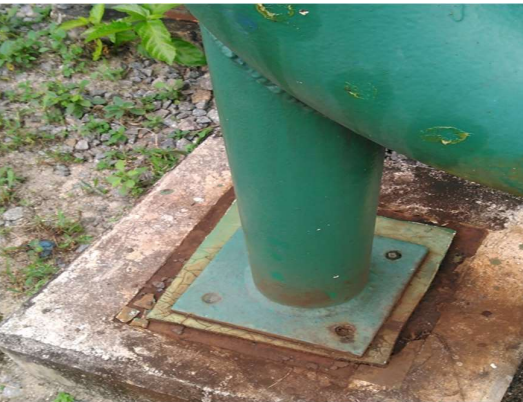
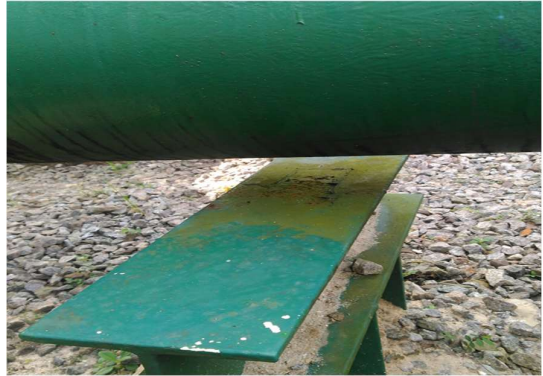
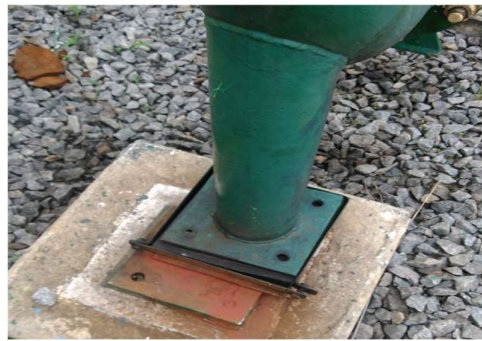
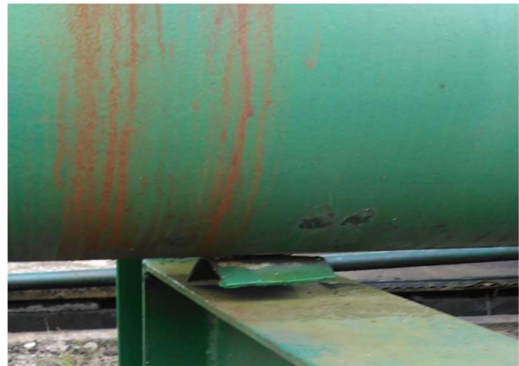
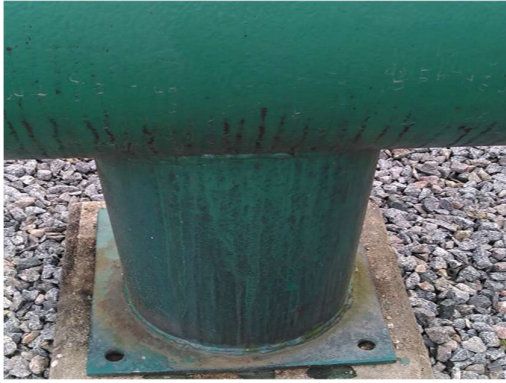
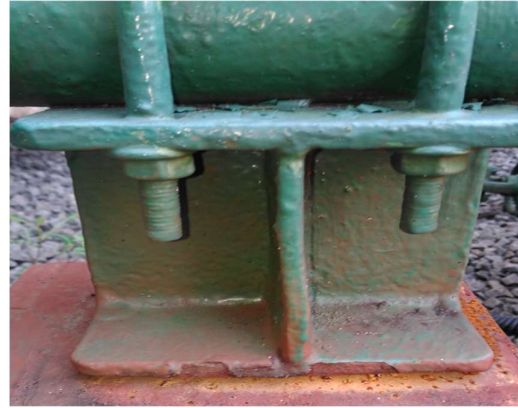
- c) Pipe support. The visual examination of the entire pipe support around the condensate spiking pumps revealed the following.
 - Failed/no resilient pad between support and pipe.

- Concrete pipe support plinth detached from the ground.
 - Pipe work is flexible and insufficiently stiff. A catalyst for excitation
 - Pipework guide support slid off hanger allowing the pipework to vibrate.

- Poor practice of missing or damaged support.
 - Defective support foundation.
 - Pipework clear of resting support (air gap).
 - Temporary fix of mass loading to detune of a structural resonance still in place.

- No support/bracing/clamping for SBCs on discharge and suction lines.

Table 1 - Pictures depicts the current defective state of the pipe support system of the pipework around the spiking pumps.

The inspection thus revealed a total failure of the entire pipe support system around the condensate spiking pumps. This total collapse of the support system/structure exposes the entire pipework to vibration initiated by excitation of natural frequencies by the least excitation force.

2. Tighten up clearance on support; the existing clearances on the pipework allow the pipework to move freely resulting in excessive vibration. By tightening the clearance on the support, the fundamental natural frequency of the pipe is increased thus reducing energy level in the system.
3. Avoid metal to metal contact; Install wear resistant compliant layer/ resilient pad between the pipework and the support surfaces to avoid the risk from fretting.
4. Reduce fluid velocity: Increasing the diameter of the main pipe and the operating conditions will reduce the excitation energy from fluid induced turbulence and the response of the pipework. Reduction in excitation energy and the response of the pipework will reduce the vibration level currently experienced in the system.
5. Install anti-vibration mounts to isolate the source of excitation from the rest of the system.

6. The speed of the condensate spiking pump should not be within $\pm 20\%$ of the nearest acoustic natural frequency.
7. Install two (2) plane brace and clamp on the SBCs located on the discharge drain line and the suction drain line on each of the spiking pumps A, B, C & D. Ensure that the SBCs are firmly supported.
