REPORT ON CORROSION CONTROL SERVICES AND FACILITY PAINTING OF UNIT 14 PRODUCED WATER PLANT

Rev	Description	Status	Date	Prepared by	Review & Approved by
0	Report on Corrosion Control Services and Facility Painting Of Unit 14 Produced Water Plant	Issued for Approval	18/04/22	Osunkoya Ruth	Opel Joel

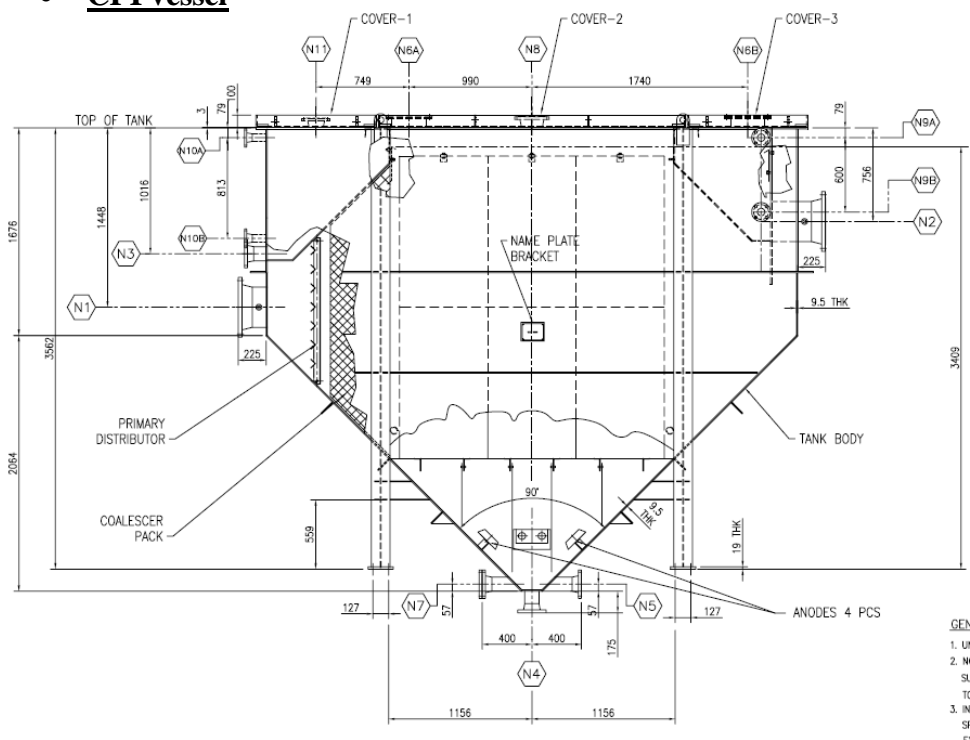
- **CPI vessel**

A total of 10 numbers of CPI vessels (2 per train) was worked on during this project. The surface area for each vessel was 61.42m². This brings the total area for the 10 vessels to 614.2m².

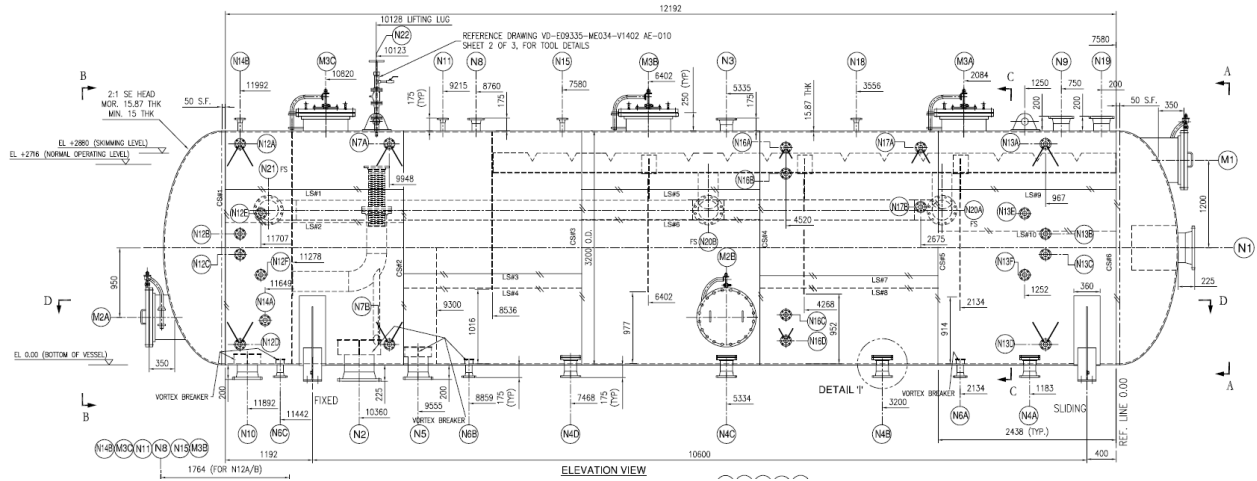
- **ISF Vessel**

A total of 5 no's of CPI vessels was worked on during this project. The surface area for each vessel is 143.7m². This brings the total area for the 5 vessels to 718.5m².
